*Mr. Wick*14UD TANK OPENING REPORT NO.11April 3rd to May 10th 1978
(37 days; 27 working days)PREAMBLE:

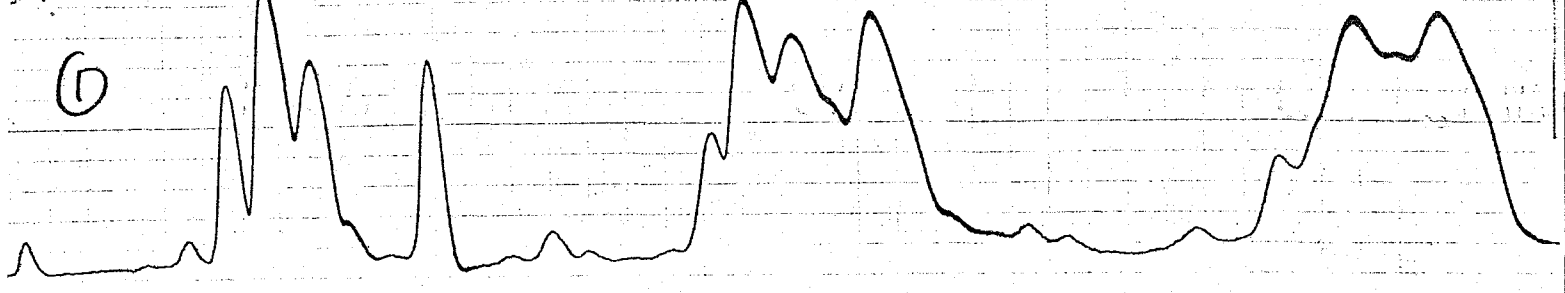
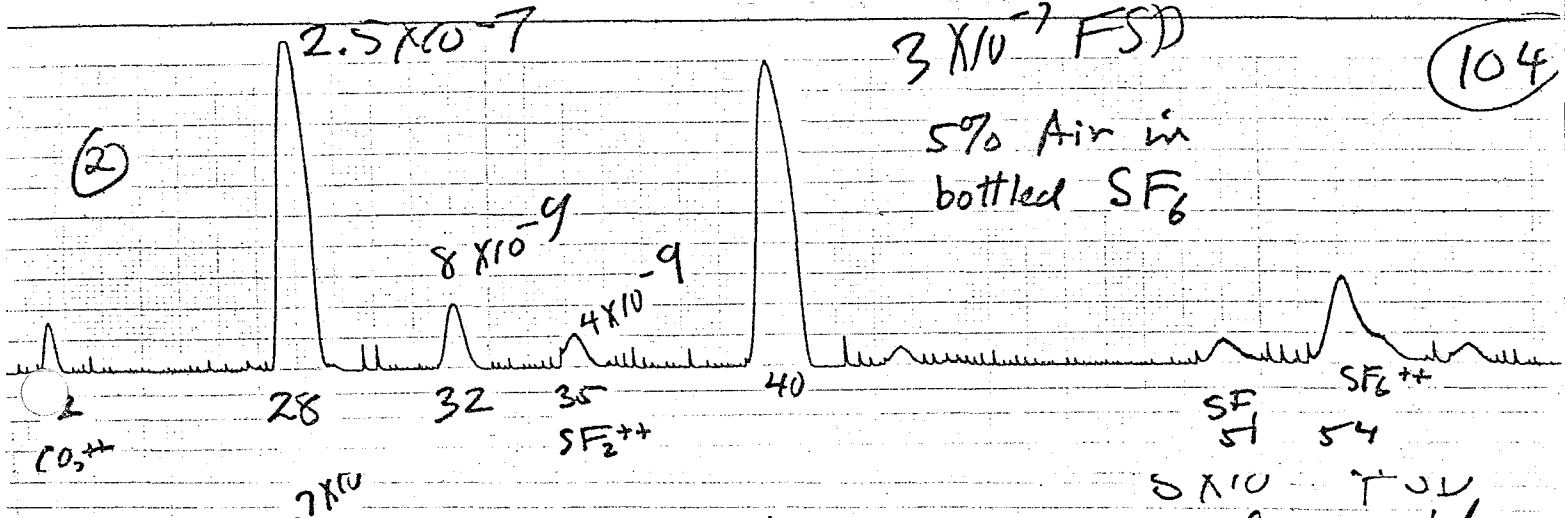
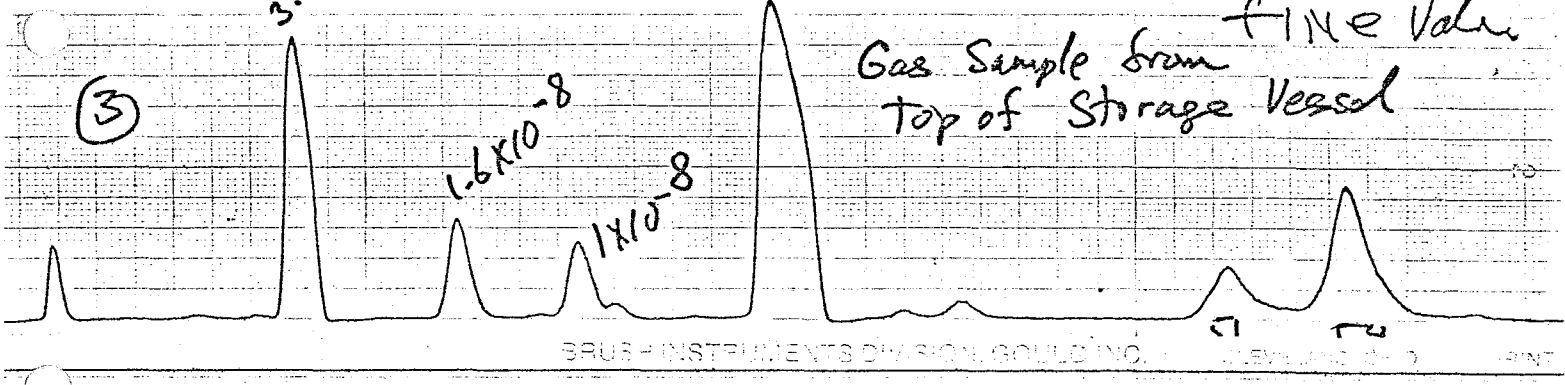
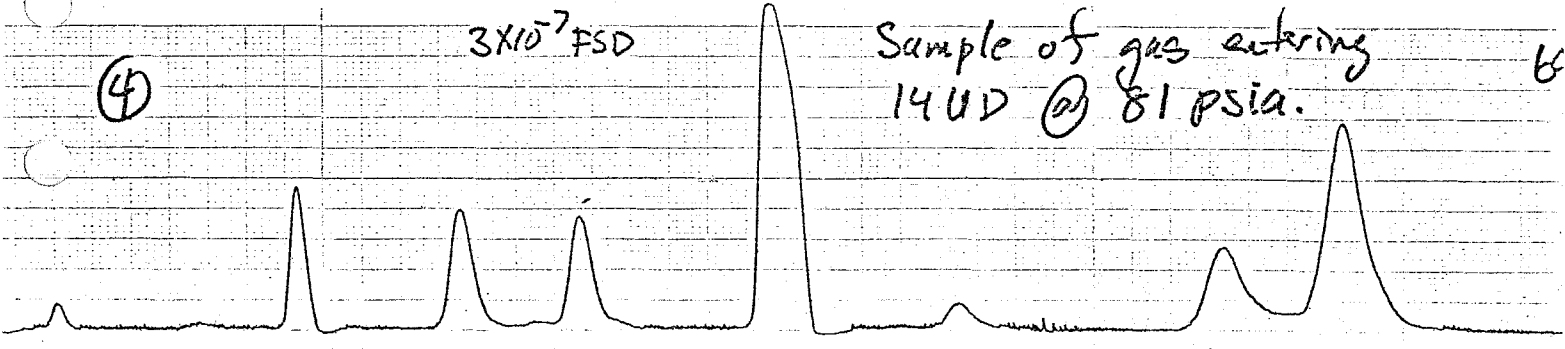
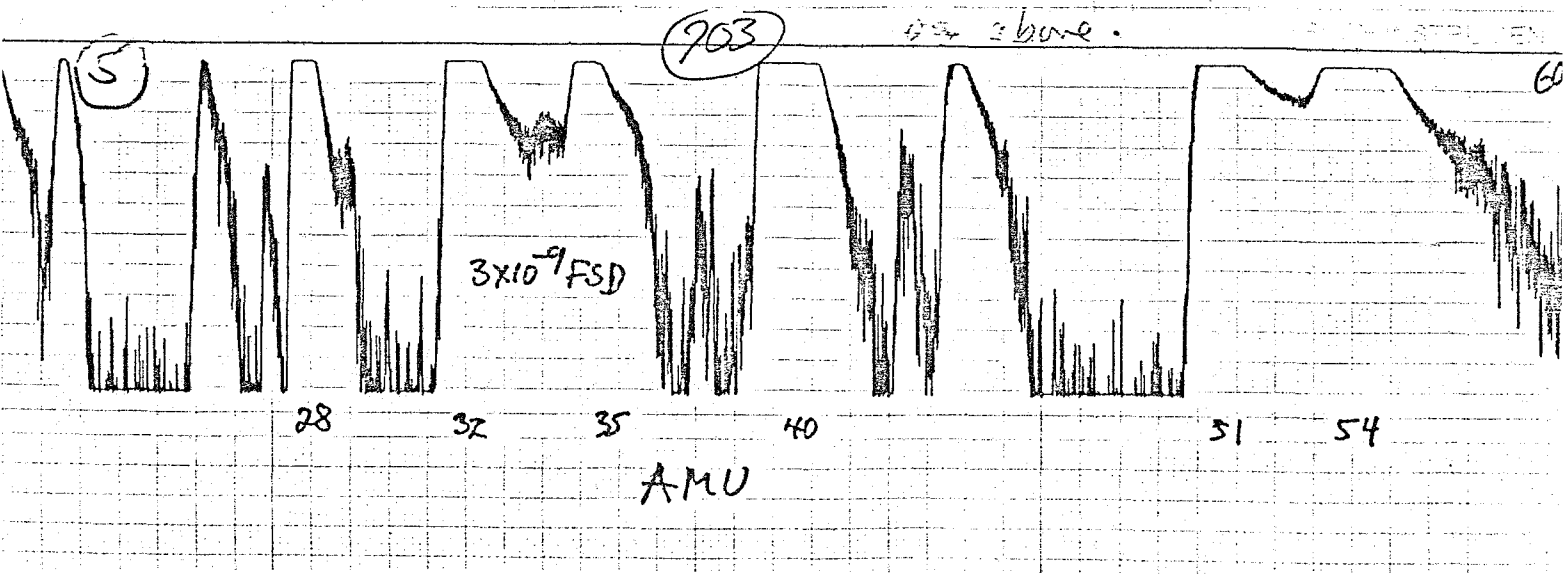
The graphs enclosed show the mass spectrometer response for various samples in log scale. The top trace displays the many dominating peaks characteristic of oil contamination; this sample was taken from the liquid phase in the storage vessel. The oil peaks predominate over the SF6 peaks which are at 32, 35, 51 and 54 amu.

The next trace, No. 2, is for a sample of commercial gas adulterated with 5% air, by volume.

The third trace is a sample from the top of the storage tank, i.e. gas phase. Clearly it is free of oil peaks, but it indicates about 3% air.

The fourth trace is the gas entering the accelerator vessel when at 81 psia.

The fifth, (bottom) trace is the same sample as the fourth, but amplified by a factor of 100.

Clearly SF6 peaks dominate the spectrum. The high mass (48 - 240 amu) portion of the spectra are compared in the second page of graphs. The top trace, and its linear version directly below, show the oil contamination. The bottom two traces show no sign of oil at 80 psia.

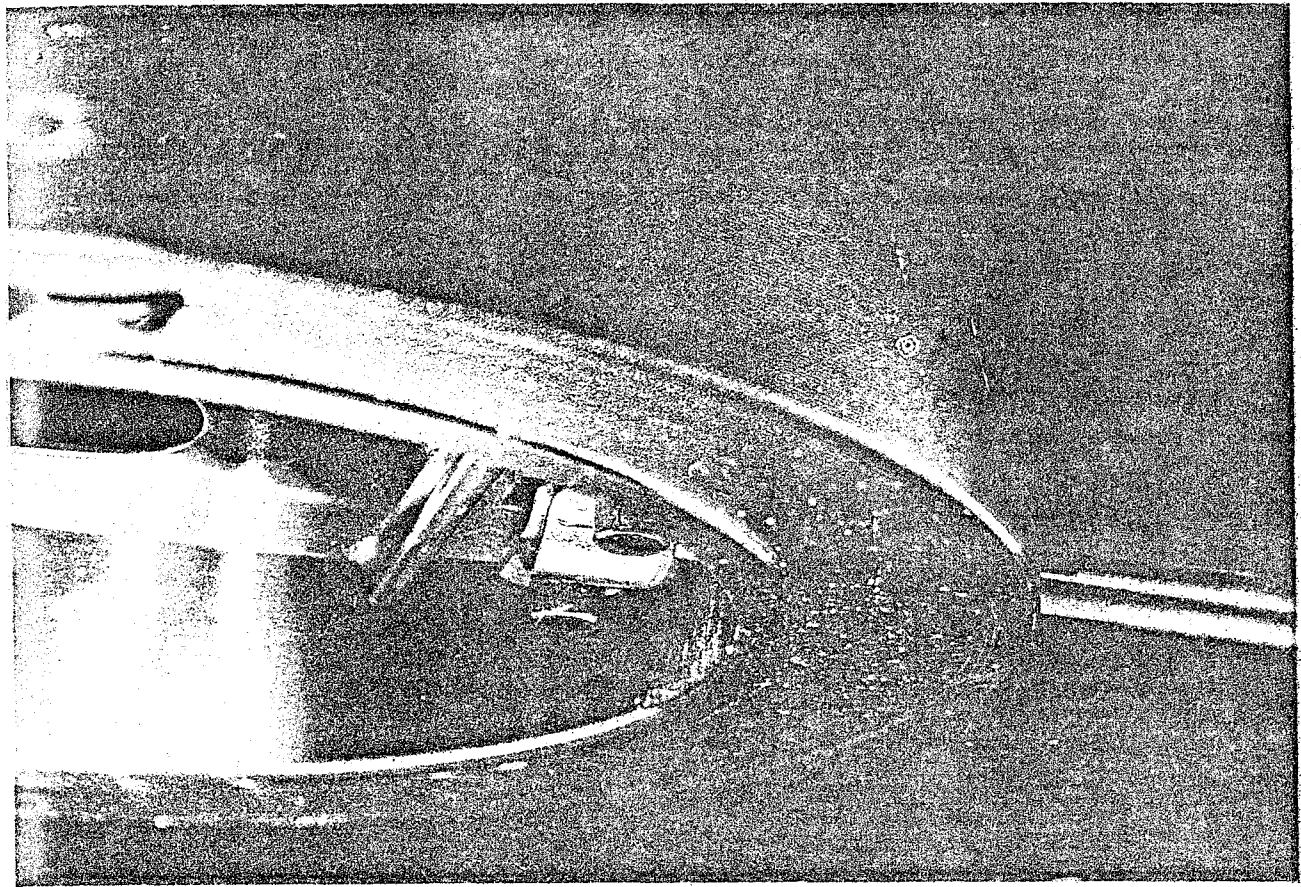
Photograph of carbon foil.

It has been observed for some time that the only change in thickness of stripper foils removed from the 14UD terminal has been in the neighbourhood of dust particles stuck to the foils. At these places a thinned halo appears around a more dense dust particle. In the absence of carbon build-up, in principle achievable only in a carbon-free system, such imperfections might be a limiting factor in foil lifetime. Indeed, the occasional 'super' foils, which operate for more than 24 hours with 500 nA of MgH_3 incident, may, by chance, be dustfree.

A final limitation on foil life must be thinning of the foil due to sputtering. The stripper assembly now displays a clear pattern of sputtered carbon from the foils. The downstream components of the assembly are discoloured with clear shadow lines from the foil. There is no discolouration on the upstream side of the system.
