AUSTRALIAN NATIONAL UNIVERSITY

DEPARTMENT OF NUCLEAR PHYSICS

14UD TANK OPENING REPORT NO.14

Four openings: November 28th to December 6th (9 days; 7 working days)

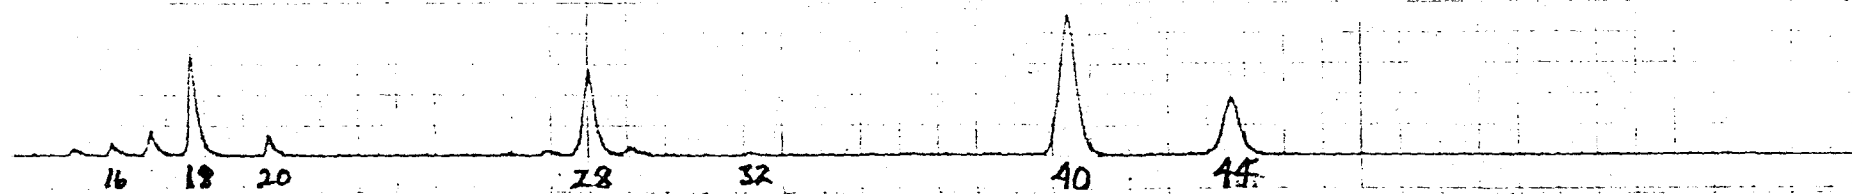
#1

ISOLATED SYSTEM  
 $1.8 \times 10^{-8}$  TORR

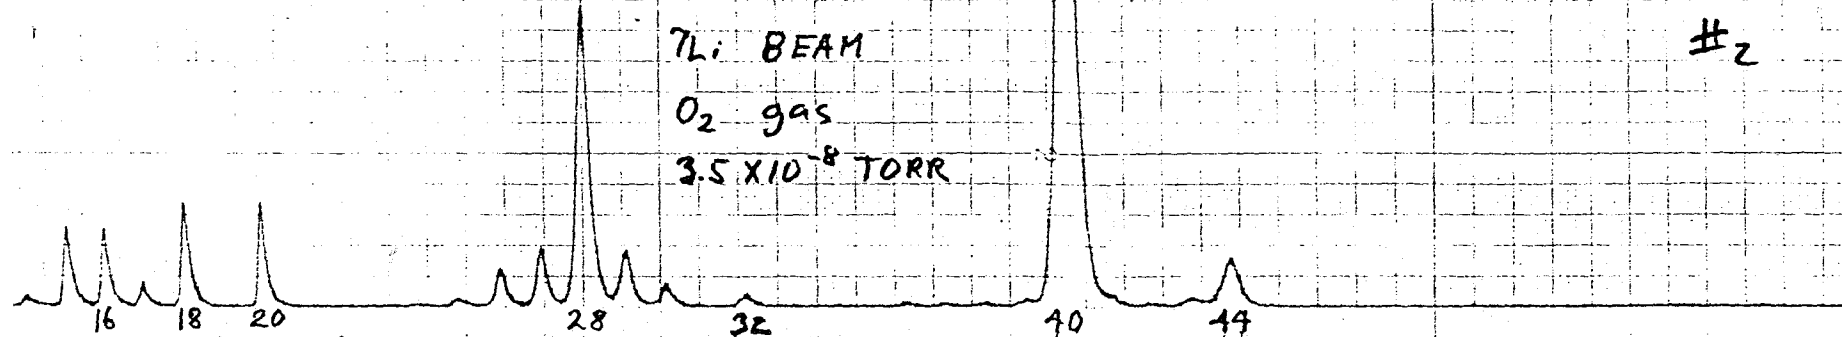
#2

7Li BEAM  
 $O_2$  GAS  
 $3.5 \times 10^{-8}$  TORR

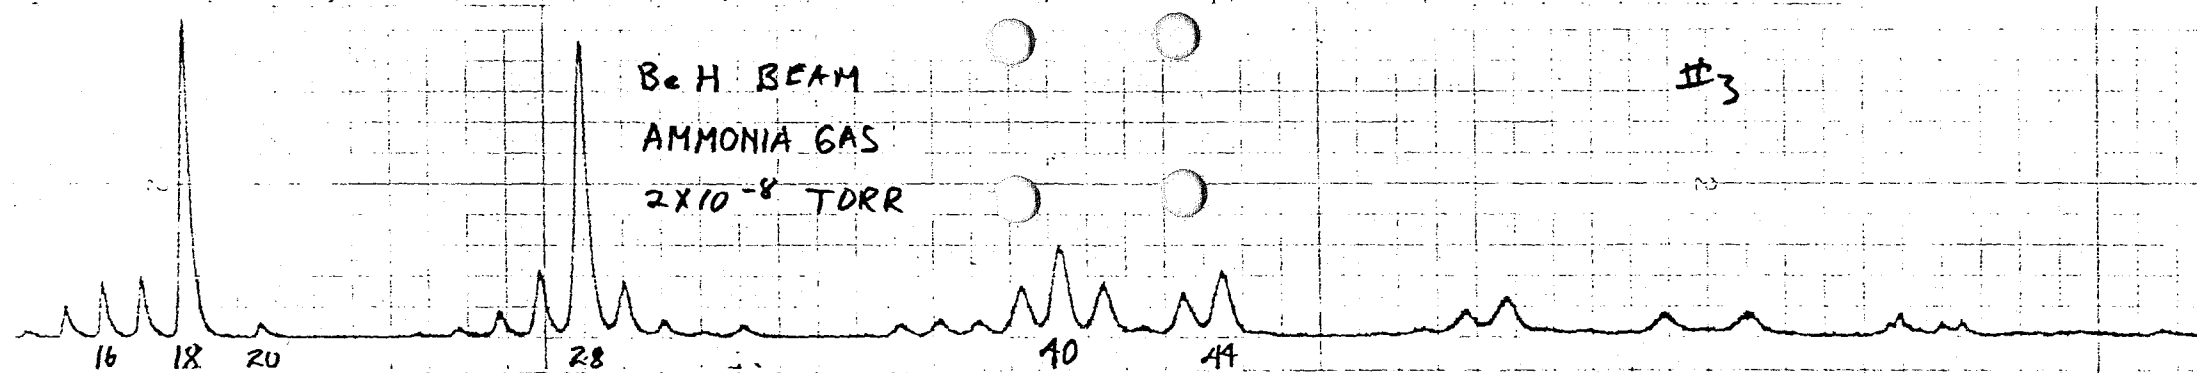
#3

Be H BEAM  
AMMONIA GAS  
 $2 \times 10^{-8}$  TORR

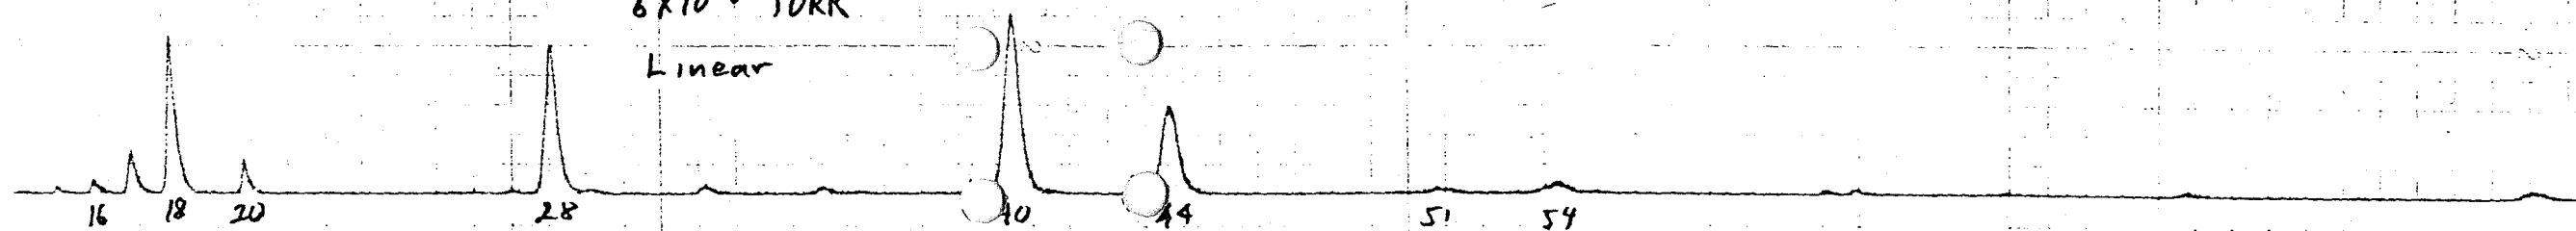
#4

A Vacuum Generators Micromass 2A residual gas analyzer has now been installed at the low energy pumping manifold. Several spectra are included. Our experience of interpreting the spectra is quite meagre. The effects of an SF<sub>6</sub> leak can be seen clearly (#4 and #5), likewise the difference when the sputter source is using ammonia (#3) and oxygen (#2). The isolated machine spectrum (#1), shows a large H<sub>2</sub>O (mass 18) peak. The large ratio of 28 to 32 suggests that the 28 may be mostly from CO rather than N<sub>2</sub>. We shall continue to monitor the residual gas spectrum in order to gain a firmer understanding.

$SF_6$  LEAK  
 $6 \times 10^{-8}$  TORR  
Linear

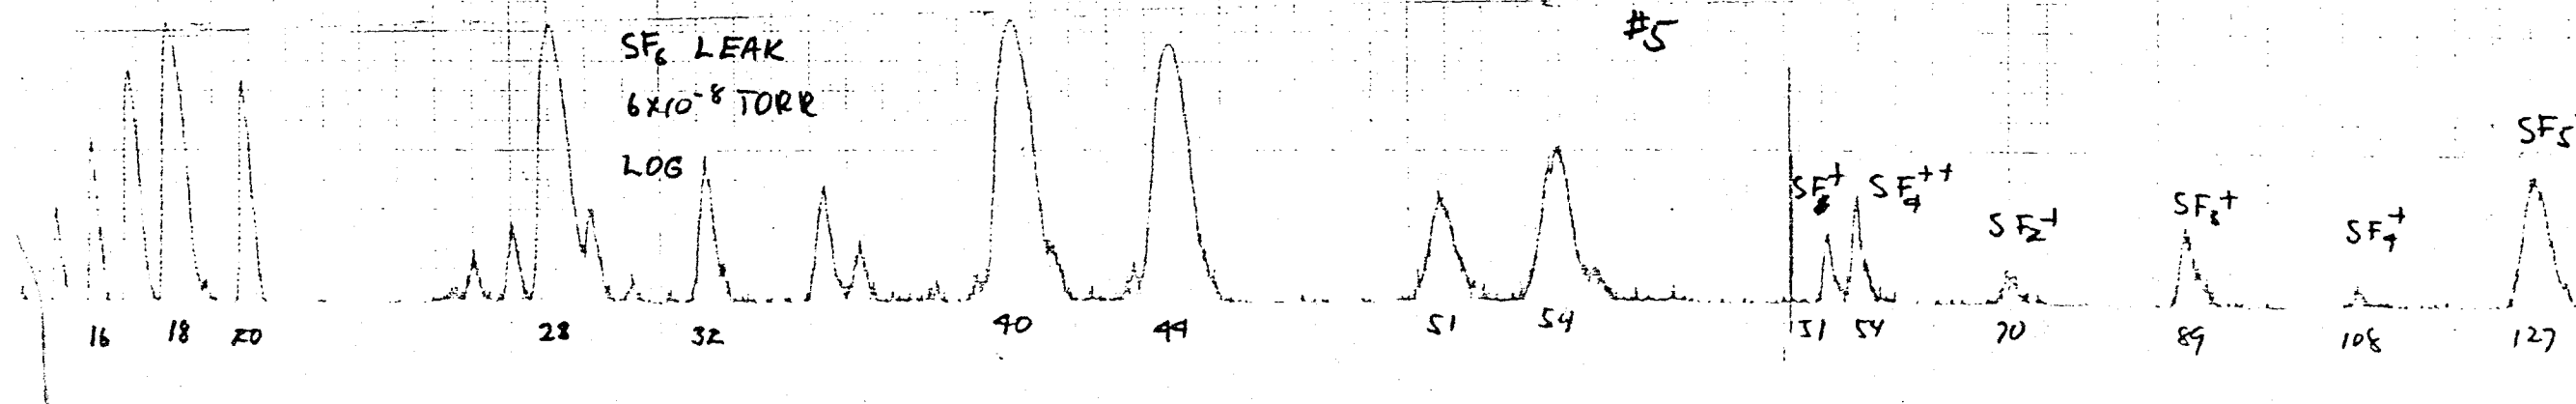
#5

$SF_6$  LEAK  
 $6 \times 10^{-8}$  TORR  
LOG
