AUSTRALIAN NATIONAL UNIVERSITY

DEPARTMENT OF NUCLEAR PHYSICS

14UD TANK OPENING REPORT NO. 25

(February 24th to 26th. 1981)  
(3 days open)

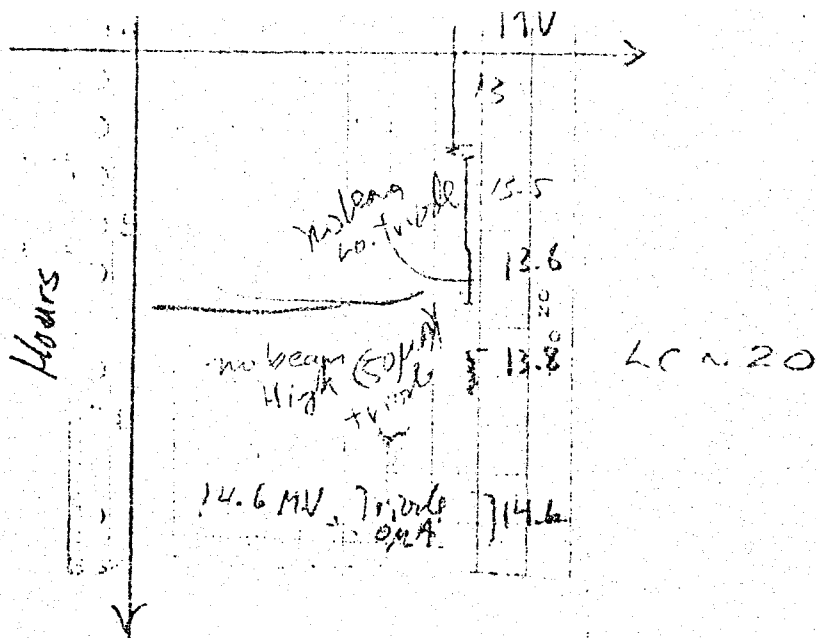
Lost charge, and terminal voltage instability associated with normal triode current (50 microamps) returned as a problem. With no beam to control on, and 50 microamps triode current, the terminal would vary by about 500 kV over a few minutes (see graph). The effect of this instability on experiments was minimized by operating with 10 to 15 microamps triode current. Here the instabilities were proportionately less and the slit control could compensate for them.

② 13 MV 50µA triode LC = 18 ~~µA~~
