AUSTRALIAN NATIONAL UNIVERSITY

DEPARTMENT OF NUCLEAR PHYSICS

14 UD TANK OPENING REPORT NO.26

(16th to 22nd June, 1981)
(7 days open; 5 working days)

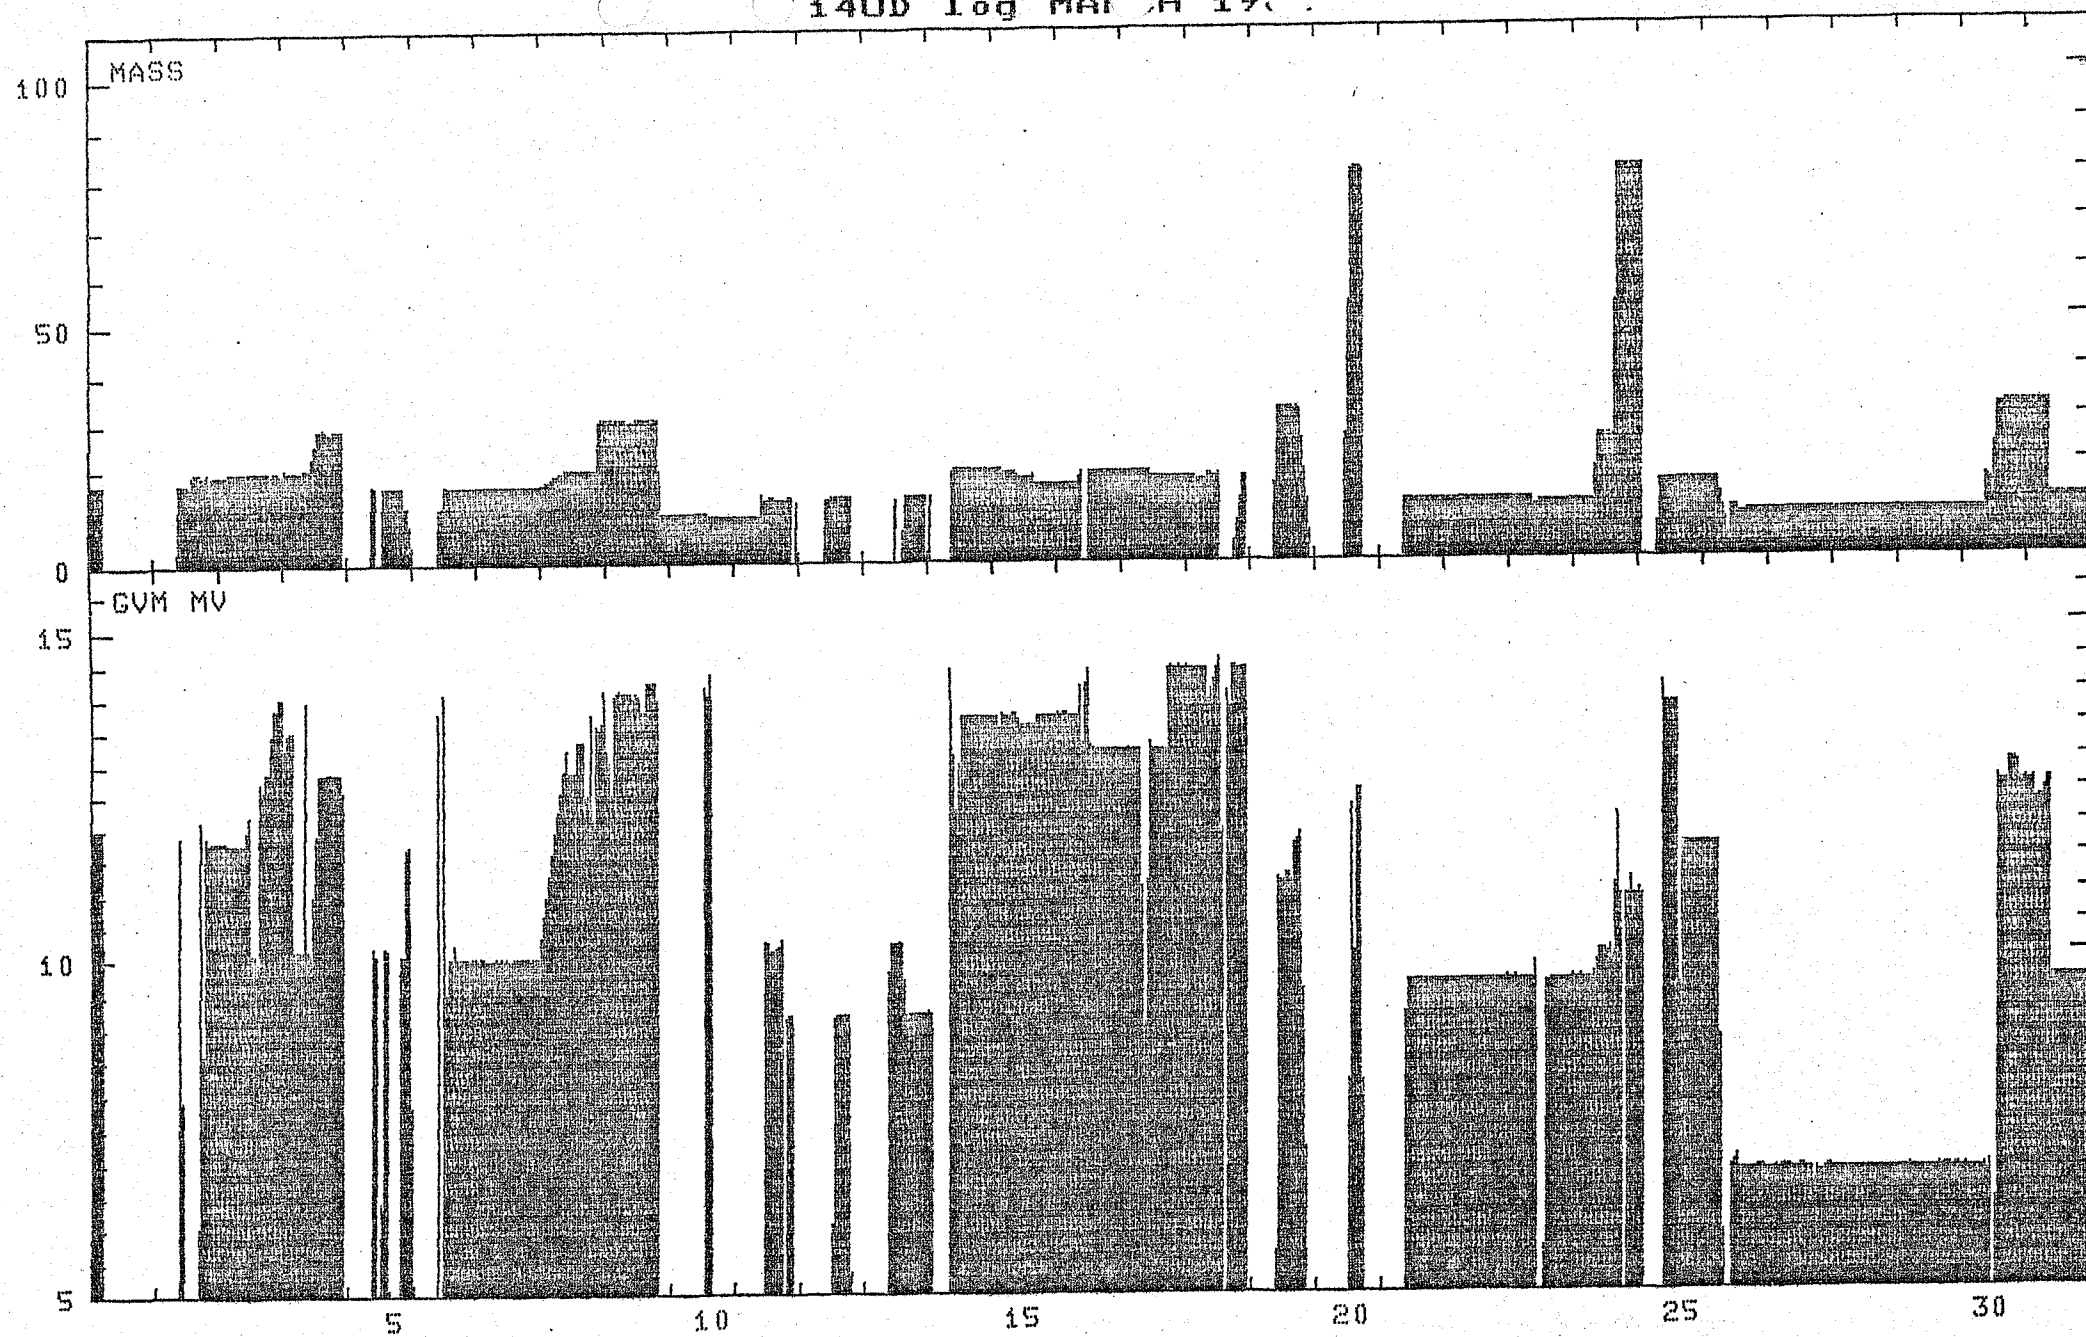
14UD 10g APRIL 1981

On the 4th day after closure conditioning began at 14.1 MV for 101 p.s.i.a. tank pressure, and quite soon the level improved with use, in fact an experimenter took data for about half an hour at 14.87 MV with no sparks. (See voltage plot for April 16th).
