AUSTRALIAN NATIONAL UNIVERSITY

DEPARTMENT OF NUCLEAR PHYSICS

14UD TANK OPENING REPORT No. 35

25th to 28th May 1982

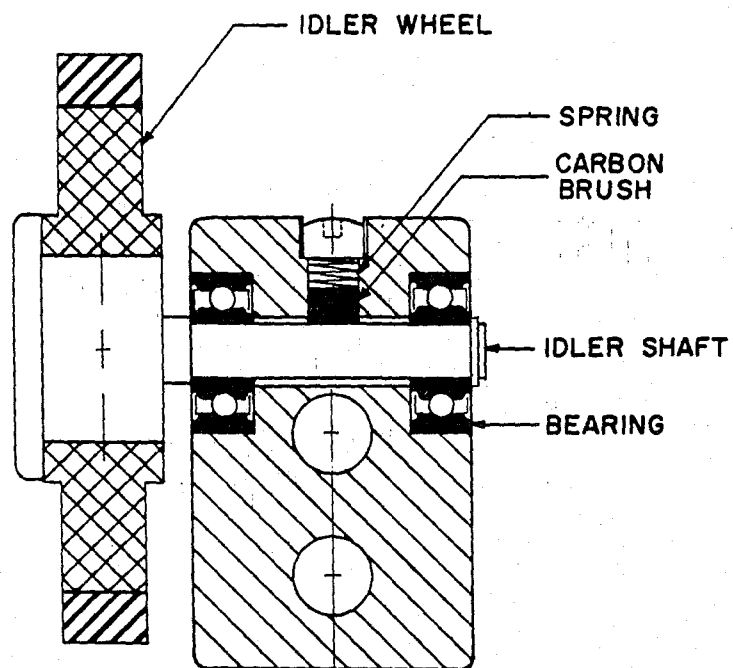
TOP VIEW A.N.U. DESIGNED  
CASTING IDLER FOR 14UD

When installed, our machine was equipped with standard N.E.C. idlers. The assembly at each position comprises three wheels, each 2.75 inches in diameter. At that time spark shields had not been invented. Over the years we had consistent trouble with idler bearings due, we felt, to spark damage of the balls. In order to alleviate this problem we redesigned the idler assembly so that the inner race could be referenced to local ground through a carbon brush, (14/2), (see drawing enclosed). Unfortunately, this involves a press fit of the new steel idler shaft into the bearings. When our main machine shop was asked to manufacture 72 shafts, production run variations resulted in some tapered shafts. In cases where the shaft was looser than a press fit spark erosion of the shaft rapidly occurred. In an effort to salvage undersized shafts, we nickel plated them up to the specified dimension to plus or minus 0.0002 inches. However, as for most things for accelerators, this procedure was carried out under the time pressure of a tank opening. We reported details earlier (26/3).

In the short term, June 81 to September 81, plating seemed to be a successful solution. However, we soon discovered that, in pressing a shaft through the first bearing, the nickel plating was scraped off and was not present in the inner race of the second bearing. We had no way of knowing in how many cases this had occurred. Suffice it to say, we found spark eroded shafts where they contacted second bearing inner races. In November 81 we received from the workshop a new full set of properly machined idler shafts and, from then onwards, we have been installing them wherever replacements were necessary. Because of these confusing secondary failures due to dimensional quality control, we are unable to assert that the design using a carbon brush results in longer bearing lifetimes.
