AUSTRALIAN NATIONAL UNIVERSITY

DEPARTMENT OF NUCLEAR PHYSICS

14UD TANK OPENING REPORT No. 36

23rd to 26th August 1982

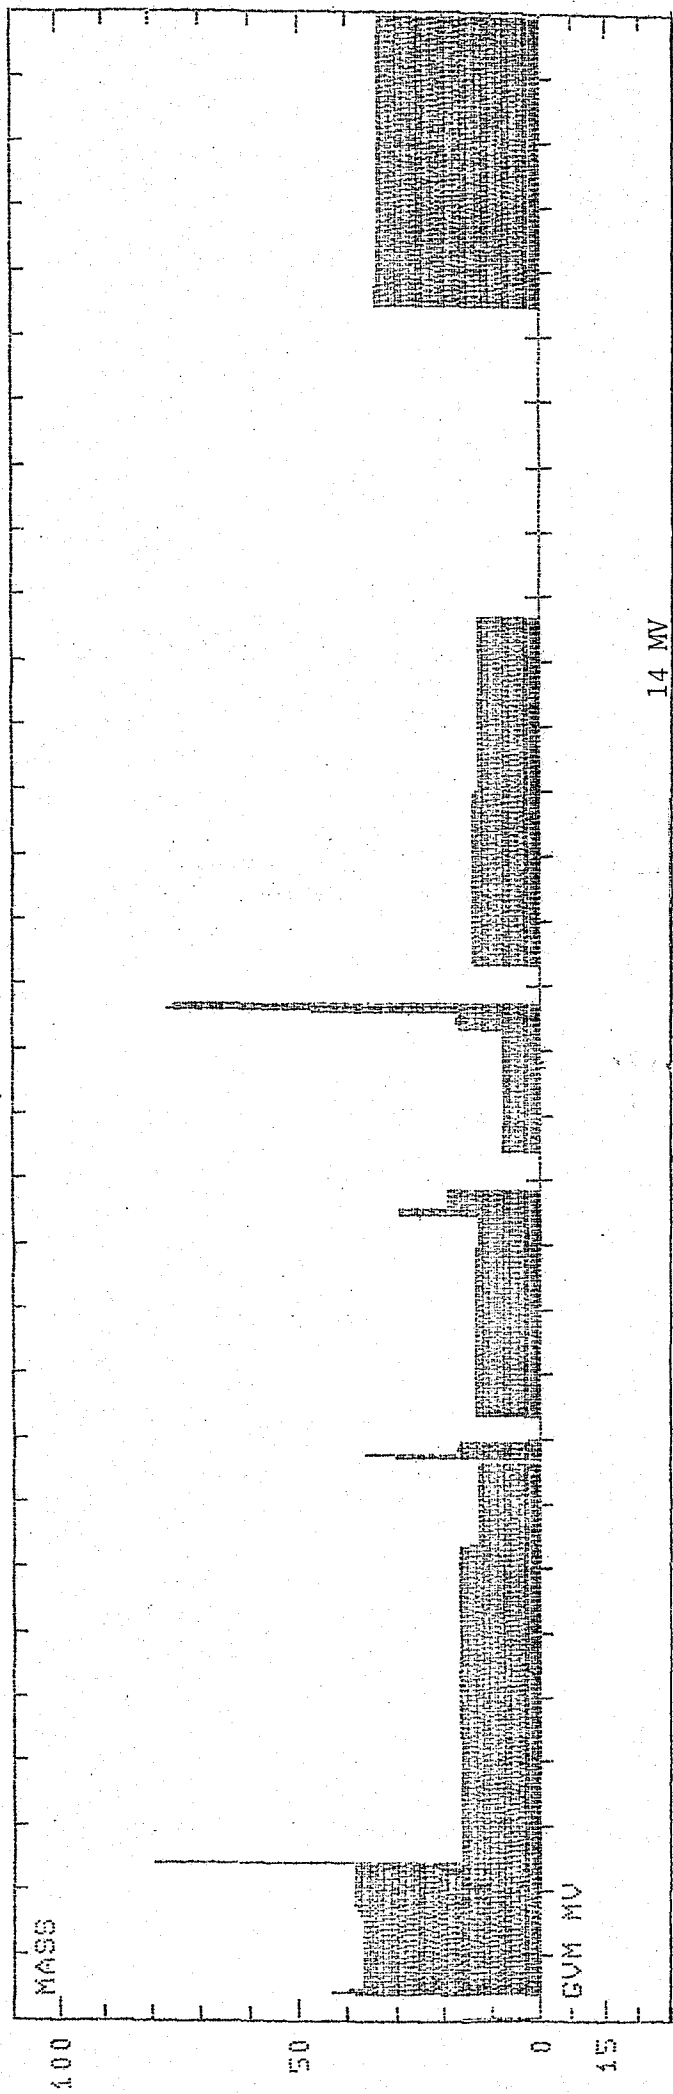
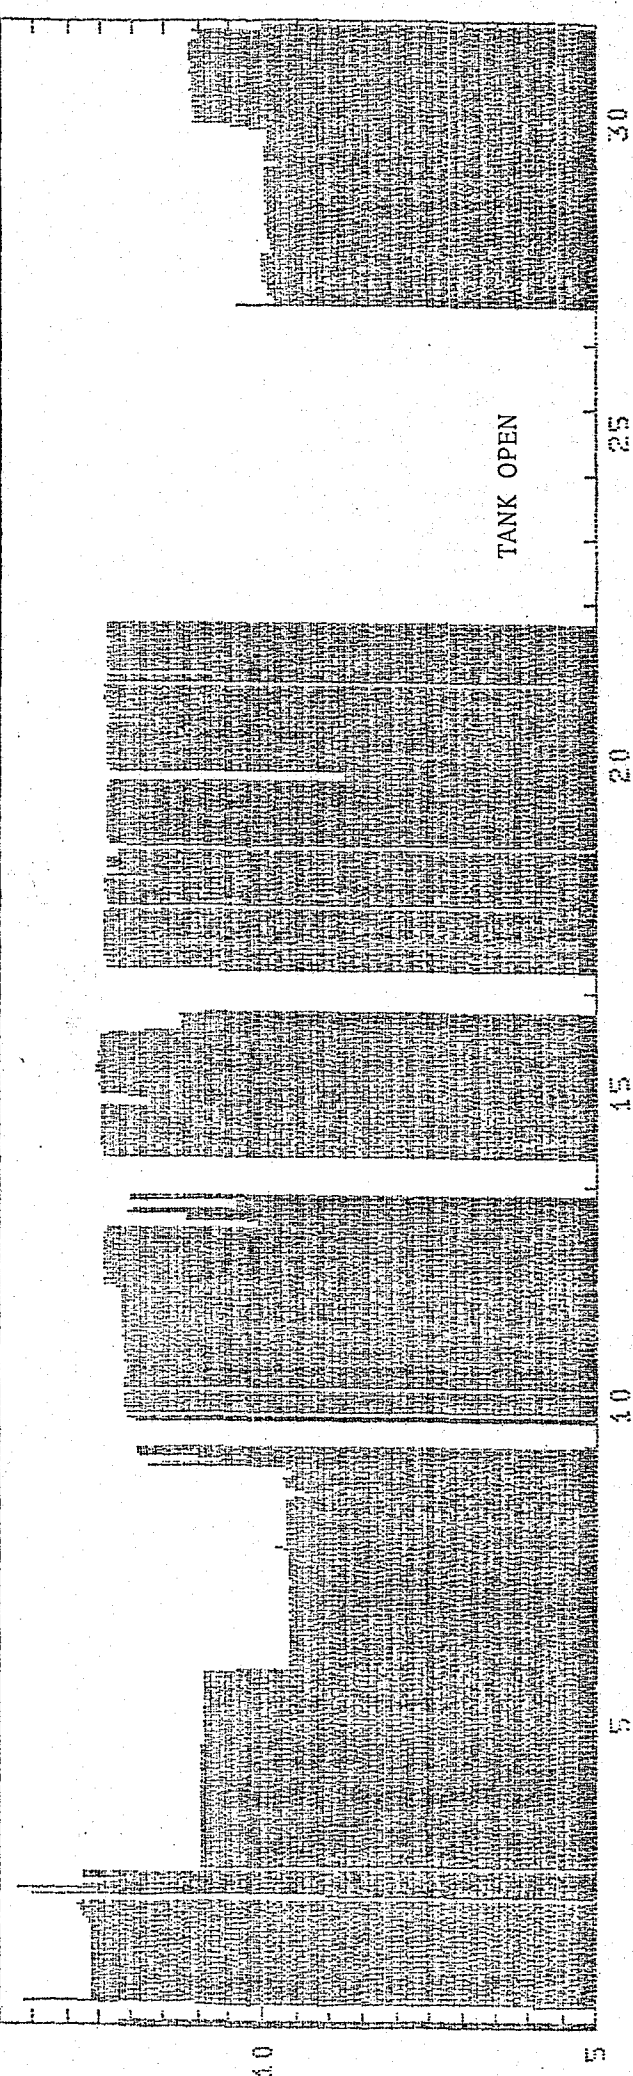
14UD 109 AUGUST 1982

After the last experimental run ended in the evening before the tank opening, we did some tests on all chains. Under normal operation no current is drawn from the charging and suppressing supplies; however, with Chain 2, these currents, and chain current, jumped every 1.3 seconds (chain rotation period) for only 5 kV inductor volts. For Chain 1, only the chain current was so affected, and then not below 30 kV. These symptoms were what one would expect if the plating on the pellets were flaking.

When the upper door was opened the smell in the tank was close to being the worst on record and, in view of the recent sparking, this was not surprising. Two large plating flakes were found on the inside threshold at the lower door. About 200 flakes were lying on the bottom of the tank, and on the motors. We examined Chain 1 and found spark damage on the rims of many pellets, with plating beginning to lift. At first glance there seemed to be nothing much worse on Chain 2, but when we continued to turn it by hand we came across a string of pellets from which the plating was literally hanging in tatters, half an inch or more long. These would have touched the inductors as they passed. A great deal of plating had already come off and the pellets were spark damaged, (photograph). Some of the spark shields for Chain 2 were badly pitted. With so many bits of plating in sight we checked the column and began to find flakes of all sizes between the electrodes on the tube and the column posts. Opening the H.E. castings we found flakes in every one. It was quite clear that we were in for one of the major clean-ups that we are driven to every now and then, but, as we said in the last report, (35/12), the column was in need of more than our routine cleaning.

Failure of plating on shiny pellets of Chain 2.

Our first step was to get rid of as many plating flakes as possible before putting in the new chains. We took out the shiny ones, flakes and all, and then opened all the H.E. units and vacuum cleaned inside them and inside the castings. Then, with our usual forced draught of filtered air down through the machine, we blew the entire column with nitrogen. This included an individual squirt at every one of the 2,929 tube and post electrode insulators in the machine, (we have only two live tubes in Unit 19!). After blowing we tacked the floors and ceilings of the units, and inside all the castings; this was necessary because we found the smaller flakes very hard to dislodge with either a vacuum cleaner or the nitrogen jet.

Next we installed the two replacement non-shiny chains, each of which had been pre-treated by pumping it to micron range with a vacsorb for about 36 hours. We reported doing this recently, (35/7; 35/10). Three people commented
