AUSTRALIAN NATIONAL UNIVERSITY

DEPARTMENT OF NUCLEAR PHYSICS

14UD TANK OPENING REPORT No.40

20th to 23rd June 1983.

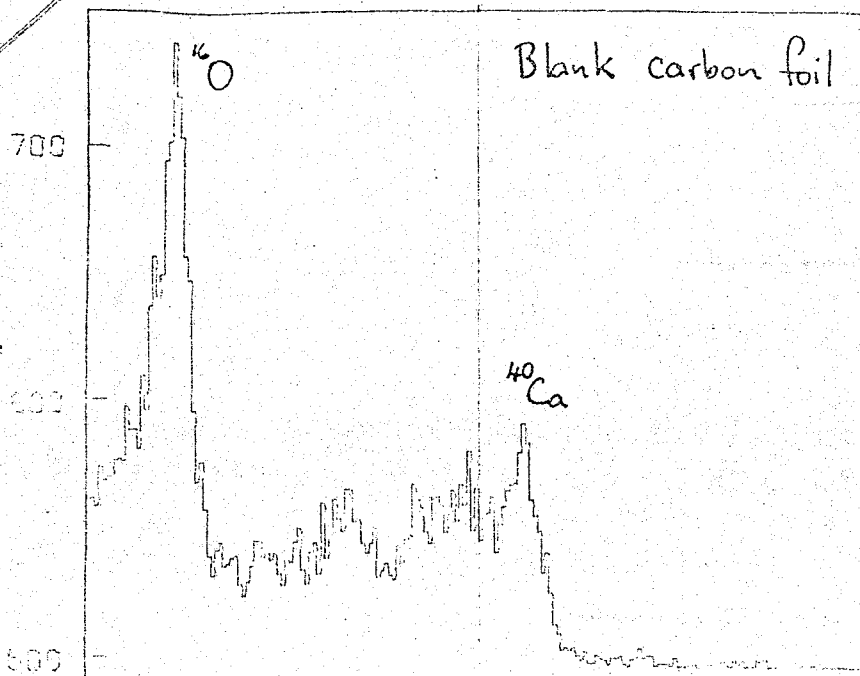
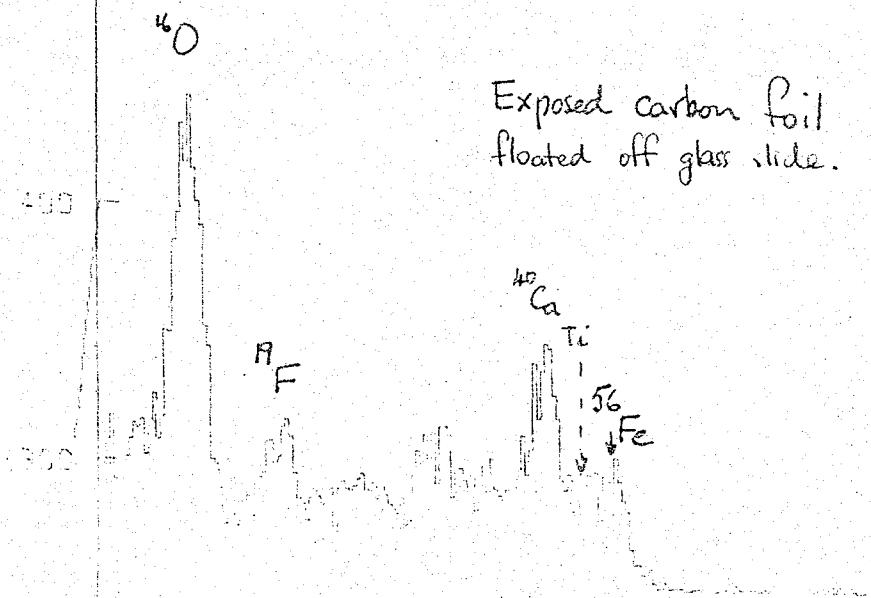
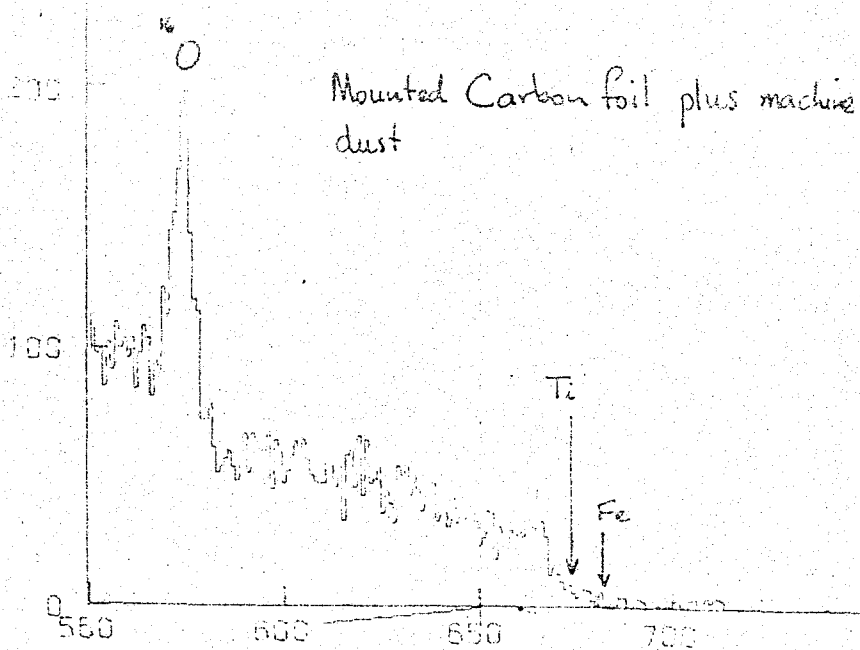
The composition of the innocent material was difficult to establish. Some was successfully transferred to a self-supporting carbon foil for Rutherford back scattering analysis. Such material is a thick target and so only provides ill-defined edges in the spectrum. The bottom spectrum in the figure is taken with the dust source. Above it is a spectrum obtained from a carbon foil which was left in the machine since the last tank opening. It was placed on top of casting No. 1, still on glass and so exposed to the rain of breakdown products. Keith Fifield floated off the carbon foil and carried out the RBS analysis shown in the centre of the figure. The top spectrum is from an unexposed blank carbon foil. (The Ca is from the release agent.) These spectra demonstrate that FeF is probably being deposited in the machine and that the terminal 'dust' is also of this composition. The fibre-like appearance may be due to the electric field collecting the FeF into strands.

Blank carbon foil

Exposed carbon foil  
floated off glass slide.

Mounted Carbon foil plus machine  
dust

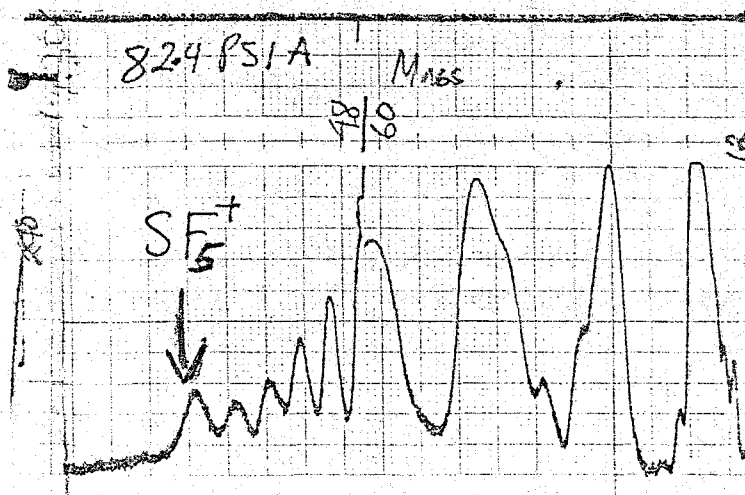
### Residual Gas Analysis

A spectrum from the residual gas analysis at the tube entrance is enclosed. The peak due to  $\text{SF}_5^+$  is marked. The other peaks are due to hydrocarbons which have always been present. (See RGA plots enclosed with Report No. 14.)

The peak marked  $SF_5^+$  disappeared as the  $SF_6$  was pumped from the tank. It reappeared when the tank was gassed up. The other peaks, at somewhat lower masses, are historic evidence of hydrocarbons.
