AUSTRALIAN NATIONAL UNIVERSITY

DEPARTMENT OF NUCLEAR PHYSICS

14UD TANK OPENING REPORT No.41

15th to 23rd September 1983

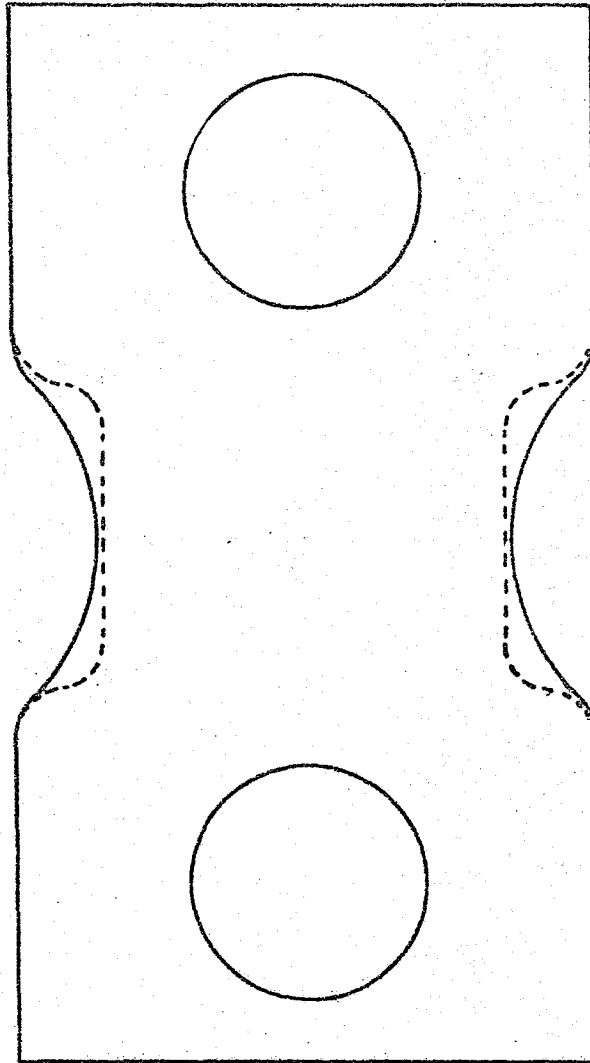
"HOURLASS" LINKS

In July 1982 we wrote to N.E.C. suggesting that the nylon links might be less susceptible to mechanical failure if they were machined to a profile in which the necks were more smoothly contoured, (see sketch). We believed that there was a stress concentration where the radius of curvature was smallest and this was where we were seeing all our cracks. The idea was not pursued, but when Robert Rathmell was with us in June this year we discussed it at length with him. Now, with the evidence of the two virgin chains before us our interest, wise or foolish, has revived. We telexed N.E.C. for a quote on the world's first

Solid line: proposed contour.  
Dotted line: existing contour.

chain with hourglass links and N.E.C., helpful and co-operative with us as ever, accepted the order cheerfully. In spite of the fact that laddertrons use hourglass links, we shall still try them.
