AUSTRALIAN NATIONAL UNIVERSITY

DEPARTMENT OF NUCLEAR PHYSICS

14UD TANK OPENING REPORT No.42

4th November to 1st December 1983

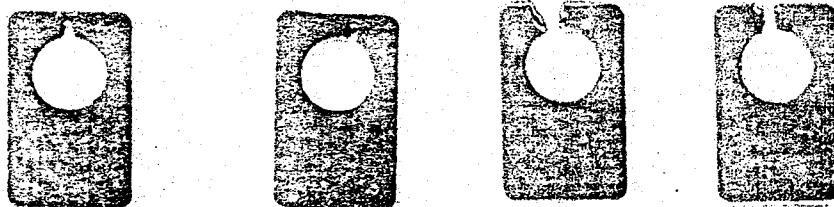
3).

In the terminal stripper we found some foil frames burned through at the edges in cases where the frames had not been normal to the beam. (Xerox pictures made by contact printing enclosed.) This confirms earlier conclusions that, contrary to beam optics calculations, the beam is of the order of a couple of millimetres in diameter, rather than 6 mm.

FOIL FRAMES BURNED BY BEAM

Most of the terminal foils were changed. Because the tube was at atmospheric pressure in order to remove the tube section, we took the opportunity to change the foils in the second stripper also.

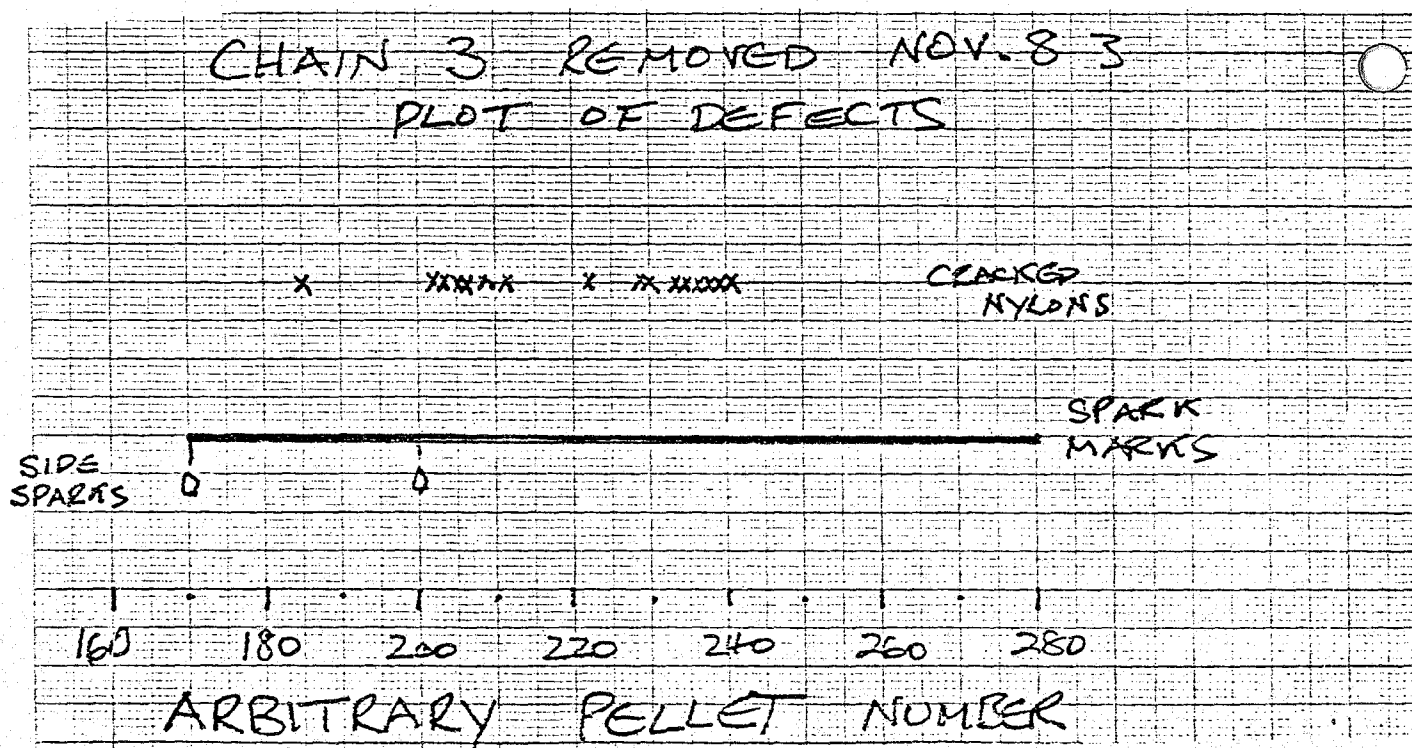
4).

When the November chain was examined in the workshop we were surprised to find that the total number of cracked links, 16 in all, were entirely confined to one length of 58 pellets.

Brian England, who was visiting us from Birmingham, gave us a helping hand. He made an unhurried, dedicated study of the November chain and observed that there was an uninterrupted sequence of 110 pellets, all with severe spark marks on their rims. No other pellets in the remaining 435 in the total chain had any sparking between the rims. The first pellet in the sequence had a severe spark mark on its side and there was a similar spark mark 30 pellets later. The collection of 16 cracked links occurred well inside the limits of the 110 rim-damaged pellets. (Positional plot of this section of chain is enclosed.)

We had just received from N.E.C. our first chain with hourglass-shaped nylon links (41/4). We were unwilling to press this hourglass virgin into service for the time being and so we cut the anomalous length out of the November chain and replaced it with a healthy-looking length, thoroughly vetted, from the September chain.
