AUSTRALIAN NATIONAL UNIVERSITY

DEPARTMENT OF NUCLEAR PHYSICS

14UD TANK OPENING REPORT No. 53

Two openings:
27th to 29th May 1986
(3 days open.)
11th to 12th June 1986
(2 days open)

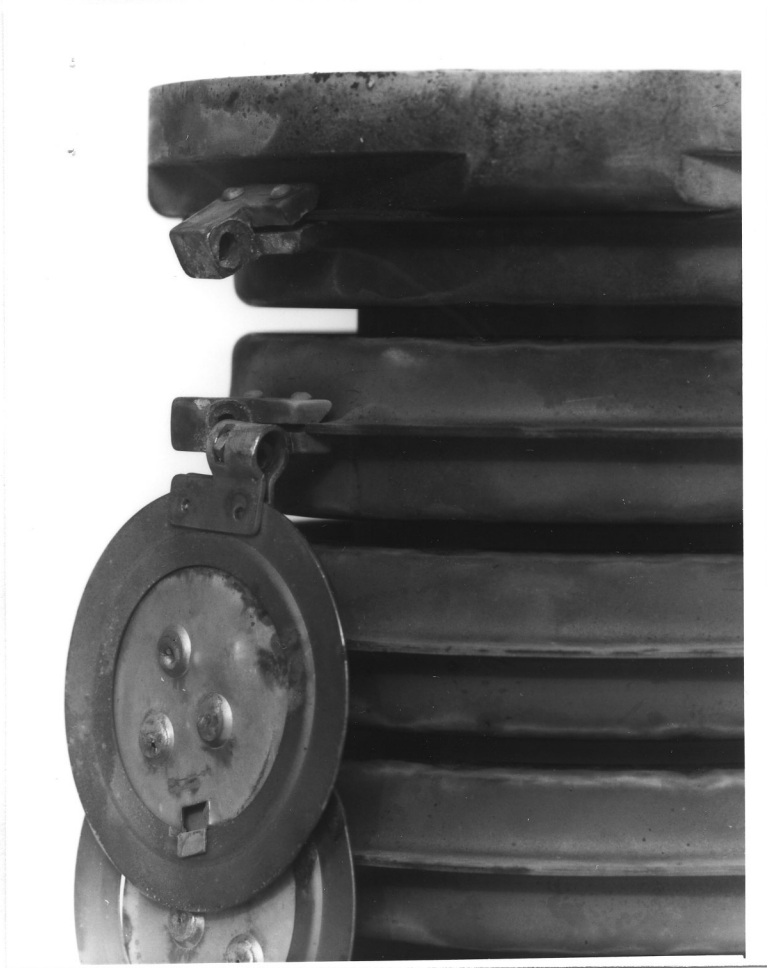
In Unit 15 we found one of the most remarkable failures we have yet seen in the 14UD. The top column corona assembly on one of the posts was missing; the nine assemblies below this position had fallen onto one another in a cascade. Two of the needle discs had disappeared. All the needles on the remaining discs had melted away entirely, allowing the holders to fall almost vertically downwards. All the assemblies were hanging so loosely that they could be flipped up with one's fingertip, yet the assemblies below the cascade, which had not fallen, were still tightly screwed. The effect was as though the fixing screws had all been loosened and the assemblies had just fallen freely, one on

the other. (See photographs). The uppermost post bracket, from which the assembly was missing, was loose at the rivet attachment as though the rivets stretched. All affected brackets were severely spark eroded.

It was easy to believe, though not beyond doubt, that the assemblies had loosened so markedly because material from fixing screws, or their brackets, had been removed during the sparking and also might have contributed to the grey dust, along with the 30 evaporated column corona needles.

- 1). Closeup of top of post in Unit 15. The point assembly is missing and its mounting bracket is very loose.
- 2). The "cascade" of corona point assemblies in Unit 15.
- 3). BDP's on the backs of column points in Unit 1.
- 4). BDP chunks spark blasted onto rings and castings.

Four new posts were put in Unit 15 and four more in Unit 10 where an historic crack had been shorted out for some time. The end electrodes of all 8 posts were bonded according to the new A.N.U. practice, (51/2; 52/4,5).

New column points were put in Unit 15 where the "po" had been found. There was a column corona break at

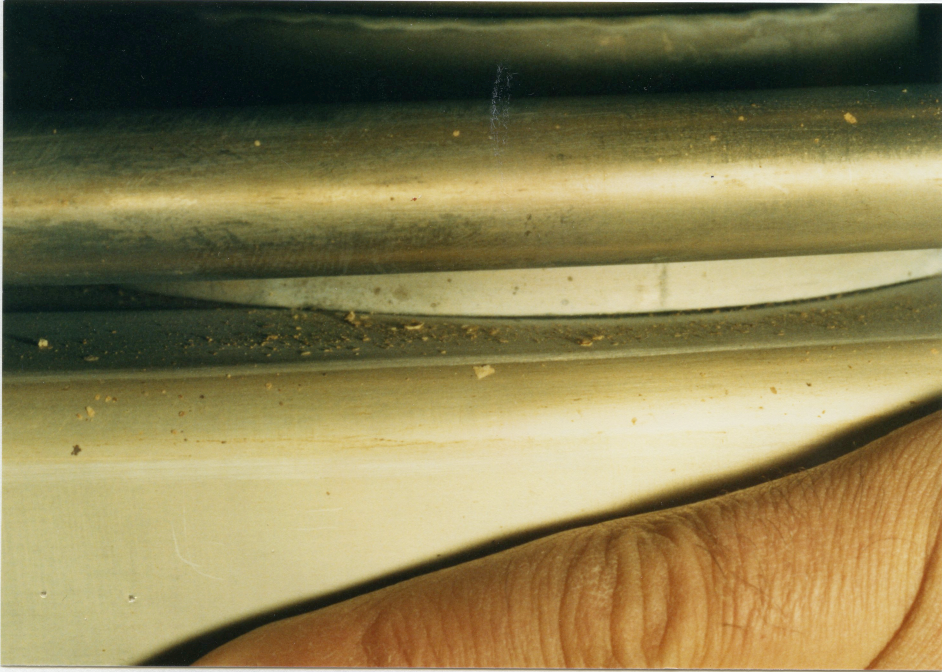
We found that, in three or four units each side of the terminal, the buildup of solid material on the backs of the column corona assemblies had significantly less material than in other units. Chunks of yellow bdps, millimetres square, were attached to the rings and the castings, particularly in units 1 - 6 (see photographs). The tank wall was gritty, especially near the L.E. end.

The rings and tank wall were tacraged to eliminate lost charge. An attempt was made to clean the large buildup of bdp using a saturated solution of sodium carbonate. While this readily dissolved the yellow buildup, the procedure was much too slow. We shortened the new chain by 3 links and buttoned up.
