AUSTRALIAN NATIONAL UNIVERSITY

DEPARTMENT OF NUCLEAR PHYSICS

14UD TANK OPENING REPORT No. 55

15th to 26th September 1986.
(12 days open, 10 working days.)

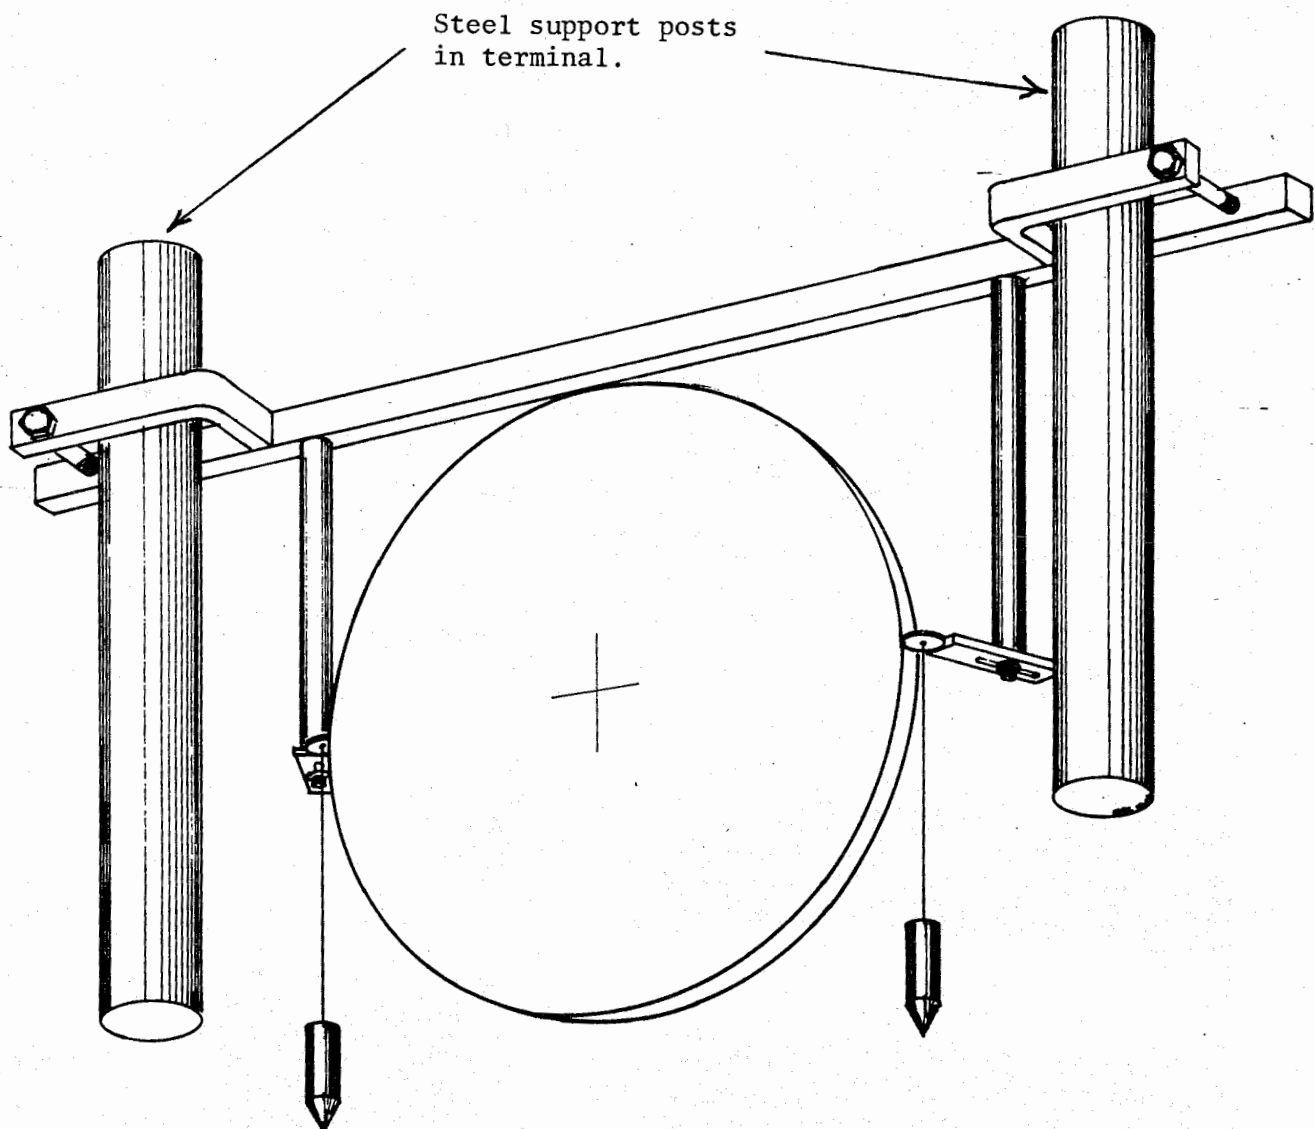
Sketch of the upper of the two A.N.U. jigs used for precise alignment of 14UD chain pulleys.

Discs of the same diameter as chain pellets are set in the chain groove on the pulley. Plumb-bobs suspended from the centres of the discs determine the centres of corresponding discs on a similar jig in the bottom of the tank; the lower pulleys are set to these discs.

The pulleys can be lifted out from the fixed discs and lowered back between them.
