AUSTRALIAN NATIONAL UNIVERSITY

DEPARTMENT OF NUCLEAR PHYSICS

14UD TANK OPENING REPORT No. 61

12th January to 12th April 1988

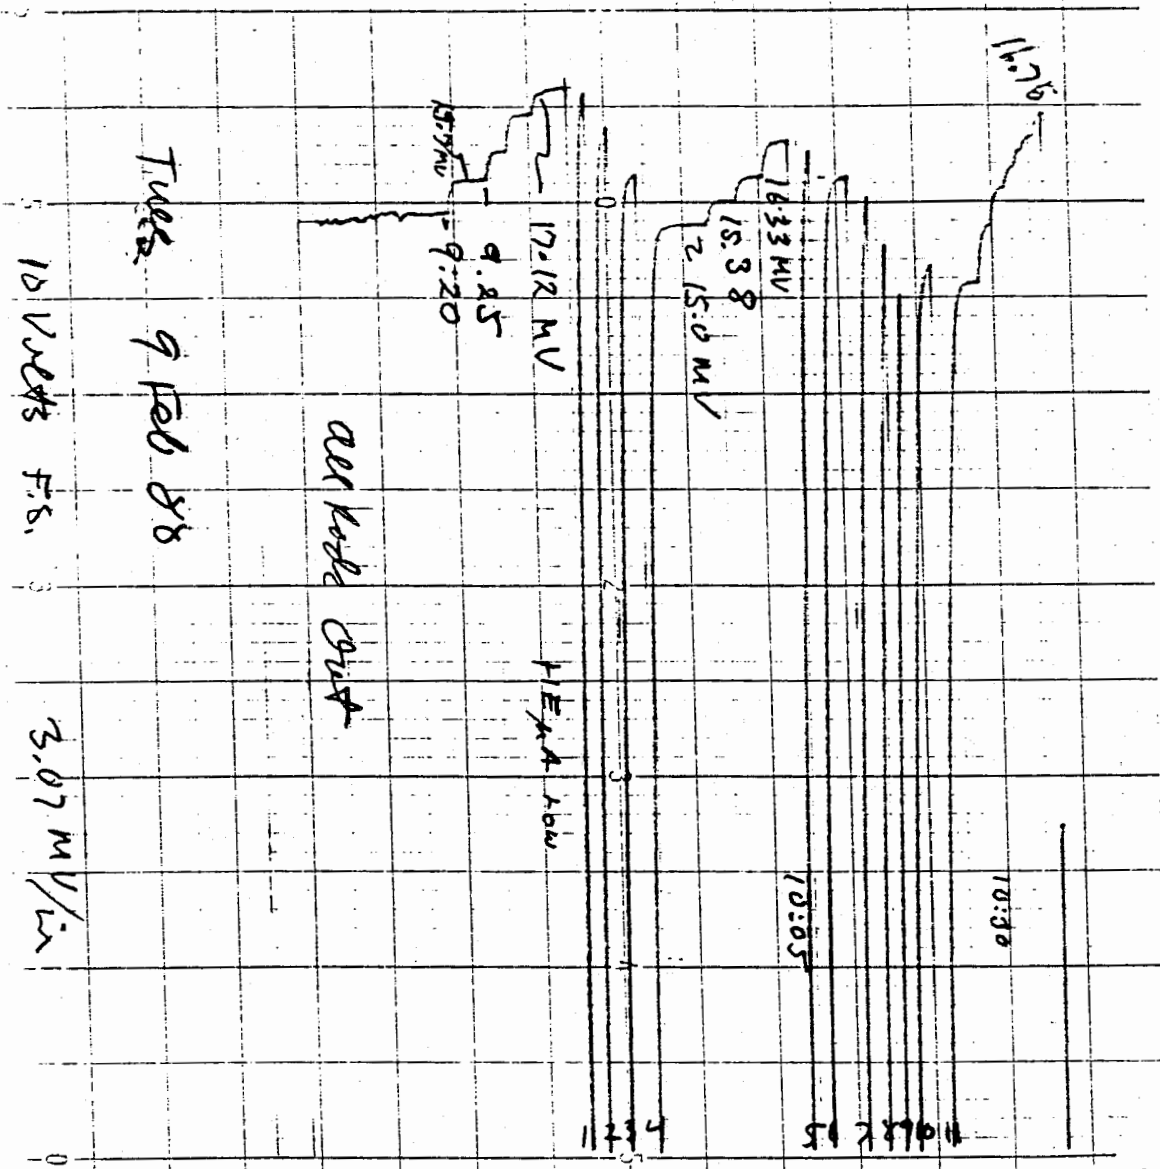
Spark Induced Deconditioning
 FIG. 1

The full machine now achieved 15.9 MV (though we thought it was 17.12 MV), and then sparked, displaying classical spark induced deconditioning, a phenomenon always associated with accelerator tube effects, rather than column effects. (See diagram). Thus we have two strong pieces of evidence that columns exhibit conditioning and deconditioning phenomena, previously ascribed only to accelerator tubes. This perception overthrows our "understanding" and interpretation of the conditioning process and refocuses attention on column cleanliness as a crucial parameter for machine performance.

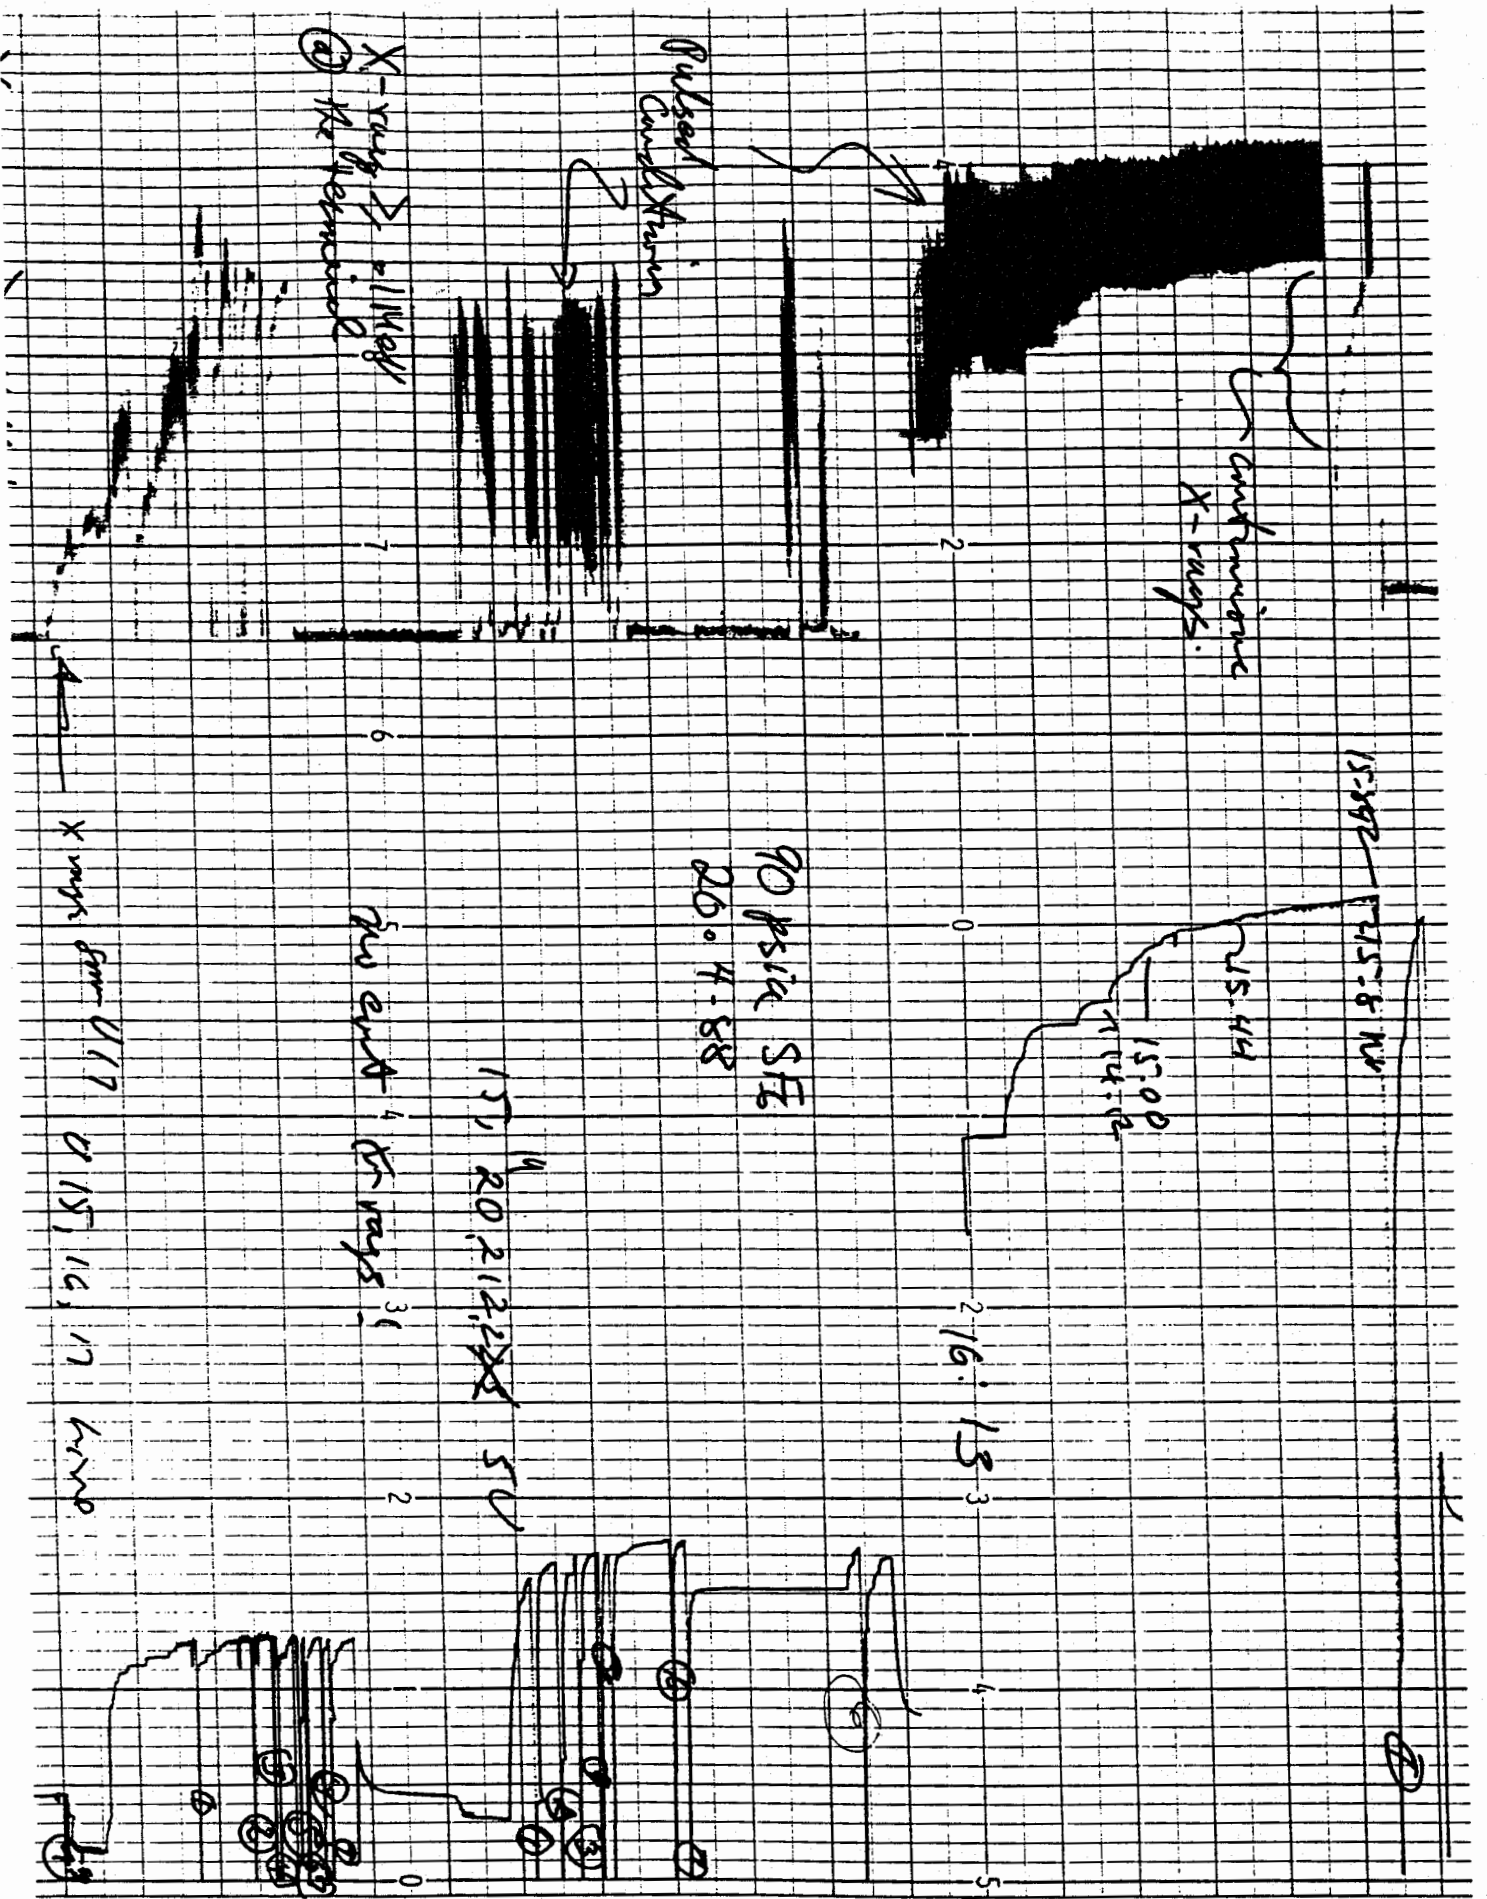
Pulse X-rays and Continuous X-rays.
 Figure 2.

the terminal to monitor x-rays > 0.1 MeV. Conditioning is dominated by vigorous pulsed x-rays superimposed on a continuous background with increase smoothly with increasing gradient. (Fig.2)

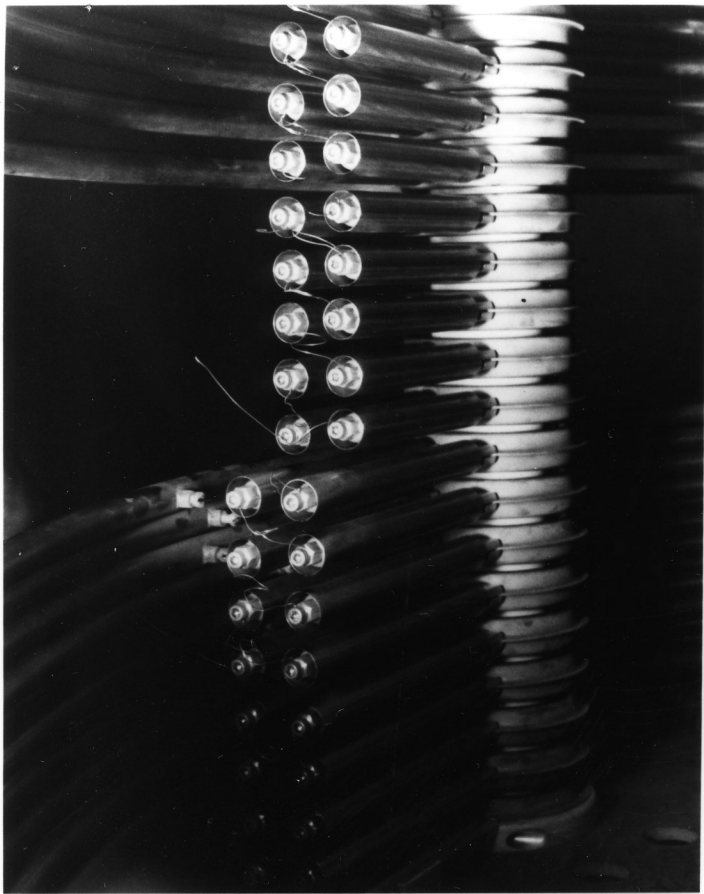
During this opening we installed a set of resistors on one of the posts in Unit 14. The resistor assemblies comprise Welwyn 800 megohm resistors, cantilevered from one end, coaxially inside stainless steel tubes. The free end of the resistor supports an electrode serving as half of a decoupling capacitor and spark gap. A pair of resistors in series grades each column gap. The free ends of resistor pairs are connected with a one-turn loop of tinned copper wire. All the resistors are mounted on one side of a single column post, (photo).

Victory! There was no measurable change in value to 1% to any of the resistors themselves. The connecting wires between some of the resistors were burnt through due to the high fields caused by the inductance of the loop. There were spark marks between adjacent tubes and the aluminium electrodes were badly spark eroded. The connecting wires were thin, 0.6mm, because we had found that thicker wires tended to pull the resistors off centre in their tubular shields, leading to a narrow gap at which there could be breakdown. Next time, lower inductance connections should be fitted.

1. RESISTORS - MARK 1

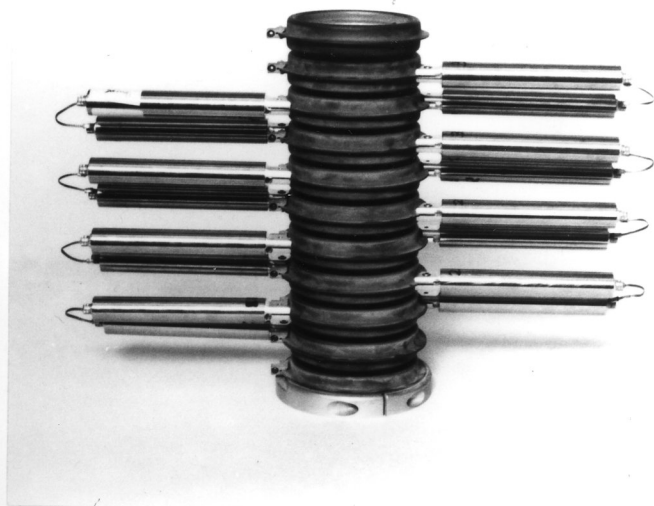
2. RESISTORS - MARK 2

The resistor design was improved by 1). replacing the inductive, single strand loop with thin copper braid, 2). redesigning the capacitor/spark gap electrode from titanium and changing its shape, 3). monitoring the resistors on both sides of the column post to increase the tube to tube distance. See photograph of the new installation.

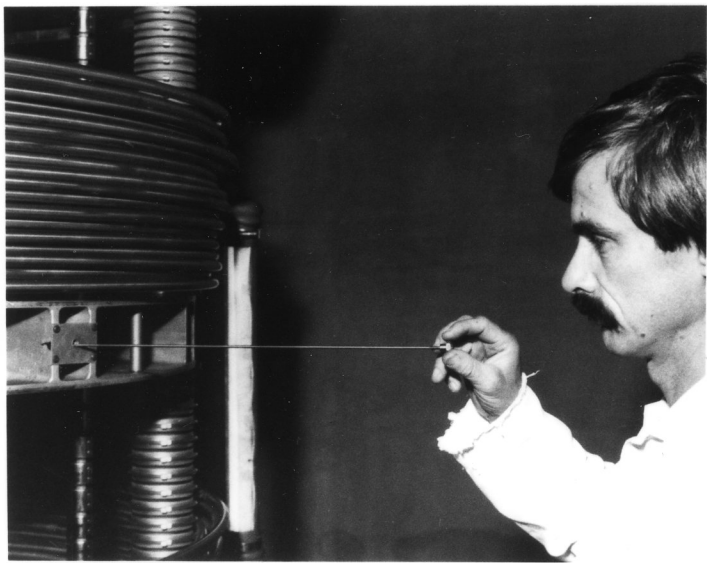
David Weisser's new tension devices, for holding the tube on alignment, were brought into use, replacing the original compression rods. (photo). The devices, which are adjusted and perform much like the spokes of a bicycle wheel, promptly became known as spokes. They are made of 1.5mm stainless steel, are electrically similar to stringers and tolerate vertical movement of the tube for segment replacement. The Cooper/Wallace jig displayed its versatility by locating new tube lengths precisely onto the aligned upper flange of the last length to be put in position.

3. ALIGNMENT SPOKES INSERTED IN OLD STABILIZER HOLES.

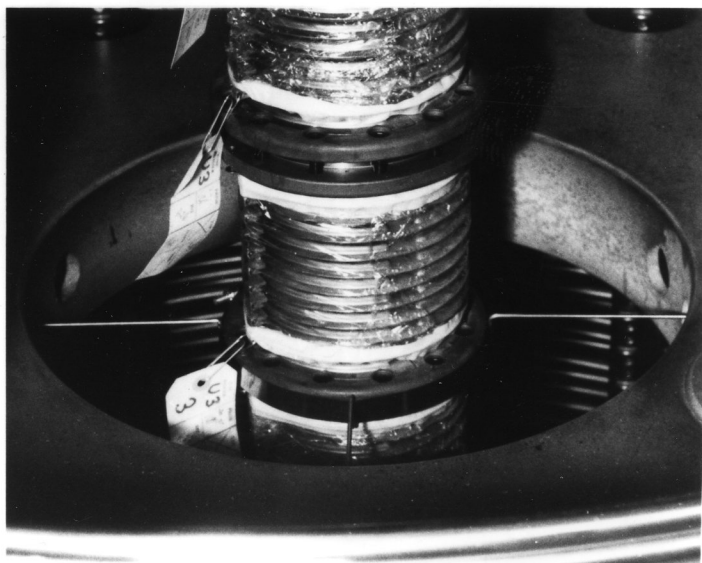
4. ALIGNMENT SPOKES CLAMPED TO TUBE FLANGE.
