## **DEPARTMENT OF NUCLEAR PHYSICS TANK OPENING REPORT NO 62**

This report covers three tank openings;

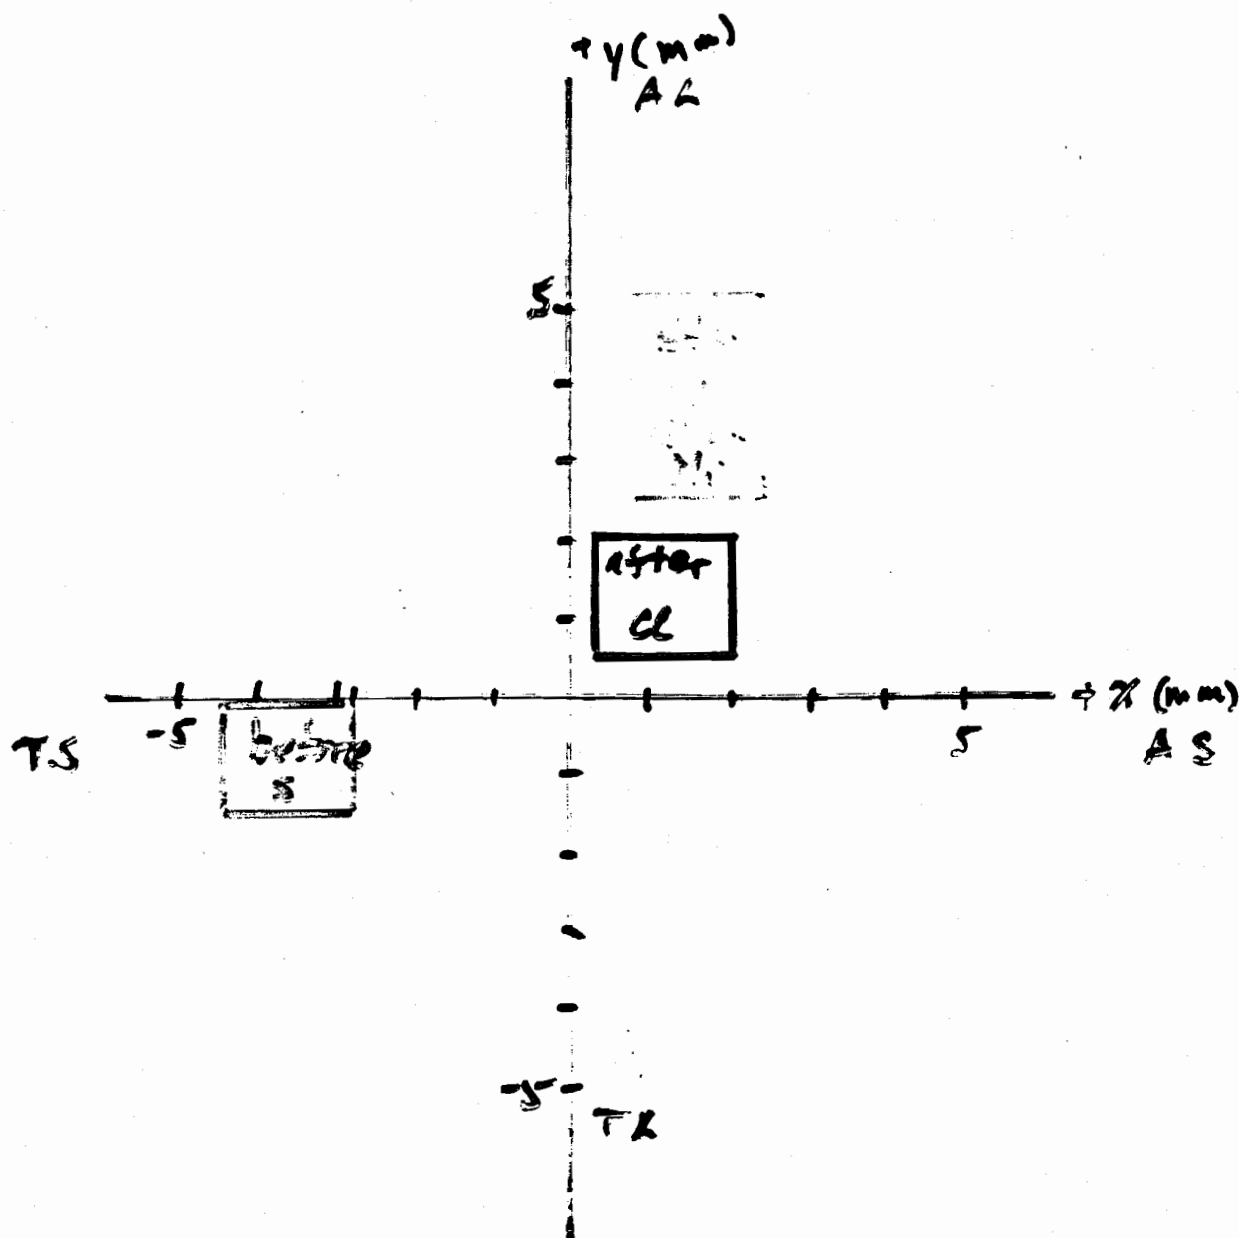
The tank was closed on 22 September 1988. The first beam was transported and transmission checked on Friday 23. The beam was now found to be within 1 mm of the nominal optic axis to get through the accelerator and the transmission improved from the order of 10% for Chlorine back to our normal 50-60%.

Entrance Slit Positions at  
edge of the beam.  
Effect of rotating  
portions of the LE & HE Tube.

Clearly, we had to rotate some tube. Which tubes? The best solution would be what NEC does, that is rotate alternate tubes, or better yet, measure each tube section and match its bias with that of another. This would require complete disassembly of the entire tube in the machine. Not acceptable. If one assumes a consistent bias, then one can calculate how many tubes to rotate to return the beam to the terminal stripper axis. But then the bias in the HE tube will still steer the beam that same 7mm! We choose a combination of tube rotation in the LE and the HE end which put the beam only 1mm off axis at the terminal stripper and .2mm off at the exit of the HE tube. This involved rotation U1; U2, U3/1 and U15, U16, U17/1,2.
