**AUSTRALIAN NATIONAL UNIVERSITY
DEPARTMENT OF NUCLEAR PHYSICS
14UD TANK OPENING REPORT NO 68**

24 July - 3 Aug 1989

Reason for Tank Opening

Broken nylon shorting rod stud.

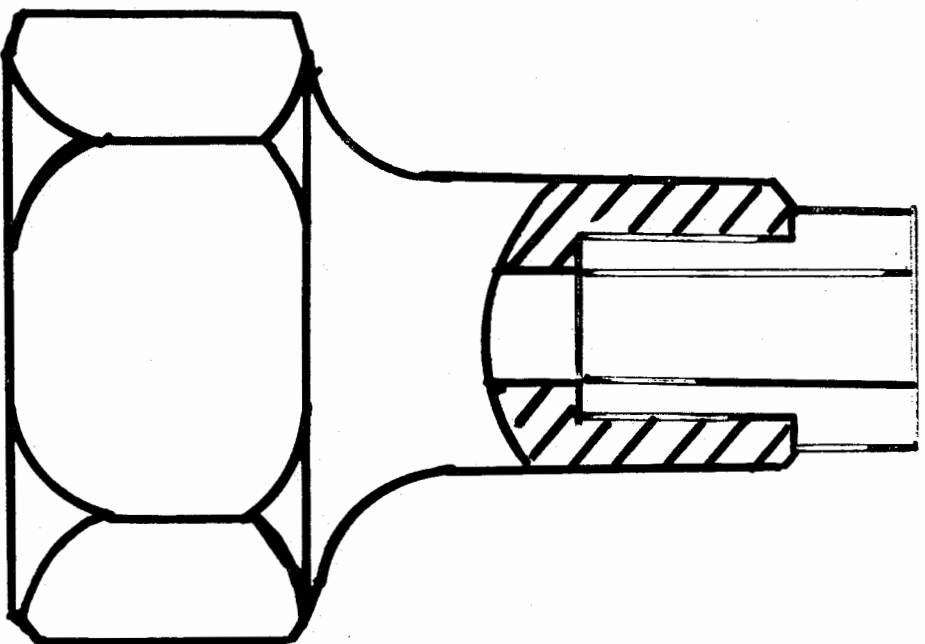
ALUMINIUM NUT WITH GOLD
PLATED INSERT

All plugs and sockets were checked for blackening and were replaced with gold insert nuts where necessary.

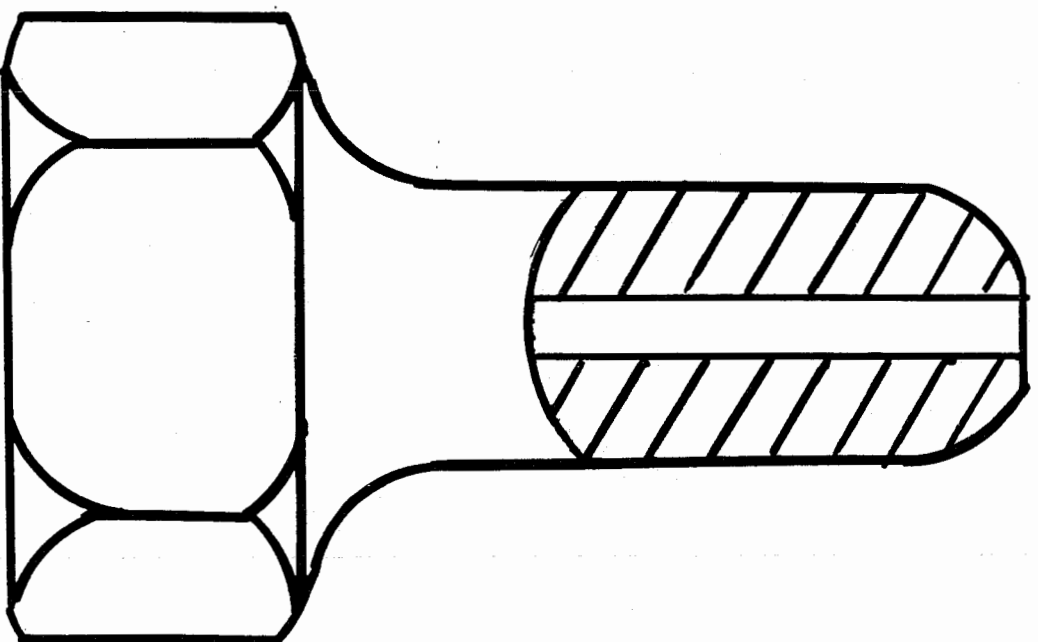
ALUMINIUM NUT
