**AUSTRALIAN NATIONAL UNIVERSITY
DEPARTMENT OF NUCLEAR PHYSICS
14UD TANK OPENING REPORT NO 70**

3 SEPTEMBER - 18 SEPTEMBER 1989

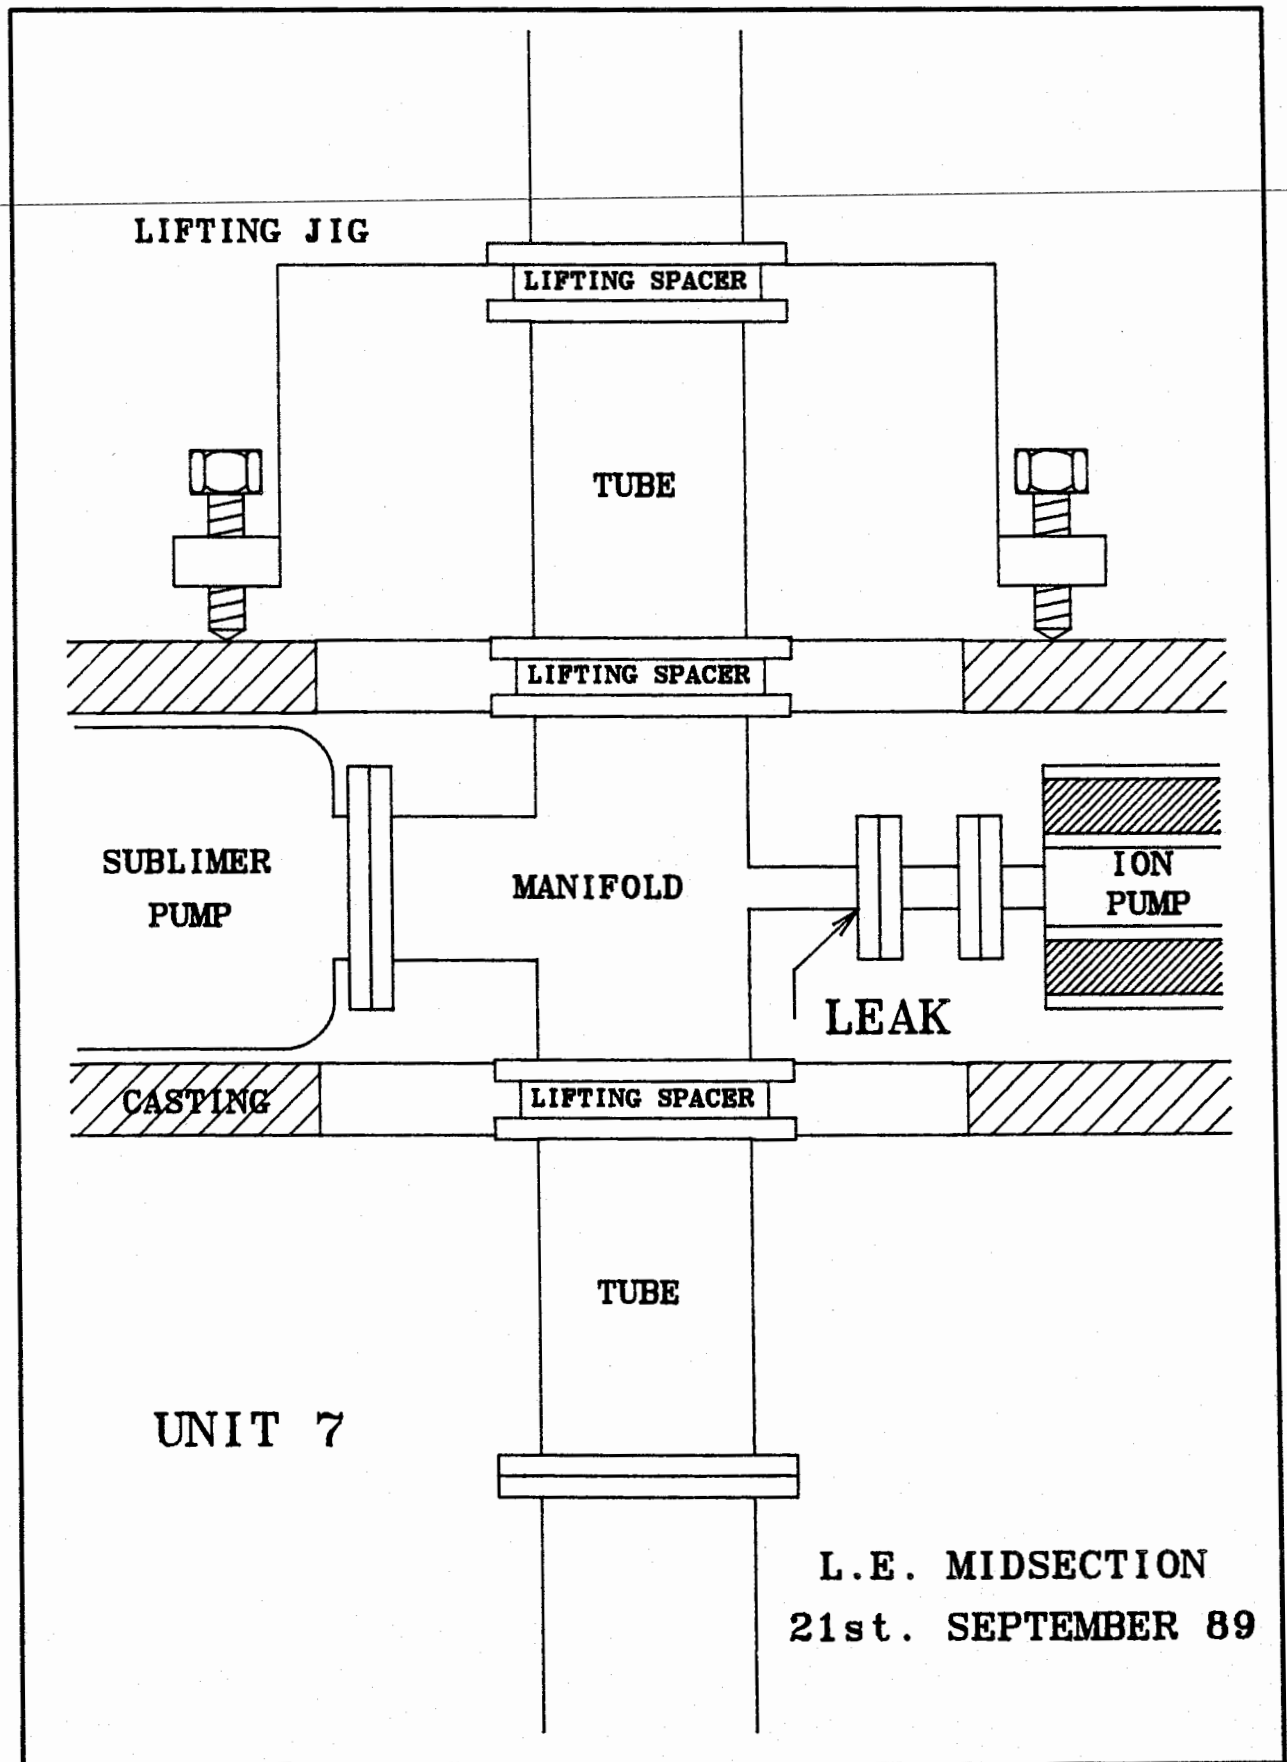
With a helium leak head installed at the LE pumping station on top of the 14UD tank, we went straight to the midsection and started leak chasing. It took a few minutes to find the leak on a tube to flange weld, that carries the 10 l/sec ion pump. See diagram at end of report.

We suspect the leak came about because of the vibration in the midsection associated with the midsection alternator, plus the fact no pump support bracket had been installed during the tube upgrade in 1988.

The cracked weld was re-run on the inside of the flange and leak chased. With its clean bill of health, the installation was as follows:

We are pleased to say that eventually we do learn from our mistakes and in this case, we supported the 10 l/sec ion pump from the manifold itself. This overcomes any vibration that may be introduced into the casting, and be transmitted via a bracket to the pump.
