AUSTRALIAN NATIONAL UNIVERSITY
DEPARTMENT OF NUCLEAR PHYSICS
14UD TANK OPENING REPORT NO 72

27 April - 9 May 1990

Reasons for Tank Opening

Change terminal stripper foil and general inspection.

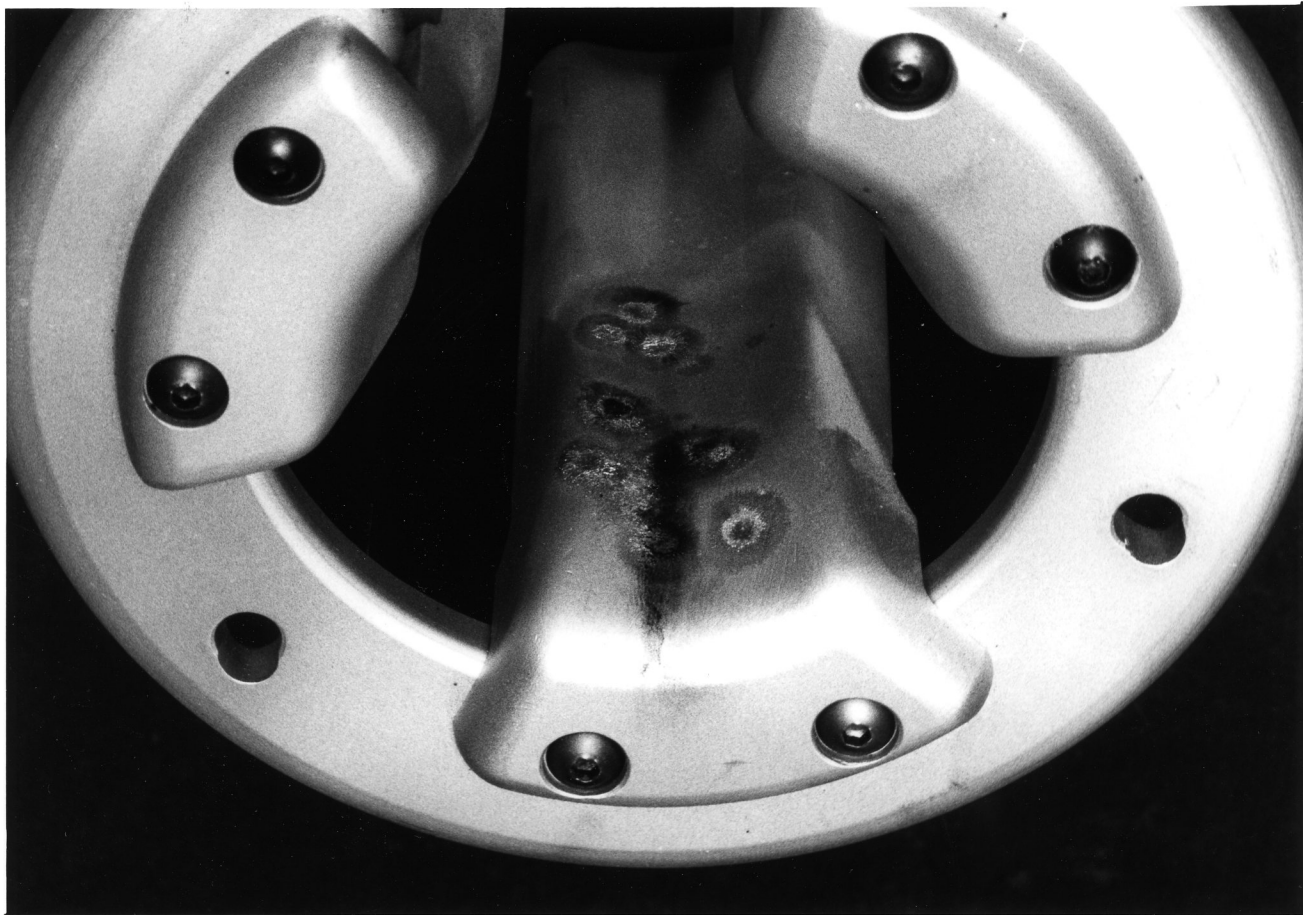
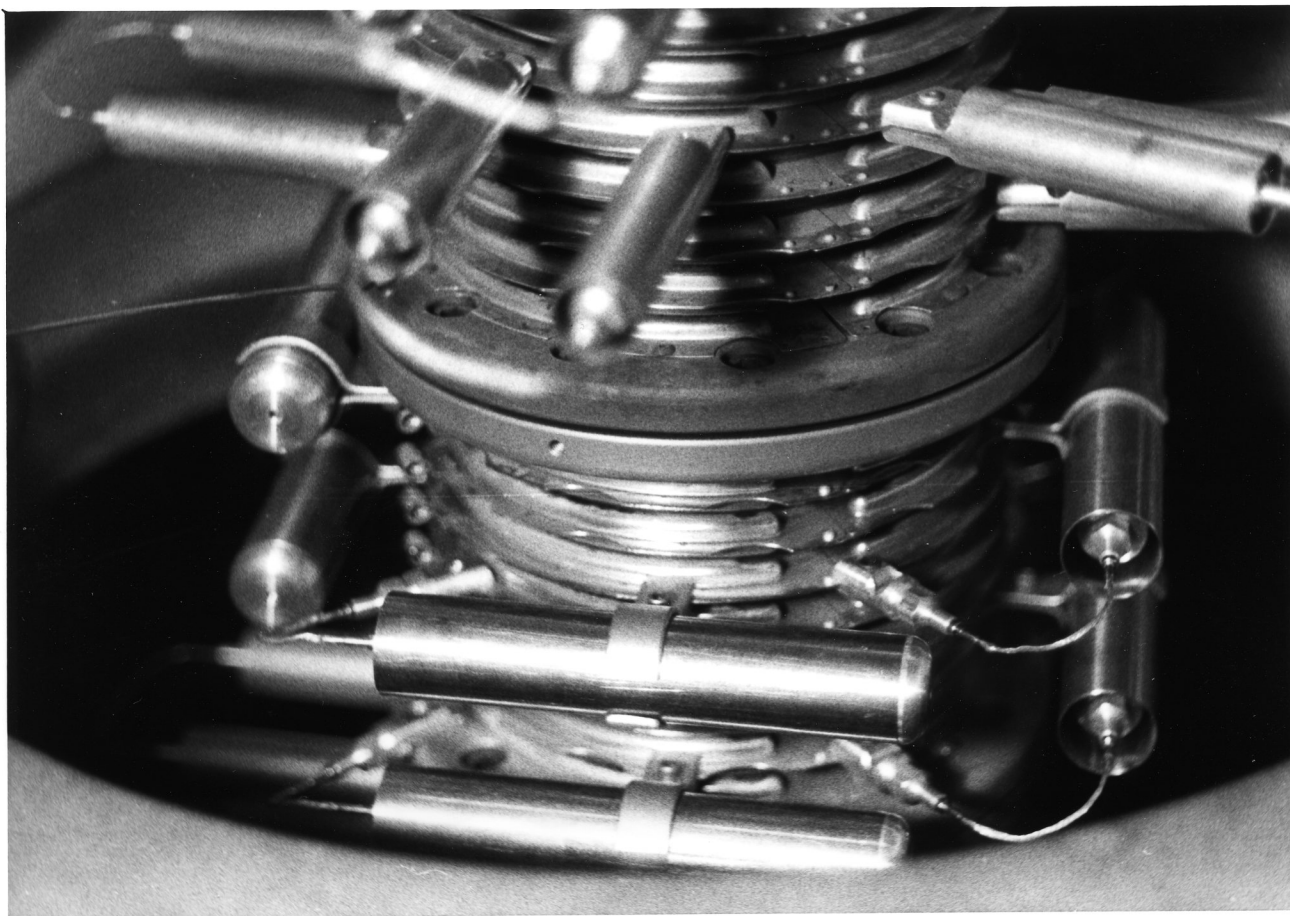
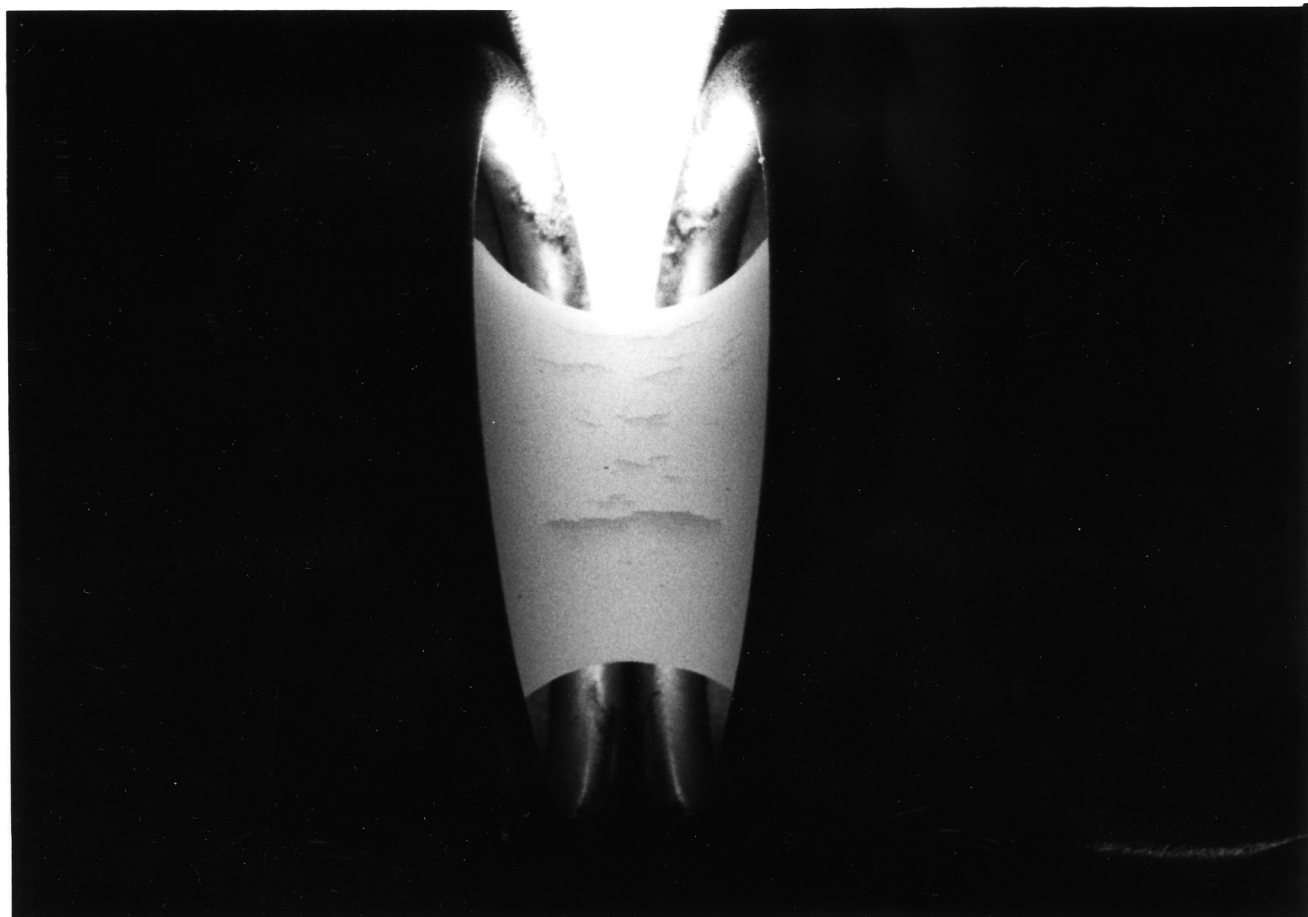
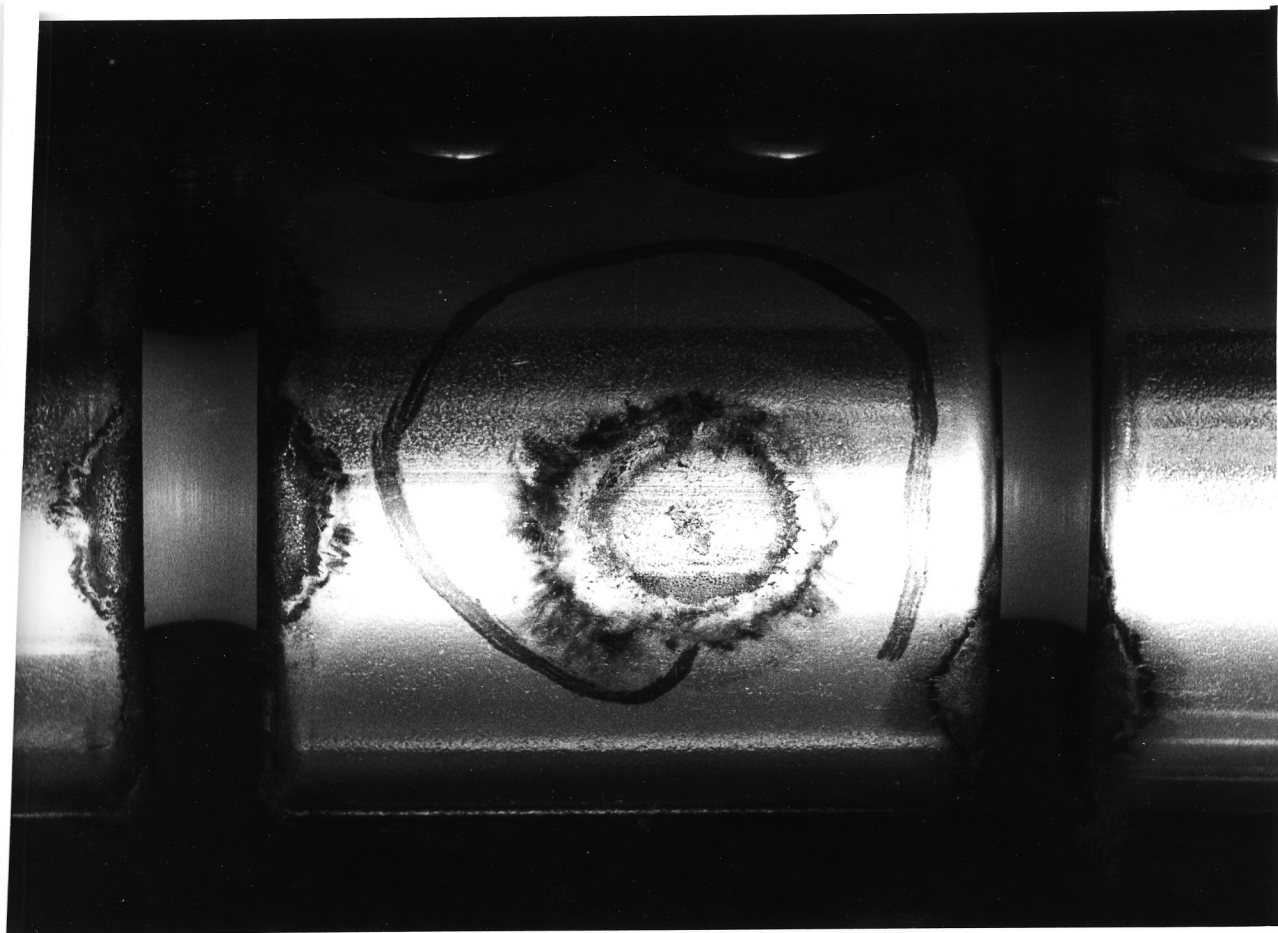
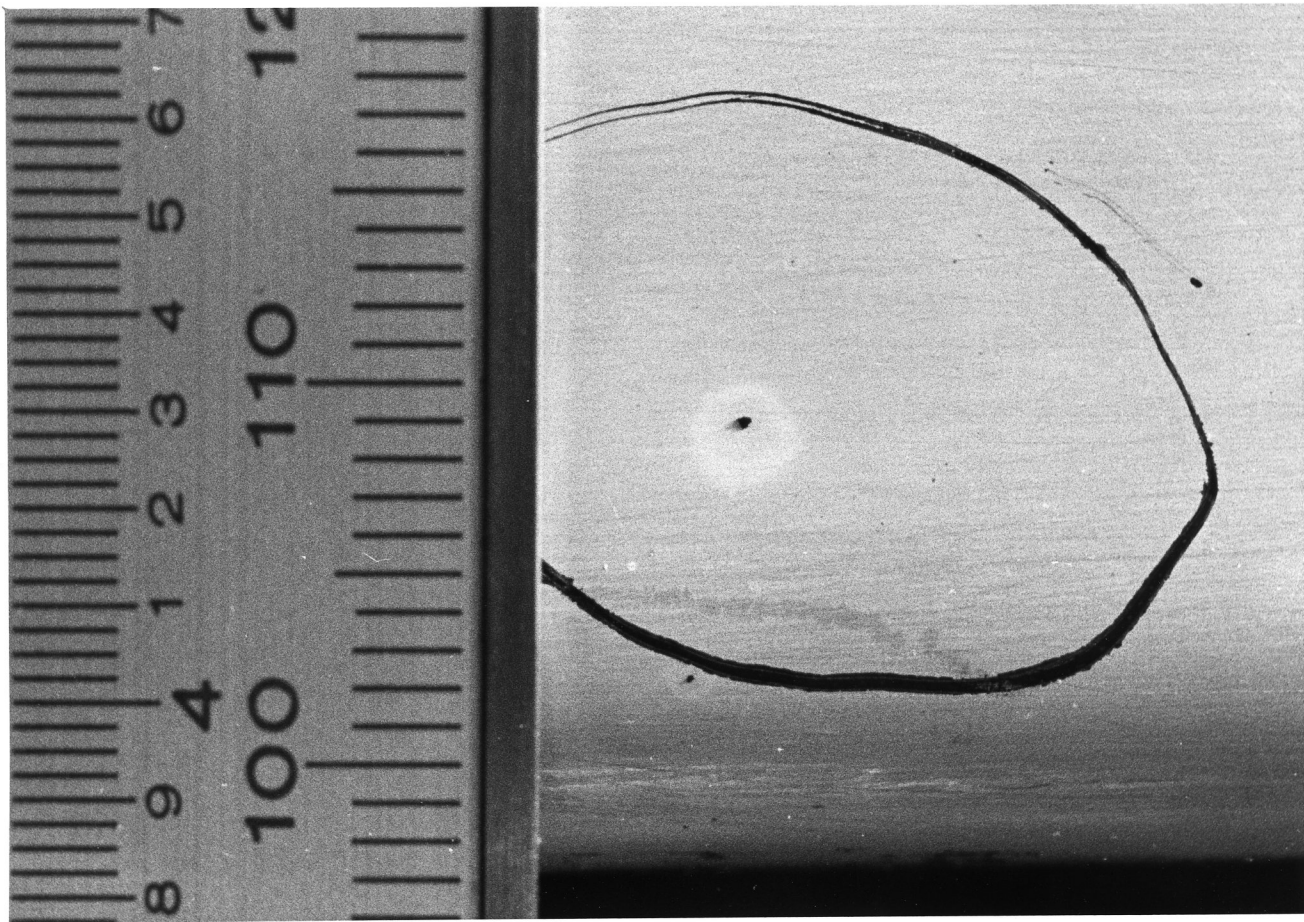
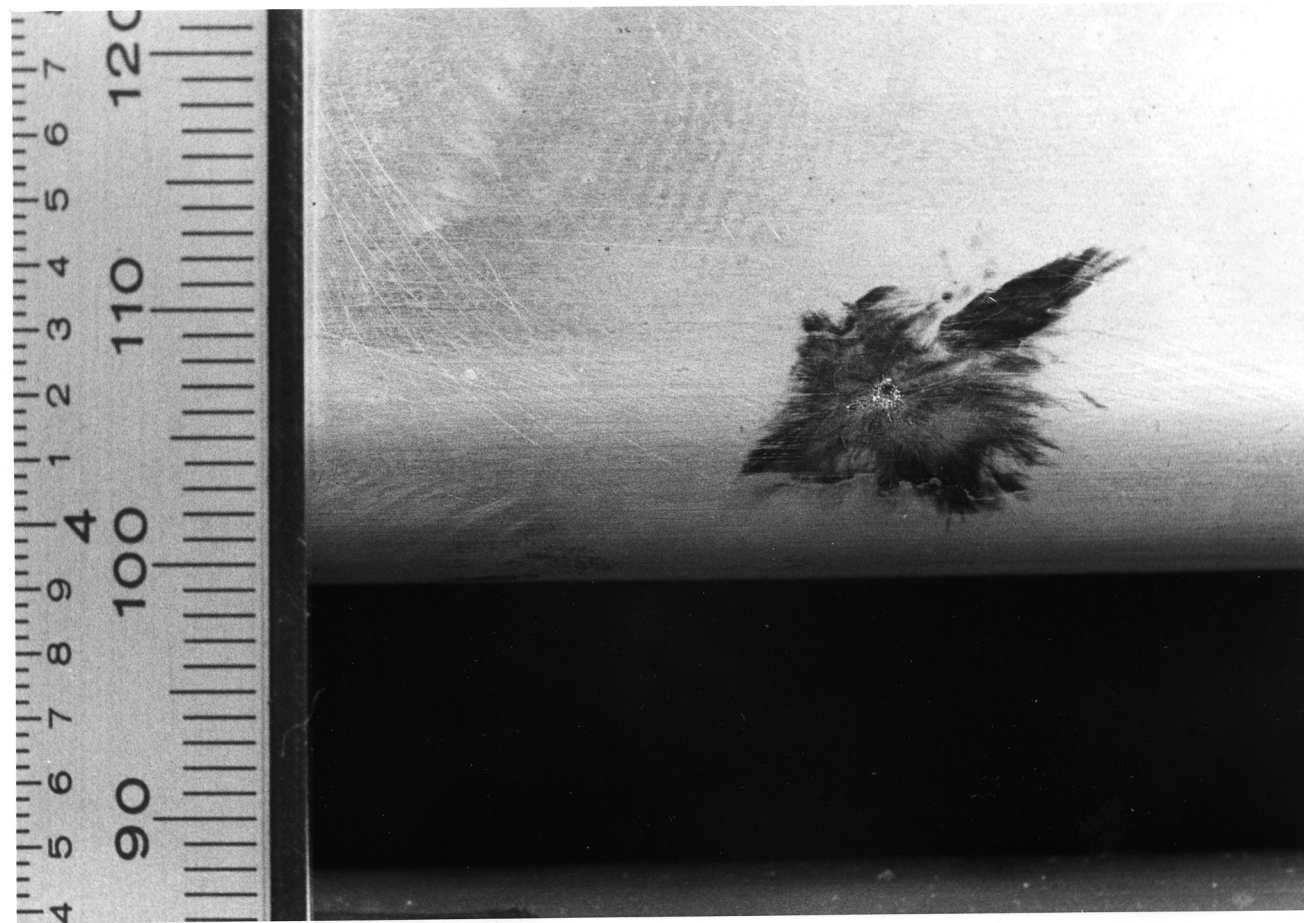
As mentioned before, another major intention was to inspect the chains and remove spark marks which had been seen on chain 2 and chain 3. During the inspection, it was noticed that chain 1 had very substantial lip-to-lip spark marks. Further inspection uncovered two areas of major radial sparks to a region of the chain with the lip-to-lip spark marks. The lip-to-lip spark marks affected about 46 pellets with the radial spark marks occurring one near either end of the 46 pellet length. But there was worse news to come since it was

noticed that the nylon links in this region also had been damaged. See photographs of the radial and lip spark marks as well as damage to the nylon. The nylon had surface cracks along the direction of motion of the chain. This is to be contrasted with cracks across the direction of motion in the previous nylon damage associated with breakdown products and mechanical stress. We take the present longitudinal marks on the nylon as witness marks of sparks, electrical discharge from lip-to-lip and along the surface of the nylon caused by sparks along the chain. Further investigation showed, as it had on chain 2 and chain 3 during the last tank opening, that there were matching spark marks on the electrodes which protect the casting idlers. (see the last photograph). Although in the previous tank opening good intentions required that the electrodes be replaced with ones with a 2-1/8" inside diameter rather than 1-7/8" inside diameter of the present ANU ones, this program was little more than initiated. We are presently in consultation with Robert Rathmell at NEC in order to arrive at an acceptable protection electrode shape that is consistent with the satisfactory performance of such electrodes that NEC has provided in other accelerators. Chain no 1 was removed from the accelerator. We chose to close the machine with just two chains, number 2 and number 3, which were still operating with our old style small diameter spark protection electrodes. The rationale for this was that we couldn't produce a new agreed design in time for this tank opening and having only two chains would enforce a voltage limit on the accelerator under which conditions, further damage to the chains would be less likely. Chains 2 and 3 were removed for cleaning and removal of spark marks and then reinstalled. All of their spark protection electrodes showed no evidence of sparking during this last episode. We will use careful inspection of both chains and spark protection inductors at the next tank opening to evaluate the efficacy of the low voltage operation with the present protection electrodes.

The accelerator was generally clean. All spark marks were rubbed down with emery paper and the entire column ring assembly was cleaned with chamois and dilute RBS water solutions in the usual way. The high energy column was blown off and the low energy column was not. The accelerator was closed on Tuesday 8th May 1990.
