**AUSTRALIAN NATIONAL UNIVERSITY
DEPARTMENT OF NUCLEAR PHYSICS
14UD TANK OPENING REPORT NO 77**

Pump Out 24 Feb — Close Doors 28 Feb 92

Replace terminal stripper foils.

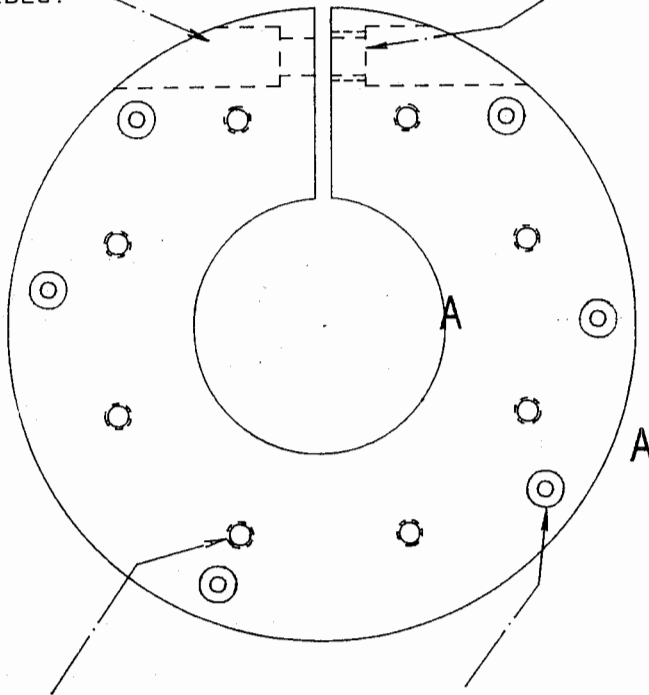
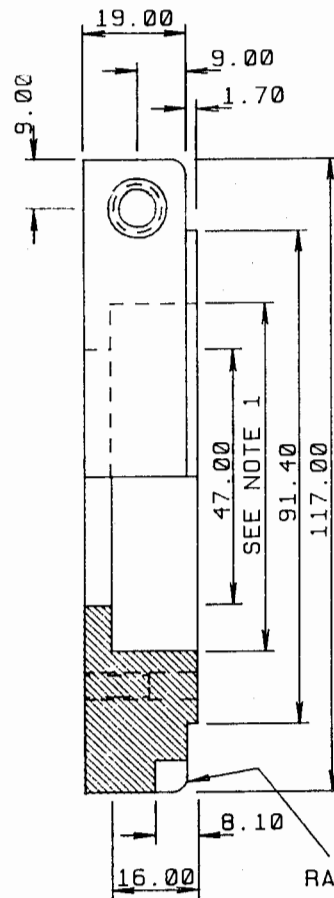
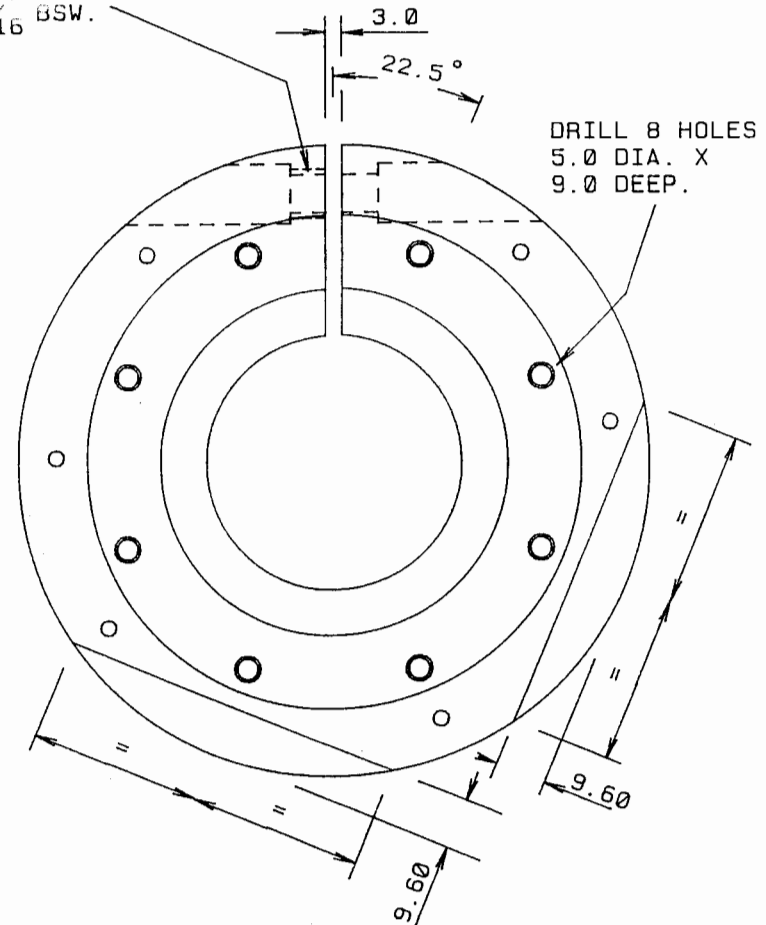
ITEM	DESCRIPTION	REQ.	MATERIAL	REMARKS
NUCLEAR PHYSICS		SCALE	PASSED	DATE
		1 : 1		28-8-91
TITLE 14 UD COLUMN POST END CAP-STAINLESS STEEL		DRAWN	RJB	DRAWING NO.
		TRACED		UD655
		APP'D		FILE: RJB:003

Stainless steel flanges are of the early, non-flexing design as shown in the accompanying drawing.

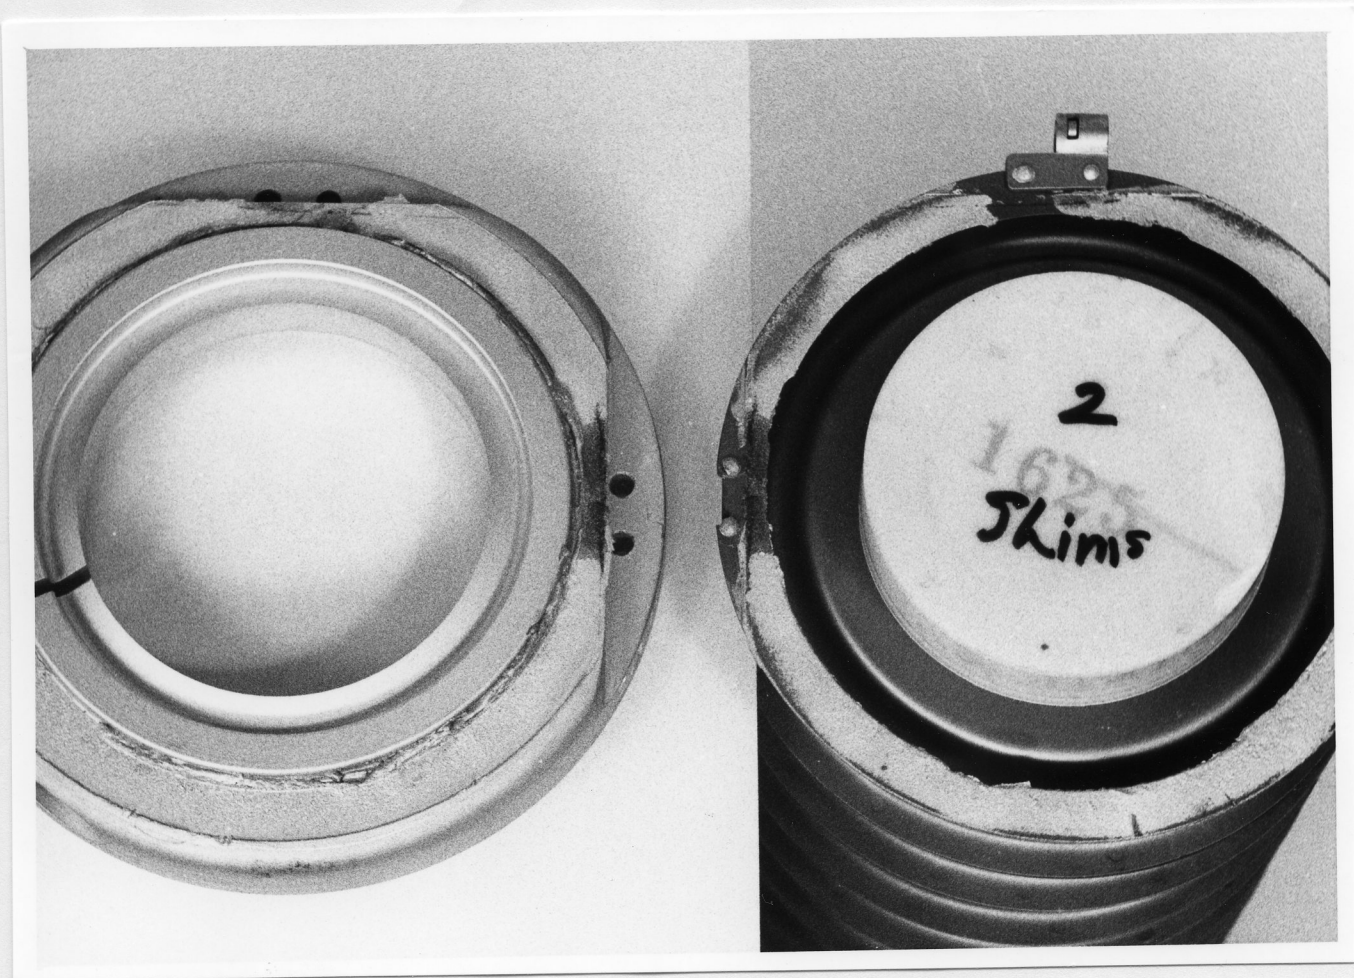
TO 77

Reconditioned posts were installed in unit 26. We will test the first use of stainless steel flanges. It is expected that the stainless steel will be more resistant to spark erosion at the interface of the cup electrode, than were the aluminium flanges. The electrical/mechanical contact over this interface is now being made with six screws. This is a change from the previous reconditioning technique in which silver loaded epoxy was used for the titanium to aluminium joint. Although this joint has proved to be better than the original pressure only joint, there is some evidence of browning of the epoxy where the ring attachment reduces the epoxy area. See photograph.
