AUSTRALIAN NATIONAL UNIVERSITY
DEPARTMENT OF NUCLEAR PHYSICS
14 UD TANK OPENING REPORT # 93
14th Nov 2002

REASON FOR TANK OPENING

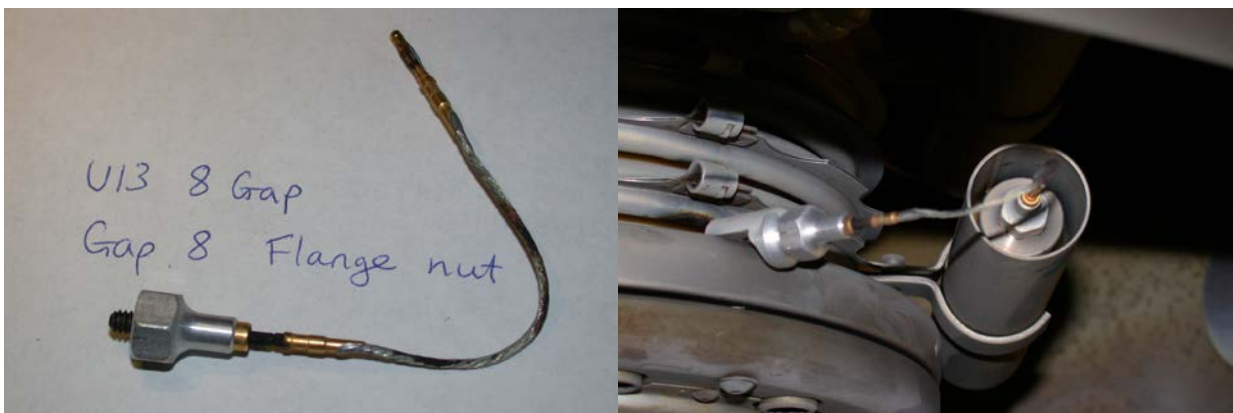
The 8-gap tube between units 13 and 14 (tube 4, unit 13 if you like) protrudes into unit 14. The banana plug and socket at the tube flange end of the tangential resistor lead was burnt out.

In the past, more minor damage has been put down to column discharges and this was most probably the primary cause. The plug and socket interface, once initially weakened by a spark, had subsequently been subjected to repeated discharges and so suffered cumulative damage way beyond that normally found. These parts were replaced.

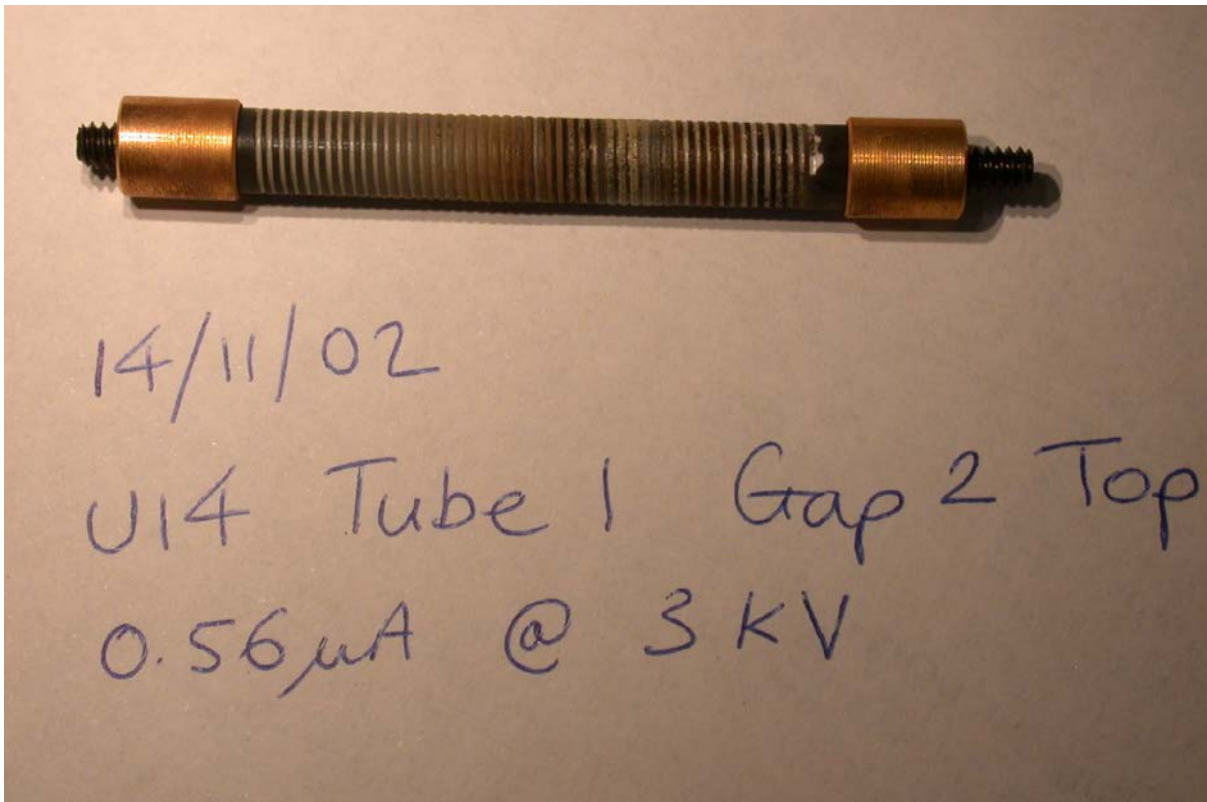
The resistor across Gap 2, Tube 1, Unit 14 was open circuit and found to be thickly coated with white breakdown products. When viewed under a microscope, a deposit of bubbly yellow material was seen along the surface of the resistor. It appeared that a high level of spark activity occurred over a long period, between the resistor and the shield tube near the middle of the resistor. The yellow deposit was removed by washing with warm water and it was found that there were extensive gaps along a substantial length of the conductive spiral.

Given the thickness and extensiveness of the deposits and damage to this one resistor, we speculate that this is a case of infantile failure not discovered until maturity, a case a congenital defect.

Testing this resistor separately at 3kV, the current was 0.56 μ A in air.

Detailed electrical diagnosis in Unit 14 revealed that a faulty resistor caused the major problem and this was replaced. Collateral failures, such as, loose connections, faulty resistor leads, plugs and stringer positioning were rectified.

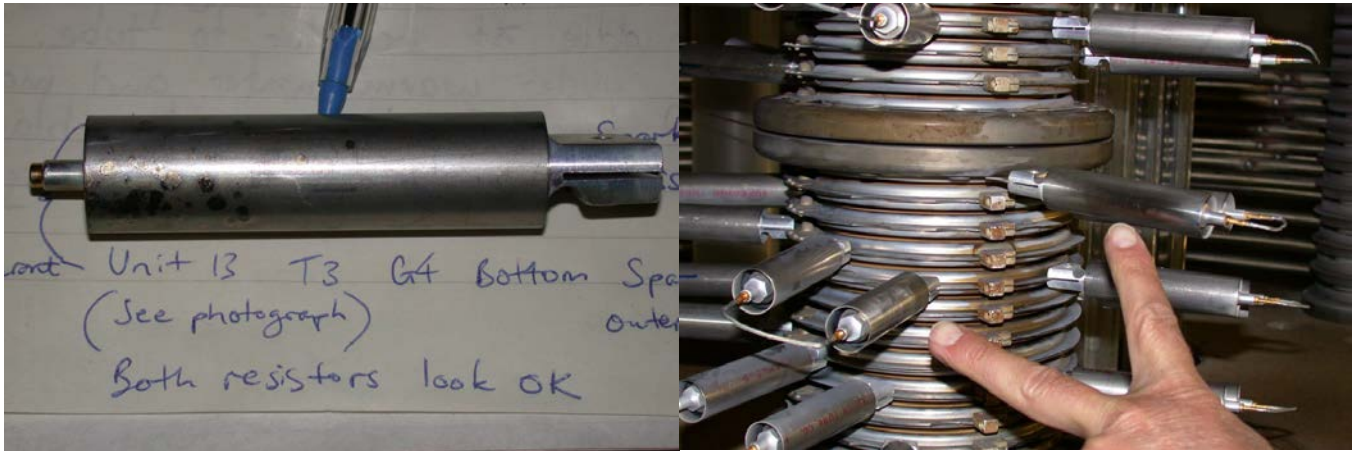
The resistor shields across gaps 1 and 4, Unit 13, tube 3, face each other and there were spark marks on the adjacent shield surfaces. The resistors themselves were OK.
