# **AUSTRALIAN NATIONAL UNIVERSITY**

## **DEPARTMENT OF NUCLEAR PHYSICS**

### **14 UD TANK OPENING REPORT # 95**

11th to 19th Nov 2003

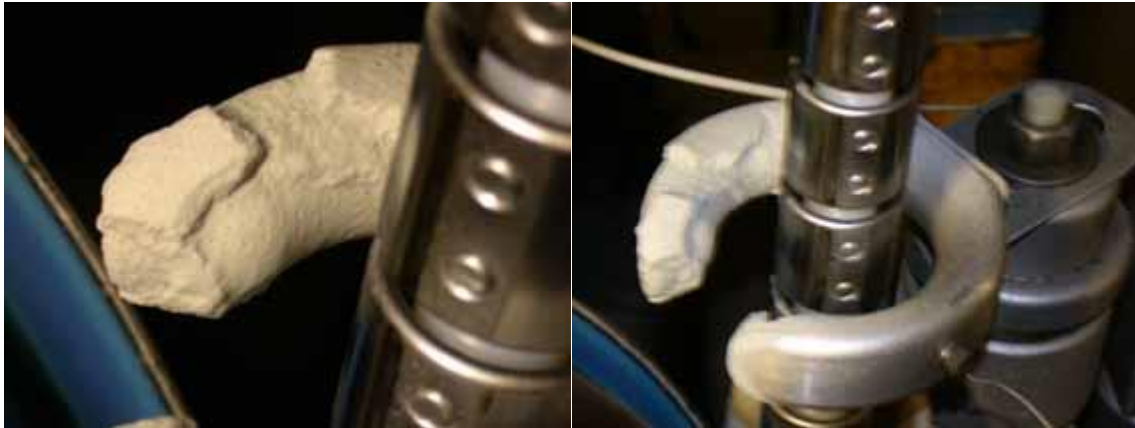
- The initial cruise down the column found the top half of the machine was very clean with only a very light dusting of breakdown products. The terminal and HE units had white spotty deposits adhering to the spinnings and rings. There were a few on the terminal but the density increased toward the bottom of the column. No obvious causes for the breakdown were found above the platform.

BREAKDOWN PRODUCTS-THE MESS

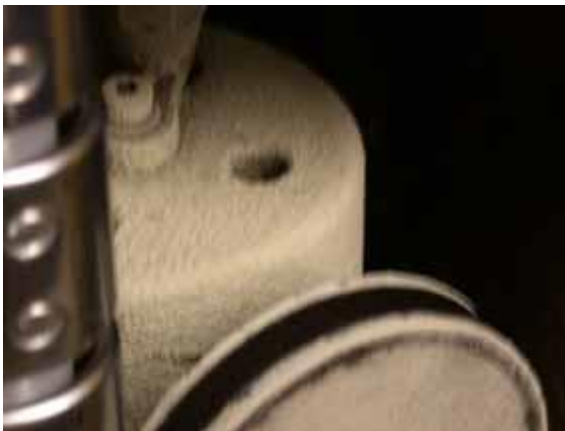
- The up side inductor was caked in soft sediment like break down products that were most probably electrostatically deposited and set semi hard by mixing with oil. Many other sites had lighter but similarly built up deposits.

Typical caking of breakdown products.

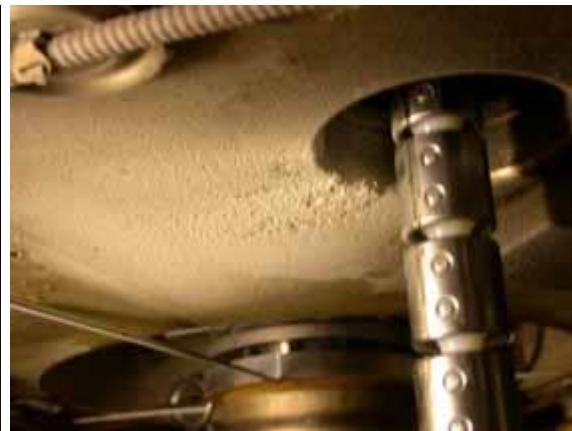
Under the bottom casting.

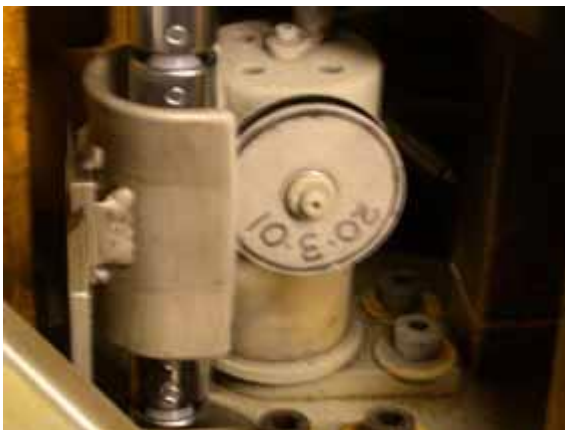
- The usual wipe down was completed and the lower terminal opened to check the extent of breakdown deposits at the top chain pulley. The terminal had quite a build up of breakdown products and the Chain #1 DC idlers were thickly coated.

Breakdown products in the terminal

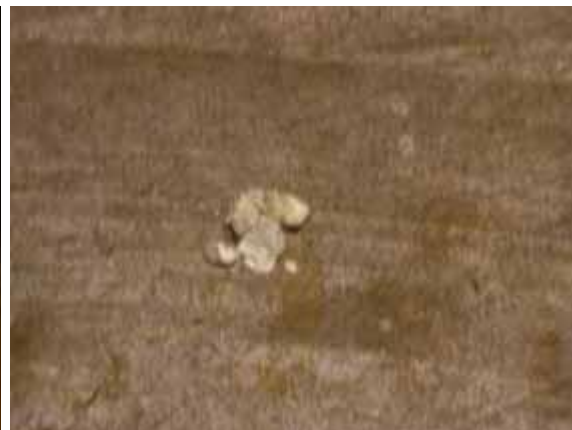
The bottom of the tank.

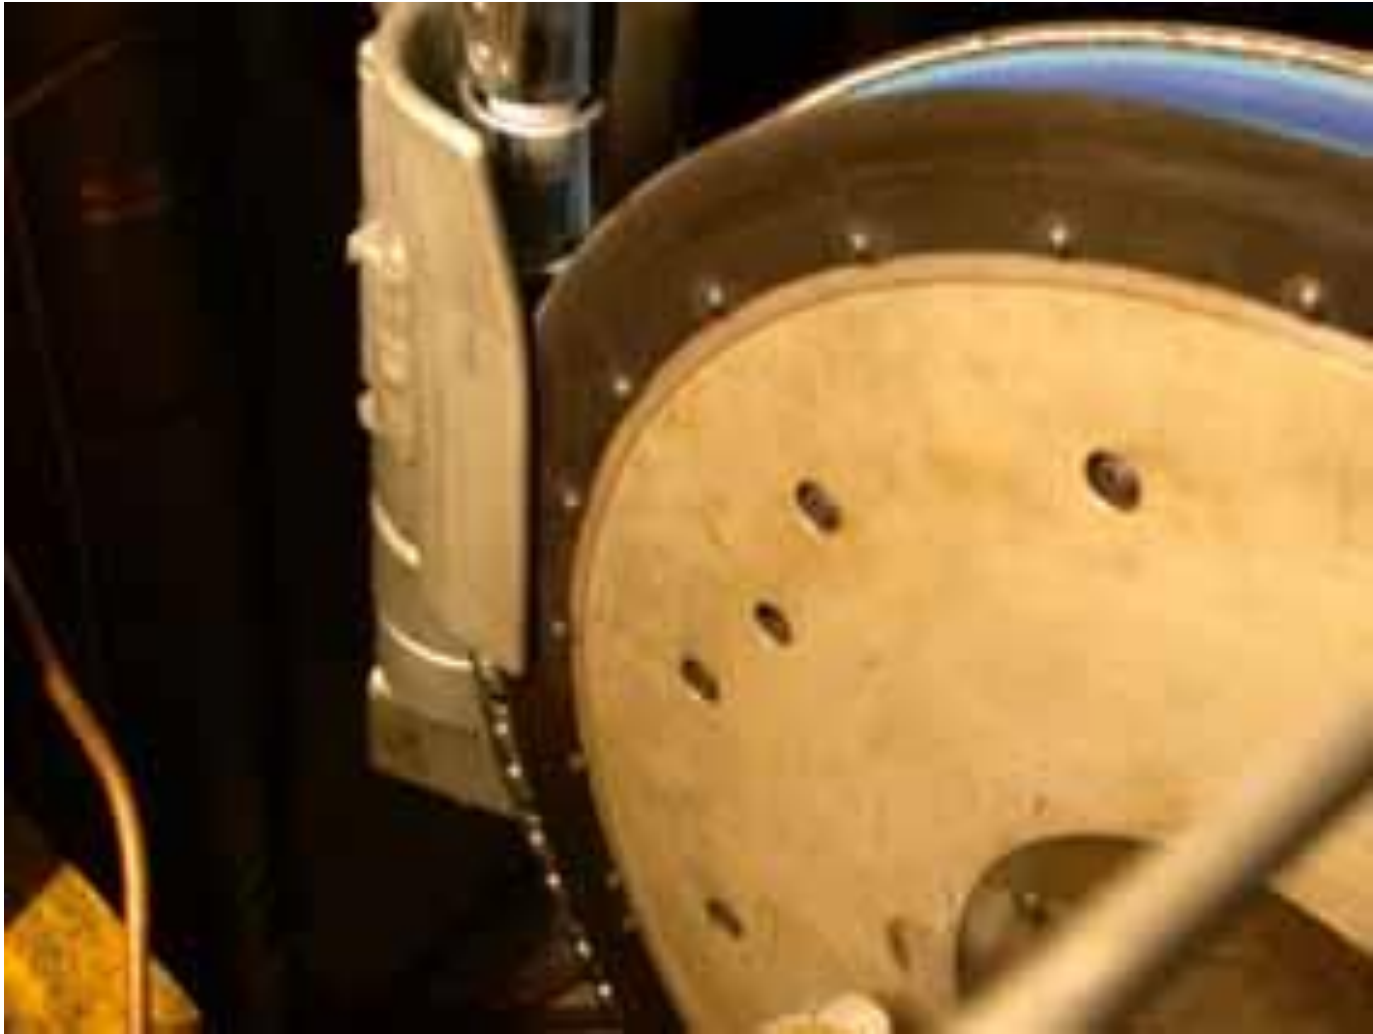
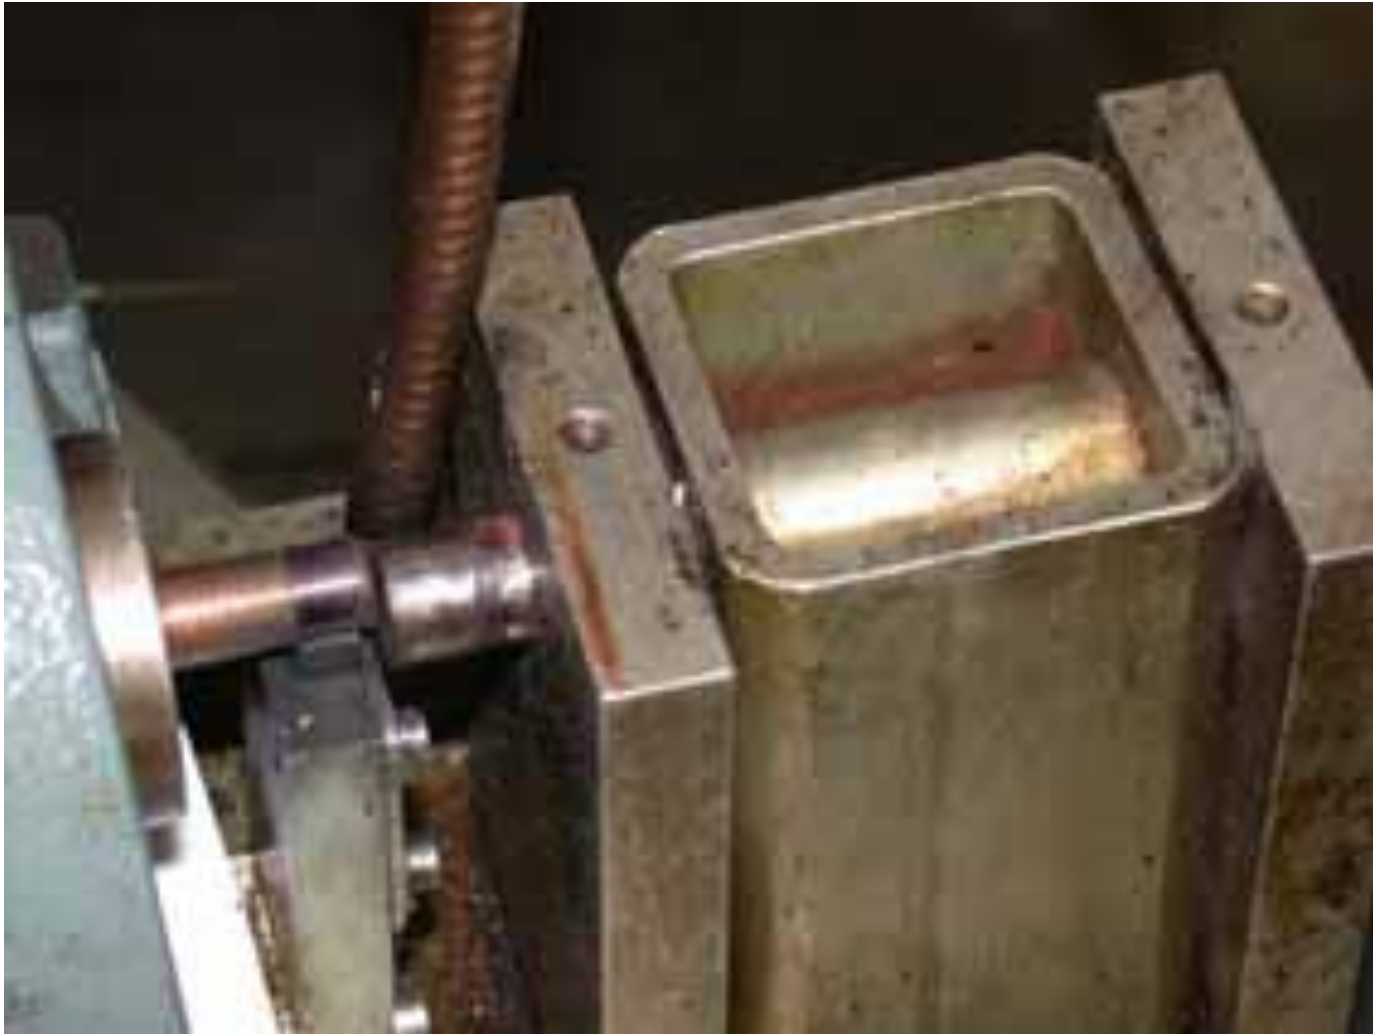
The cause of the electrical break down that led to this tank opening was found to be greatly reduced clearance between the down side inductor and the charging chain. Approximately 1 mm of clearance between inductor and wheel.

The displaced inductor frame pivot pin had allowed the inductor frame to move.

The inductor support pivot pin had worked loose and was partially disengaged toward and touching the metering pin and brush as shown in the above photo. This had allowed the inductor frame to tilt just the right amount to bring the inductor within 1 mm of the chain pulley. The frame tilted to the rear and, for an unknown reason, rotated in the horizontal plane about the up side inductor position thus only moving the down side inductor close to the wheel. The up side inductor, being at the centre of rotation, did not move closer to the wheel in the same way but was at a slight angle, never the less, due to the tilt of the frame.

It was fortuitous that the pin had moved out toward the chain wheel. Movement stopped when it contacted the chain pulley current metering shaft shorting the chain metering and leaving only one of the shear points disengaged. The limited the amount of movement prevented possible further mechanical damage. Had the pin moved the other way there would have been nothing, other than cross locking, to prevent it coming all the way out.

The pin had been in place for approximately 30 years. The two grub screws were found to be loose and so was one of the pair on chain#2.

The offending pivot pin was relocated and the all grub screws retightened. These will be routinely checked when under the platform in future.

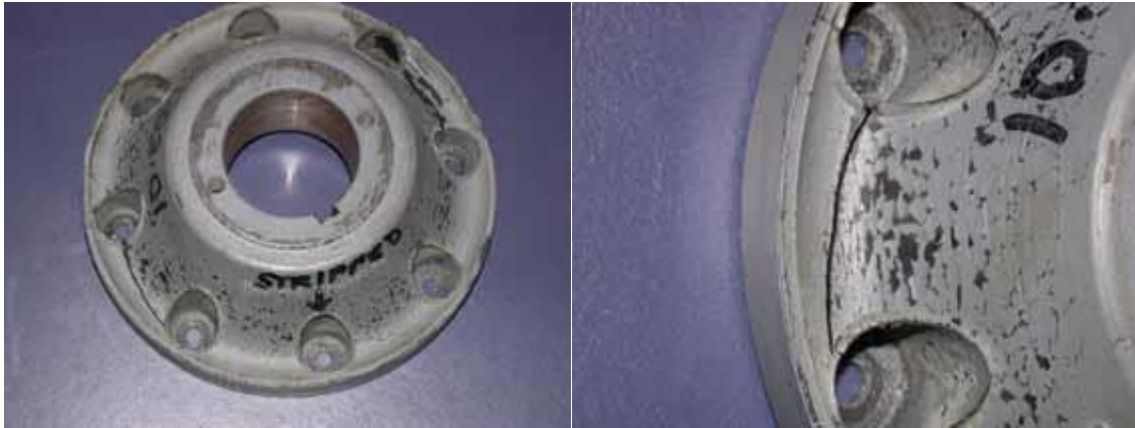
While at the top of the machine checking the tube and current metering it was noticed that the flexible coupling (modified Browning CFR 5) between the Upper Rotating Shaft and the Drive Motor was damaged.

The coupling was marked with a fitment date of 21-03-01 so must be considered an early failure.

The rubber body was fractured between two opposed pairs of mounting holes; ie 180 deg apart. This represents 25% of the shear strength and prudence dictated replacement.

Cracks at 180 deg

Some of these couplings have been in the spare parts cupboard for many years and this early failure begs the question of shelf life as no mechanical faults such as misalignment or vibration were found.

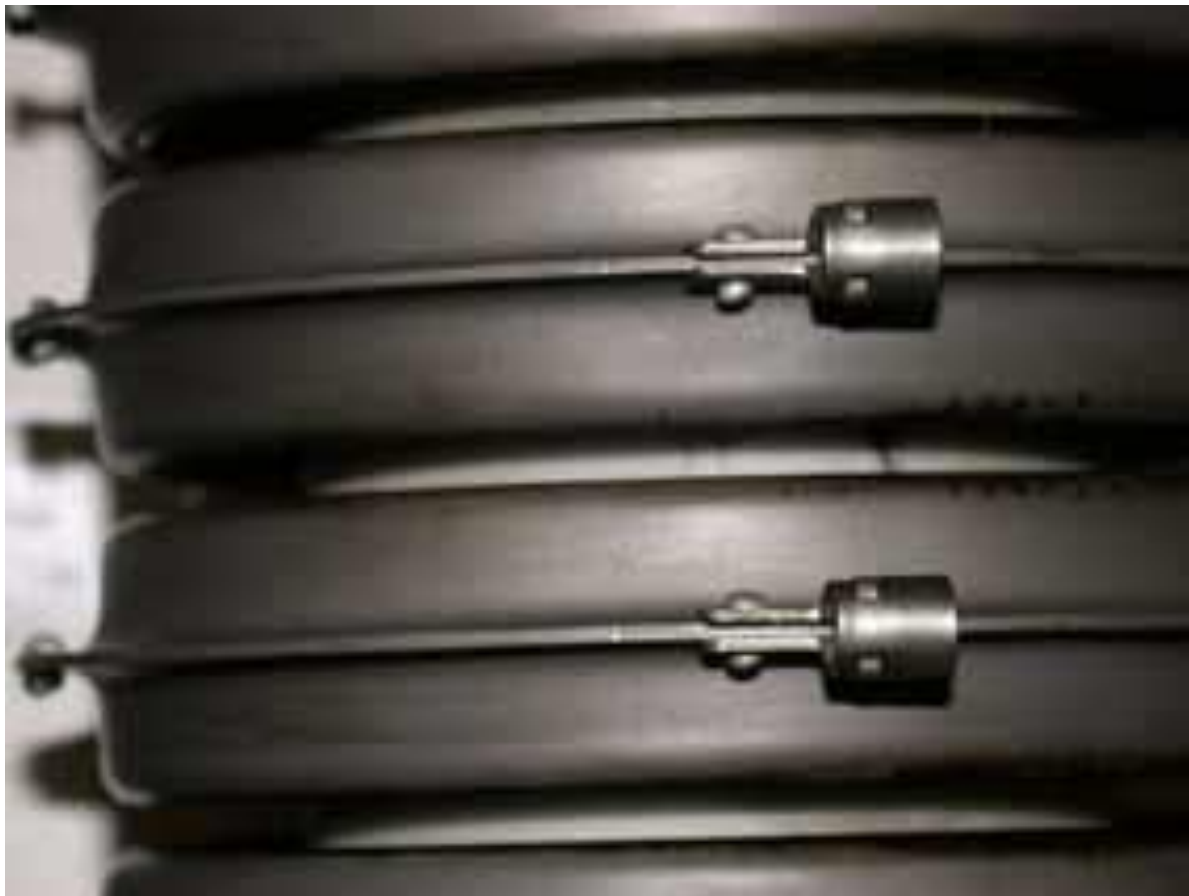
Post D in Unit 15 was found to have a cracked ceramic insulator in Gap 6.

The cracked ceramic was seen during the oil clean up even though it was two gaps below the area of concentration.

Judging from the blackened appearance of one of the cracks the ceramic must have been cracked for some time, maybe years, and would have reduced the voltage over this particular gap.

The reconditioned posts were assembled but had not been machined to length so it was decided to delay closing the machine while waiting for the workshop to finish off one post.

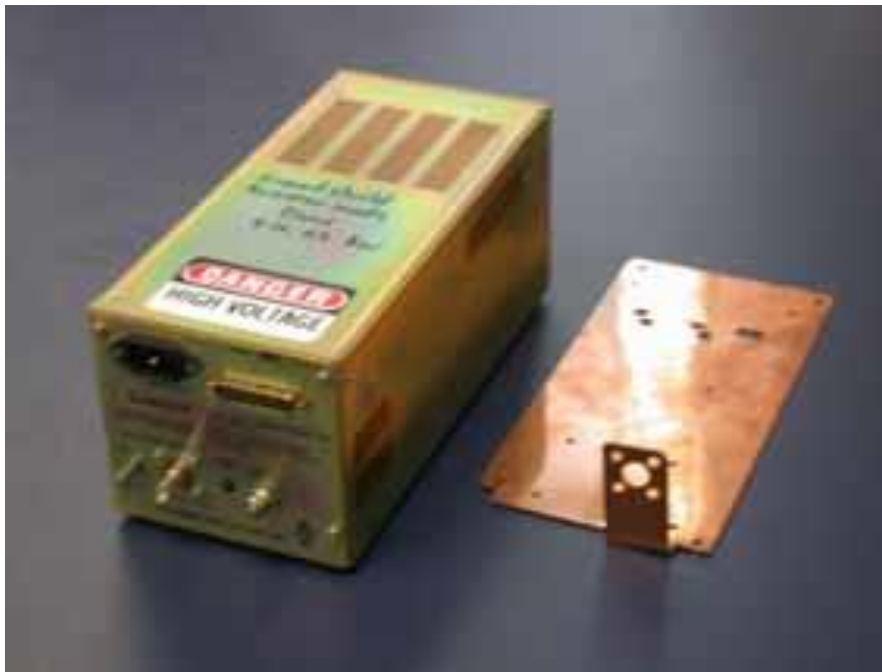
The usual ANU RF protection modifications, such as the installation of a copper ground plane shown in the photo below, were done just prior to the opening.

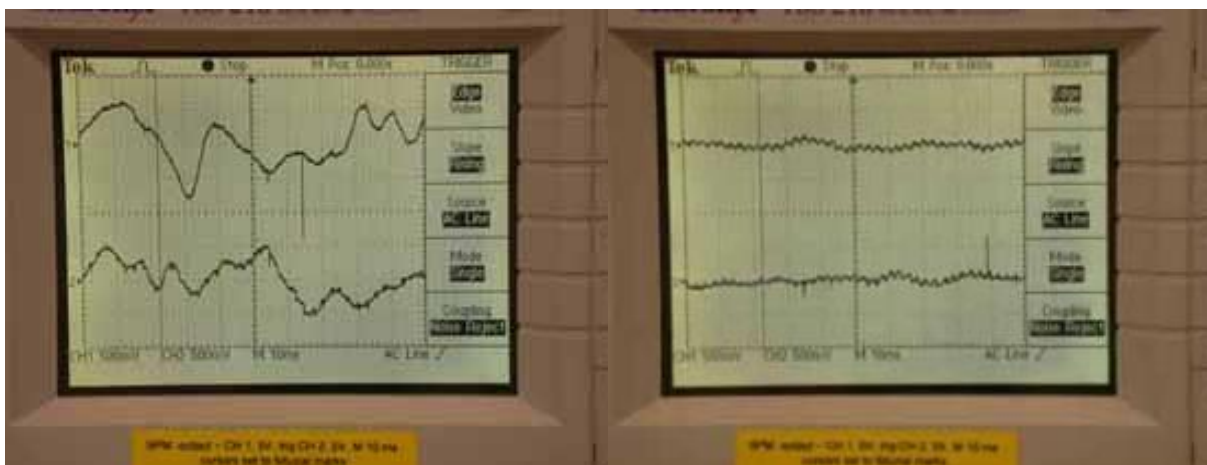
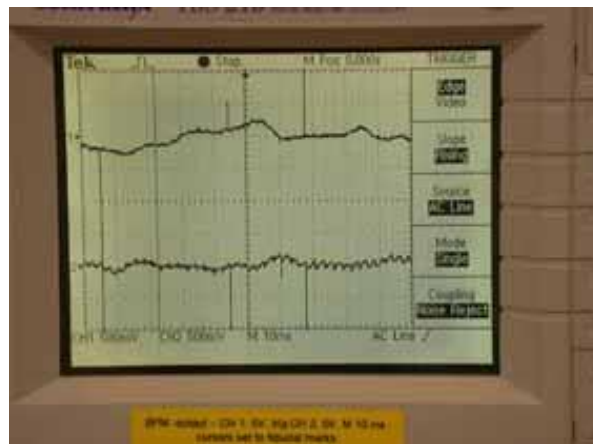
Chain 3

- The machine conditioned up to 15.2MV quite quickly and ran quietly at 14MV so the clean up of breakdown products was effective.
- Whilst the machine is running well Chain 1 is carrying 20% less charge than the other two. Oiling solves the problem for a short while.
- The pick off traces are unusual and copies of these pictures have been sent to NEC for comment.
