AUSTRALIAN NATIONAL UNIVERSITY
DEPARTMENT OF NUCLEAR PHYSICS
14 UD TANK OPENING REPORT # 96
23 Nov to 2 Dec 2004

REASON FOR TANK OPENING

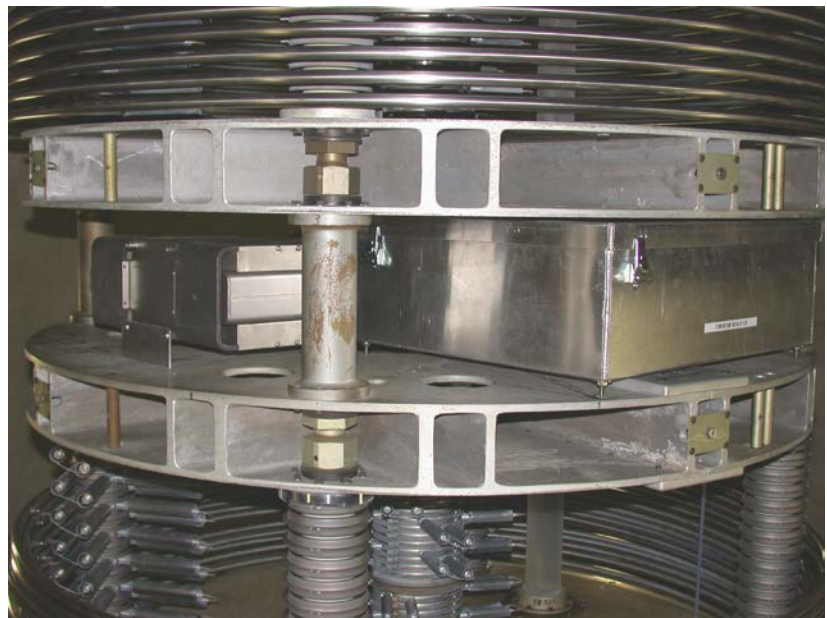
New pump to left. Control box to right.

The pump was warm after a few hours and the current was $7.4\mu\text{A}$.

The pump magnets were checked to confirm that the polarities were the same. In this standard configuration the field at the beam line was 1.6 Gauss. In order to

minimise stray magnetic field on the beam axis, one of the magnets was flipped over so that the stray field from the pair of magnets cancelled on the beam line. After the magnet was flipped over, the pump still read $7.5\mu\text{A}$, ie; no change.

The new 60 l/s ion pump was bolted to the tube tee using a previously made adaptor nipple 75mm in length. The outer end of the pump was supported on an aluminium plate bolted the pump but simply resting on the casting surface.

The new shield box was trial fitted in place. Shielded cable, optical fibre routing and grounding attachments were planned. These items were installed in the mid section while the box was finished off and the control equipment fitted to it in the workshop.
