AUSTRALIAN NATIONAL UNIVERSITY
DEPARTMENT OF NUCLEAR PHYSICS
14 UD TANK OPENING REPORT # 97
14 to 21 Jan 2005

REASON FOR TANK OPENING

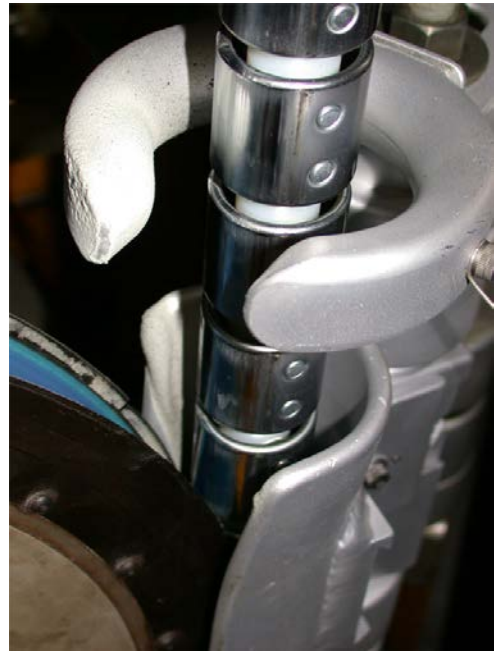
CHAIN PULLEY #1 LOWER

POWDER BUILD-UP ON CHAIN #1 PICK OFF. Note the lighter blue wear band on the tyre lip.

We found the lower pulley tyre drive surface to be worn asymmetrically.

The lip on the side closest to the centre of the column was approximately 4mm smaller than the outside lip.

A replacement on hand was a black anti-static tyre left over from the tyre fiasco of 1987 (TOR 56/3) and 1988 (TOR 61/9)

New shim stocks were fitted to the bottom black-tyred pulley and the existing blue-tyred pulley in the terminal.

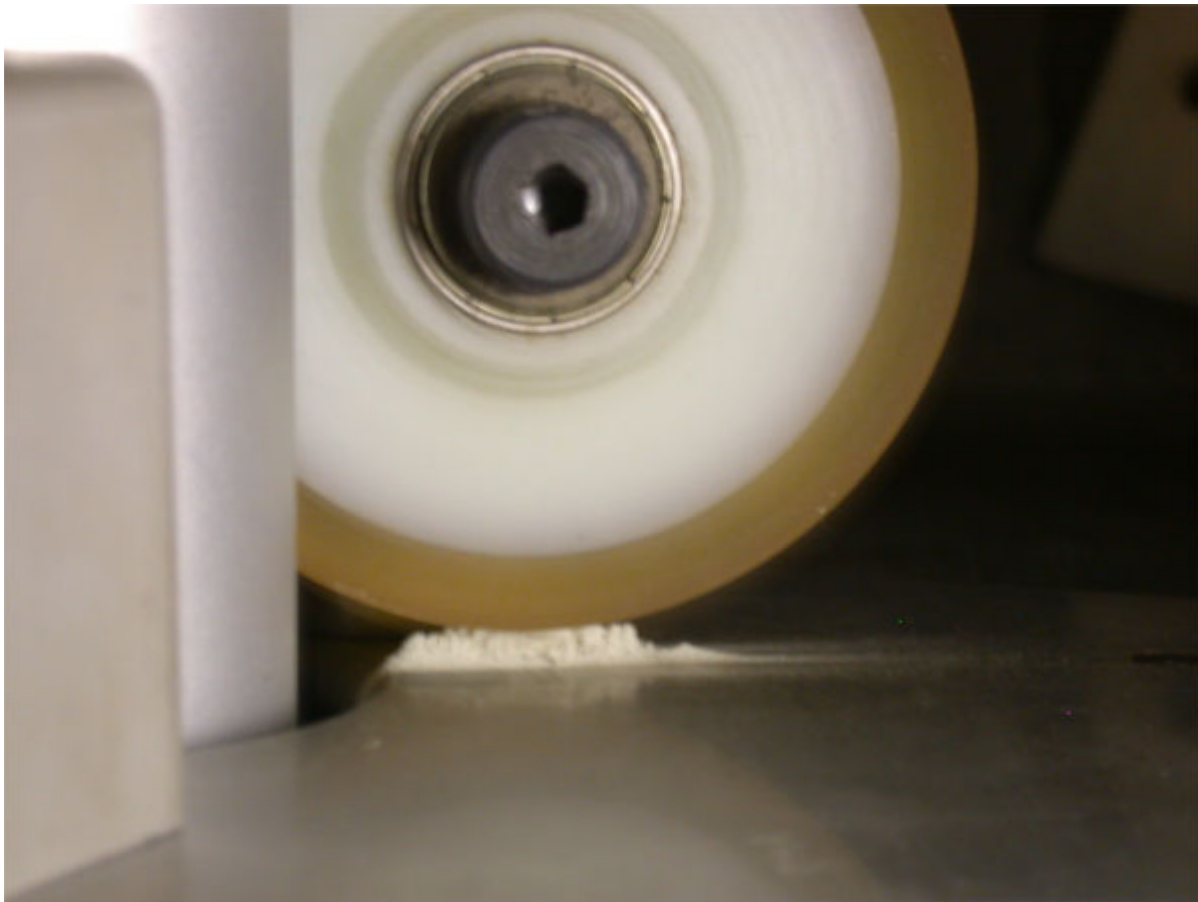
TYPICAL POWDER BUILD-UP FROM CHAIN #1 AT CASTING IDLER

The Chain #1 idlers and petal assemblies were removed for a thorough clean with RBS and water.

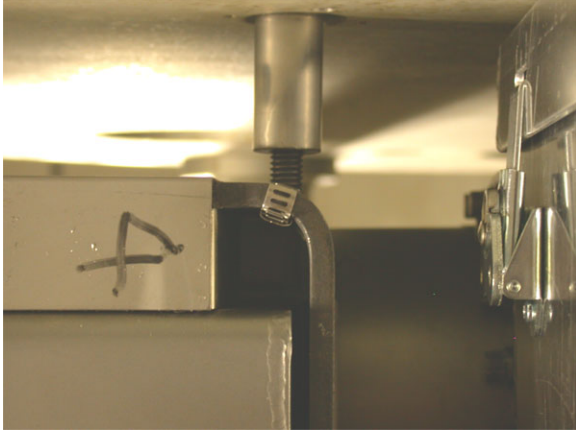
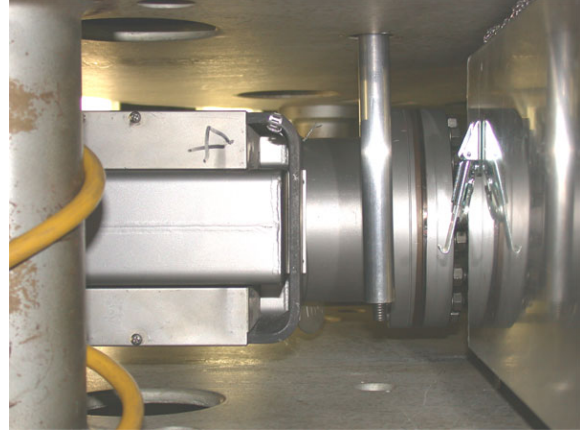
The crew certainly took the item literally because the shorting rods would not pass through the mid section after the pump installation. When the shorting rods failed to proceed it was surmised that the new Ion Pump was blocking the shorting rod hole at the mid section.

The photos show the shorting rod hitting the pump before alteration and clearing it afterwards.

SHORTING ROD STRIKING PUMP MAGNET, THEN CLEARING

The accelerator tube was let up to dry nitrogen and the mid section ion pump was removed.

The new longer nipple was installed and the pump reinstalled.
