AUSTRALIAN NATIONAL UNIVERSITY
DEPARTMENT OF NUCLEAR PHYSICS

14 UD TANK OPENING REPORT # 99

15 to 22 Feb 2005

REASON FOR TANK OPENING

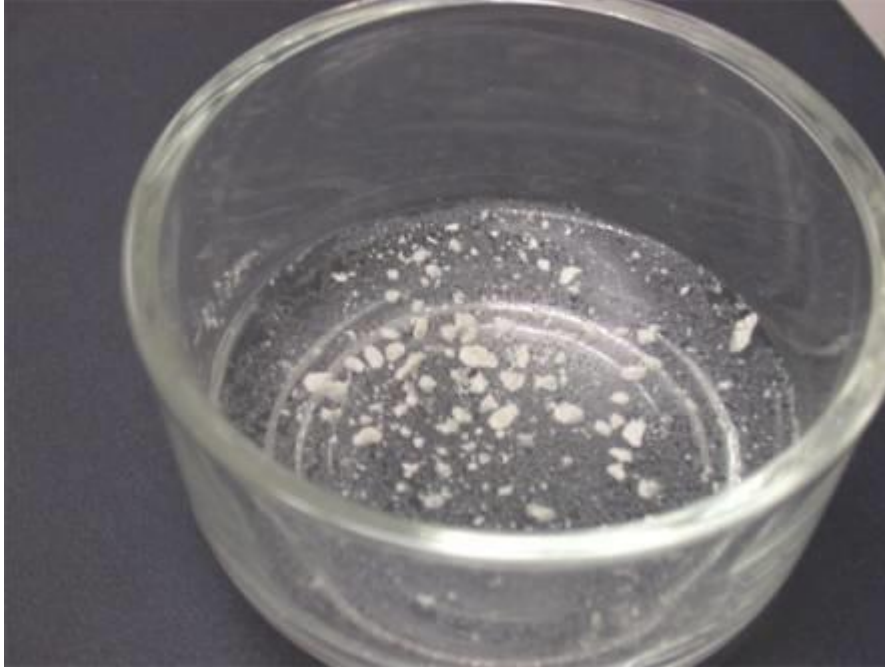
THE PENNY DROPS, PLASTIC NOT BREAKDOWN PRODUCTS

Hindsight can be a great leveller and it was hard to believe, once the evidence was understood, that the powder was not correctly diagnosed earlier. Placing some of the powder in water conclusively ruled out “breakdown products” as the power would not

dissolve and it actually floated on the surface even after vigorous stirring. It is probably bound by traces of oil into lumps that break up easily once touched. The conclusion, in light of the worn condition of the pulleys that had run against new chain 1, was that the chain was somehow different to its predecessors. The chain and most other sundry left over pellets were, literally, put under the microscope.

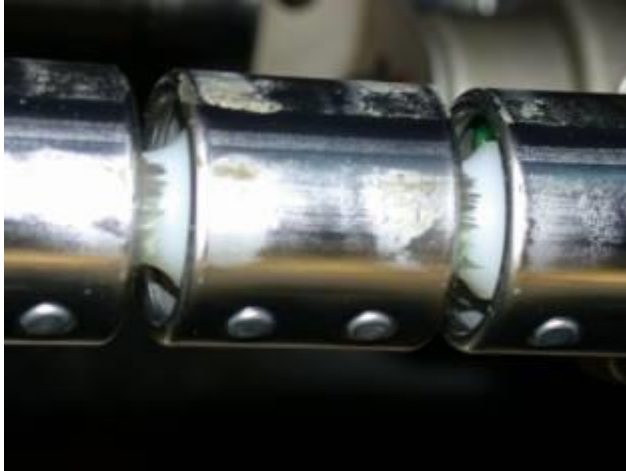
Whilst chain 1 in position 3 did not produce the copious amounts of loose white powder that it did in its own location it did produce powder that was trapped in oil and seen, as the hours passed, as a progressively drier slurry. More than enough slurry accumulated on the chain and wheel to confirm the erosion of pulley tyre material.

Dry slurry extrudes across pellet gap

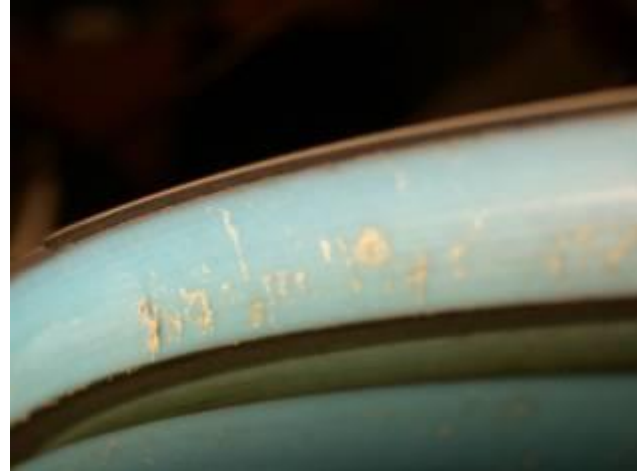
Chain pulley 3 began the test in typical shiny and oily condition, though, due to the incontinent oiler, the chain was significantly oilier than “normal”. However, after only 80 hours the tyre was scored in the same way that the chain pulleys, upper and lower, had been over the last few openings in the #1 position.

Slurry adhering to tyre rim.
