AUSTRALIAN NATIONAL UNIVERSITY
DEPARTMENT OF NUCLEAR PHYSICS
14 UD TANK OPENING REPORT # 100
28th to 30th June 2005

A.K.COOPER

D.C.WEISSER

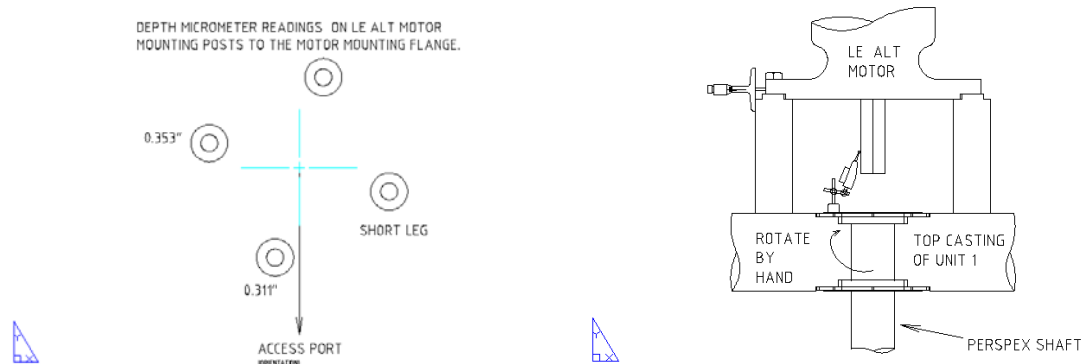
Rotation of the shaft system by hand led to noticing that the coupling fracture opened and closed according to rotational position. This condition indicated that the motor was off axis approximately 1mm.

The motor mountings were installed during machine installation and were not adjustable so repeated installations, down the years, have been similarly off axis within some small tolerance.

The reason that there have been two failures within two years remains puzzling since the misalignment appears to have been there since day one. It may be that the particular batch of rubber be it age or manufacture is less tolerant of the misalignment than previous ones.

Modifications were made to the aluminium stands and bolts that allow the motor to be moved up to 1.5mm. A dial indicator was mounted on the casting alternator top face, with the coupling removed, and run around the motor shaft. The run out was less than 0.004" when finished.

The fitting of the coupling required that the set up be moved so a depth micrometer was used to measure the position of the motor in relation to the aluminium stands. The drawings show which stands and the measurement in thousandths of an inch.

The coupling was installed to the motor shaft and then the micrometer was used to reposition the motor and the aluminium stand bolts were tightened. The coupling flange was then bolted to the casting alternator flange.

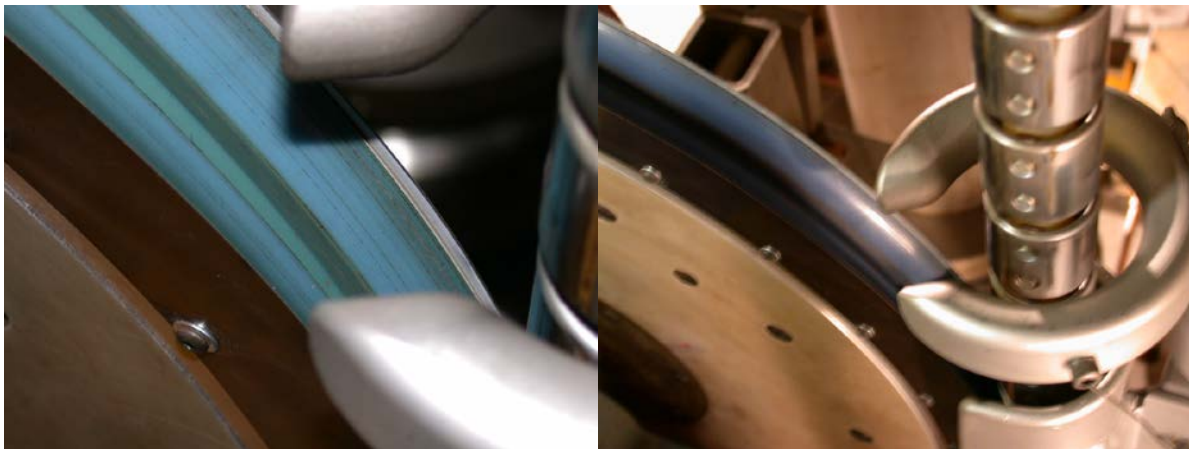
Old Chain #1 had not generated white powder since being reinstalled last opening. See the photos below and compare with those in (TOR99) (TOR97) (TOR95).

Note, however, that a small amount of white powder was found during the clean of the column prior to closing the machine. It was on the casting surface at an idler set on the upside direction of chain #1 and was dismissed as insignificant during the run down to tank closure. Next opening this will be checked again.
