AUSTRALIAN NATIONAL UNIVERSITY
DEPARTMENT OF NUCLEAR PHYSICS
14 UD TANK OPENING REPORT # 101
9th to 20th December 2005

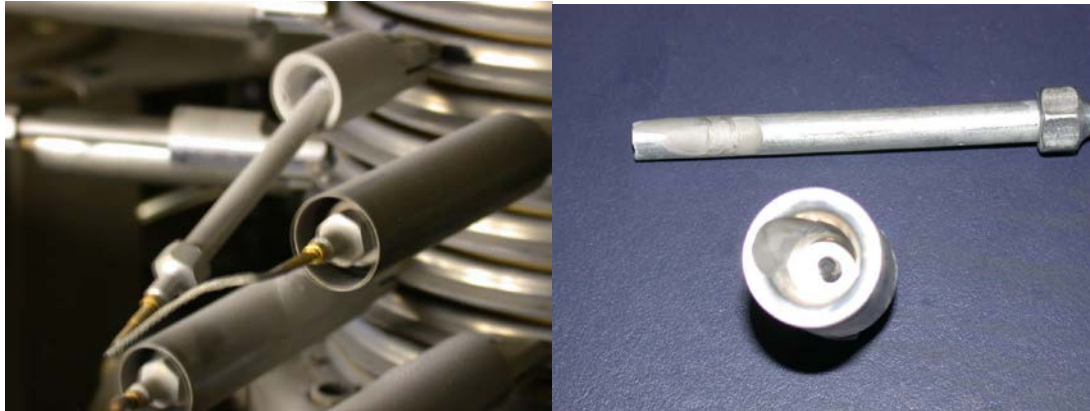
- The initial cruise down the column found the machine was fairly clean.
- It was noticed that the dummy resistor across gap 5, tube 2 in U19 had stripped from its stud and fallen against the aluminium resistor housing. Sparking had caused erosion of the aluminium and a lot of breakdown products in the immediate area. Dummy resistors are used in unit 19, where the high-energy stripper is located, in order to match the tube gradient to the column gradient.

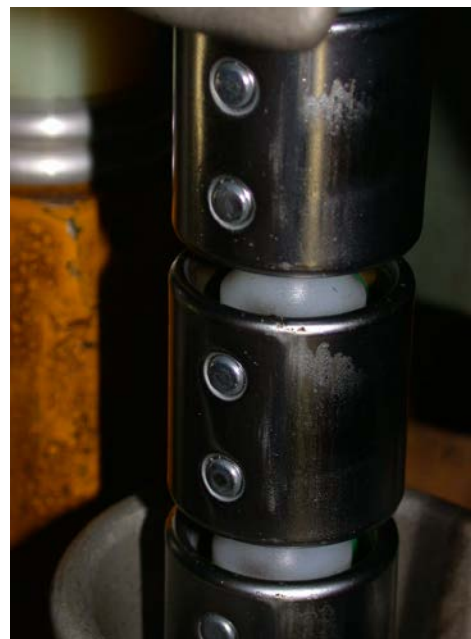
There was a slight sign of powder or oil/powder slurry evident next day (photo, slurry on pellets) so the next step, to install the new black conducting pulley rims, was taken. These were run overnight without oil and no white powder was found next day.
