AUSTRALIAN NATIONAL UNIVERSITY
DEPARTMENT OF NUCLEAR PHYSICS
14 UD TANK OPENING REPORT # 102
8th to 24th June 2006

REASON FOR TANK OPENING

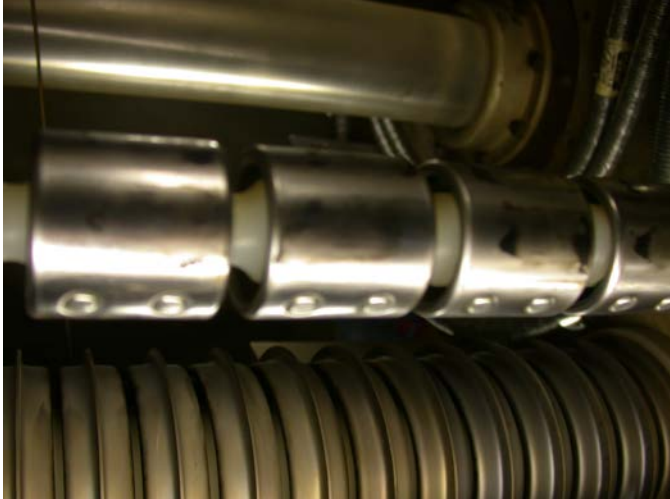
The pellets of Chain #1 had a residue like black stain that aligned to the area of contact with the pulley. The deposit was easily removed by wiping with an acetone-moistened rag.

Chain #1 had not been de-oiled when the black pulleys were installed so there would have been an oil residue present for a period of time.

The small amount of dust generated during operation, initially while oil was present, would have become trapped in the oil forming a slurry that would have dried over time. It was concluded that the black deposit found on the pellets had developed while the oil on the chain was drying, whereas, the dust was generated after drying, and not trapped in oil.

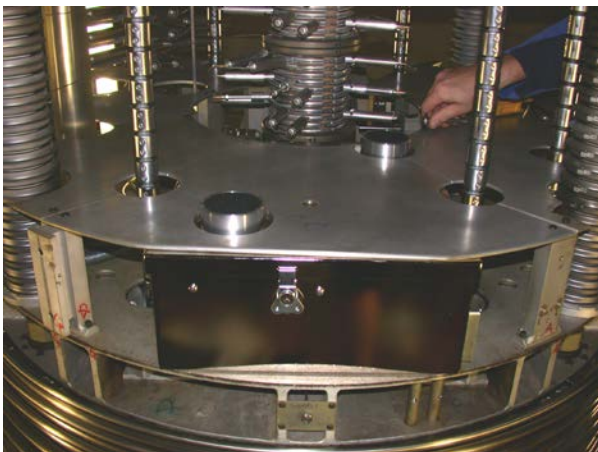
INSTALLED

The tasks involved, fitting a new enclosure containing the Group 3 gear and the suppressor supply. Modifying the existing ion pump supply enclosure to better withstand EMI/RF energy.

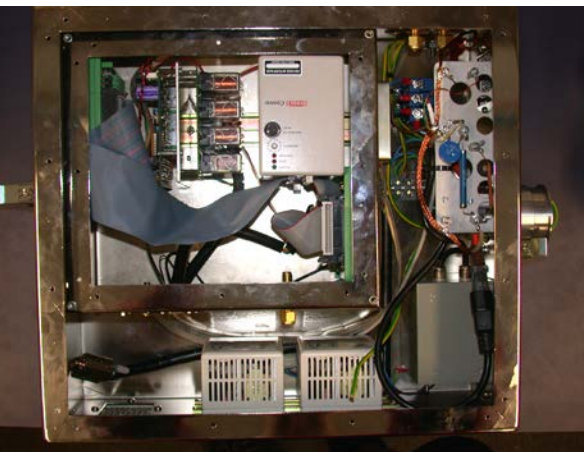
OPEN

- The terminal stripper foil changer was replenished and reinstalled.
- The noisy shaft bearings in casting of Unit #17 were replaced.
- The mid section ion pump box, which also houses the mechanical foil position readout, was modified to improve EMI/RF protection. The new ion pump power supply and resistor set were installed in the box.

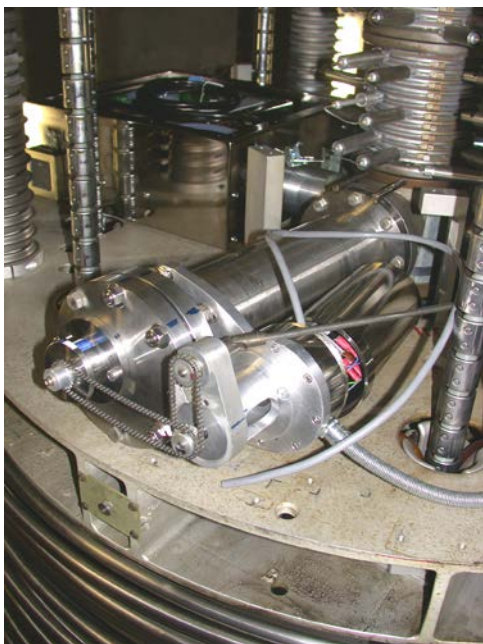
NEW DRIVE MOTOR

Fitting the new drive motor assembly to the stripper body.
Routing all wiring and fibre optic conductors, including modifications where necessary.
