AUSTRALIAN NATIONAL UNIVERSITY
DEPARTMENT OF NUCLEAR PHYSICS

14 UD TANK OPENING REPORT # 105

7th to 11th May 2007

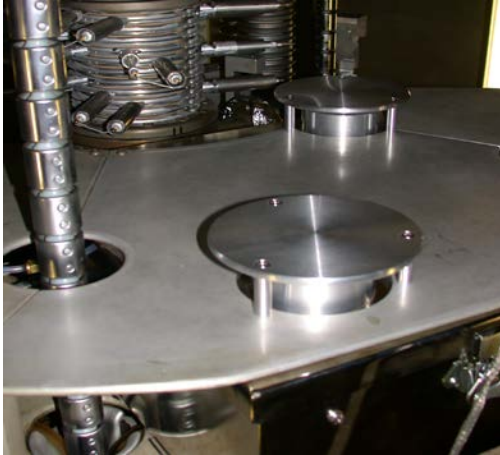
BAFFLE IN DECK

The aluminium deck was fitted with a baffle designed to block “line of sight” through the outer Group 3 shield box EMI/RF vent.

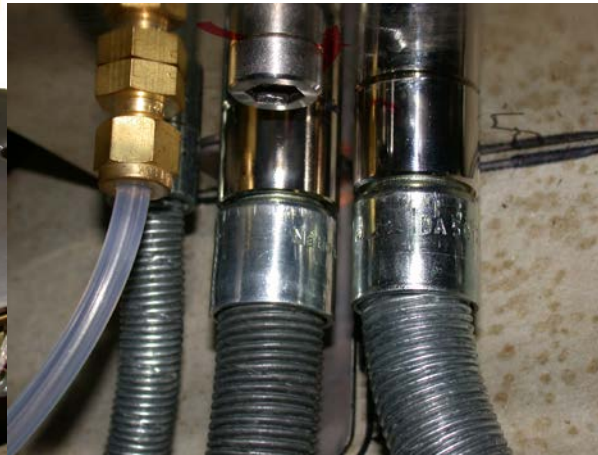
CONDUIT CONNECTOR

Pi filters were fitted into the conduit connector between the alternator junction box and the outer Group 3 shield box at the wall of the latter.

These measures should finalise spark protection of all Mid Section control equipment. Time will tell.

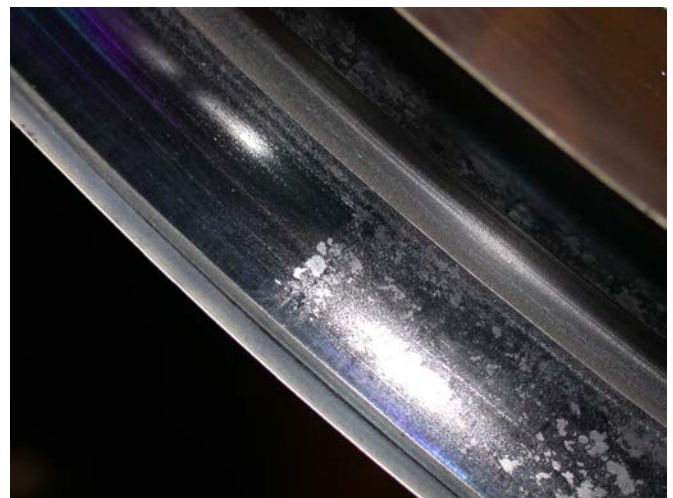
CHAIN #1 BLACK TYRES

There was a light dusting of, presumably, tyre material adhered to the charging chain. Other than that, all was well and it will be checked again next opening.

Based on performance so far, black tyres for the other chains can't be fitted soon enough. It would be nice to retire the oilers before the older, or even the younger author, do.
