AUSTRALIAN NATIONAL UNIVERSITY
DEPARTMENT OF NUCLEAR PHYSICS

14 UD TANK OPENING REPORT # 106

4th to 8th February 2008

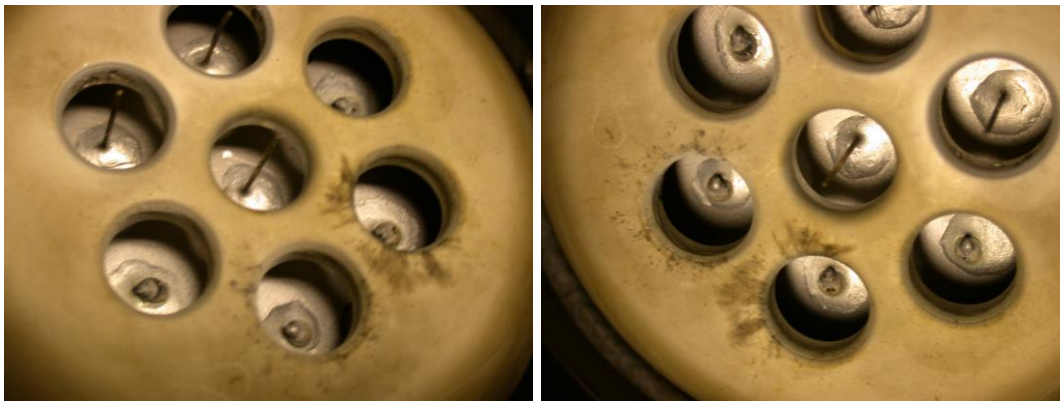
Four of the Triode needles were melted off and had become a blob of solidified metal almost flush with the mount plate. The remaining needles were very blunt.

This is the first time needles had become so severely damaged. Usually they erode away fairly uniformly and becoming blunt.

The melted points are due to tank sparks initiated by discharges between the sagging 1/8" rod connecting the needles to the vacuum tube and the hollow cylinder containing the rod in the SF6 space. There were 57 new spark marks on the terminal opposite the needles.

The assembly was dismantled and reassembled with the correct engagement of the 1/8" rod and the triode needle mushroom. The 1/8" rod was retightened sufficiently to ensure it was straight and therefore more concentric with the tubular housing.

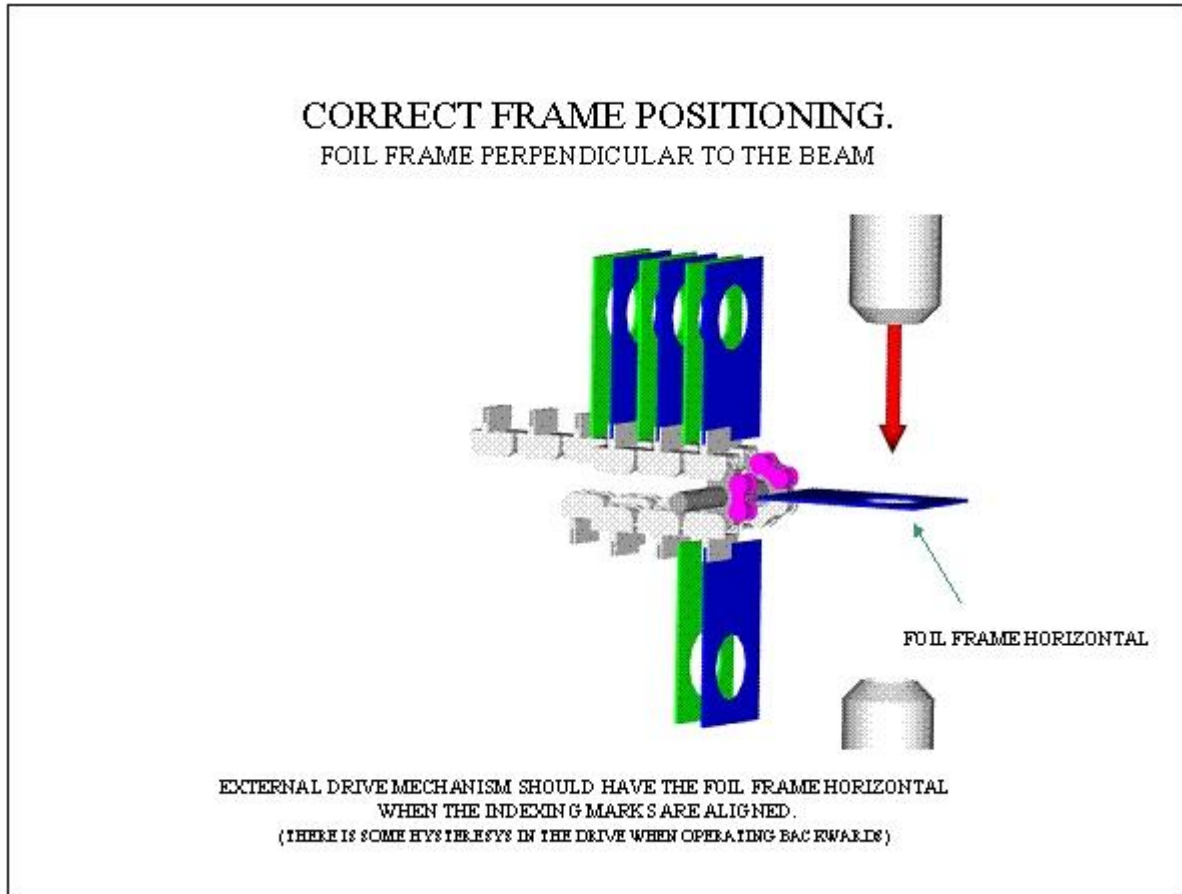
Diagram by Alistair Muirhead

The above diagram shows the correct position of the foil frames in relation to the external indexing marks of coloured masking tape on the drive pulley/body. Note the position of the joining links, shown here in purple for clarity. They do not support frame clips.
