AUSTRALIAN NATIONAL UNIVERSITY
DEPARTMENT OF NUCLEAR PHYSICS
14 UD TANK OPENING REPORT # 107
4th to 8th April 2008

REASON FOR TANK OPENING

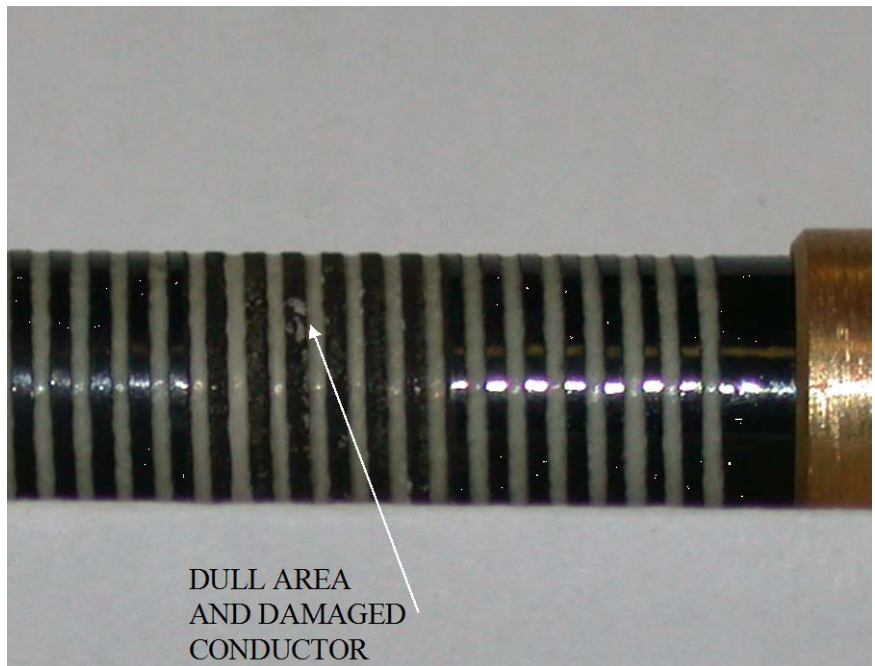
TUBE RESISTOR

The failed tube resistor had a small chip in the conductor path. Chipping is an often seen consequence of the grinding process used in creating the insulating path on the resistive coating. This suggests that this failure is likely due to the manufacturing process perhaps exacerbated by electric stress during the 20 years of operation.

The area of the break had a dull appearance that went around the entire diameter. The area of damage was found to be adjacent to the internal transition from shield to housing. The reduction in internal diameter here, even though it is radiused, enhances the field thus reducing resistance to breakdown.

Subsequent sparking across this gap had eroded the glossy finish and finally severed the conductor.

pair across Gap 8, Tube 4, Unit 1. The resistor was changed and the opening was then managed according to usual procedures.
