AUSTRALIAN NATIONAL UNIVERSITY
DEPARTMENT OF NUCLEAR PHYSICS
14 UD TANK OPENING REPORT # 108
17th to 18th April 2008

REASON FOR TANK OPENING

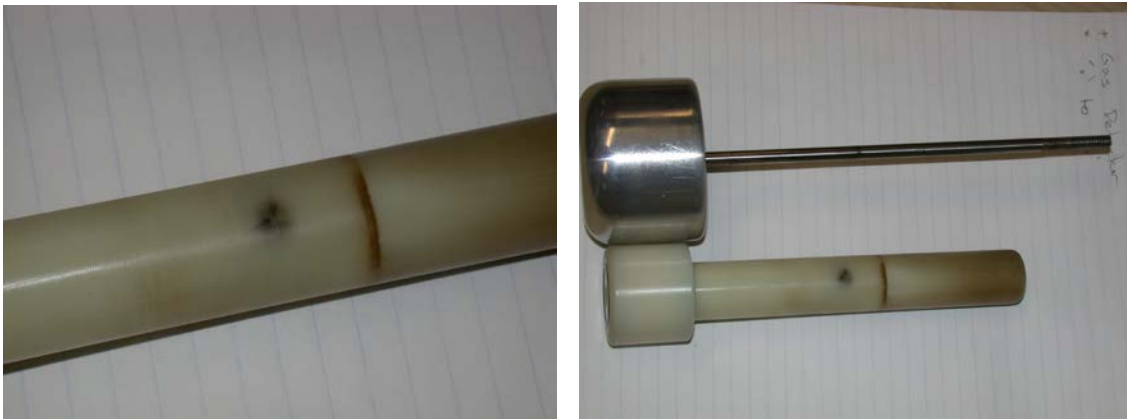
NYLON FEED THROUGH

The positive side 1" diameter nylon feed through had been sparked through between the central conductor and the tank wall.

The conductor is 1/4" diameter steel rod.

The damage was adjacent to the sharpish outer edge of the hole in the tank wall. Earlier in the machines life the inner edge had been radiused to raise the spark threshold. It was not remembered why the outer one was not done at the same time. However, it is better late than never.

- While the nylon parts were being machined the outer edge of the feed through hole in the tank wall, which had been quite sharp, was radiused at about 1.5mm.
- All the nylon conductor standoffs were replaced as well.

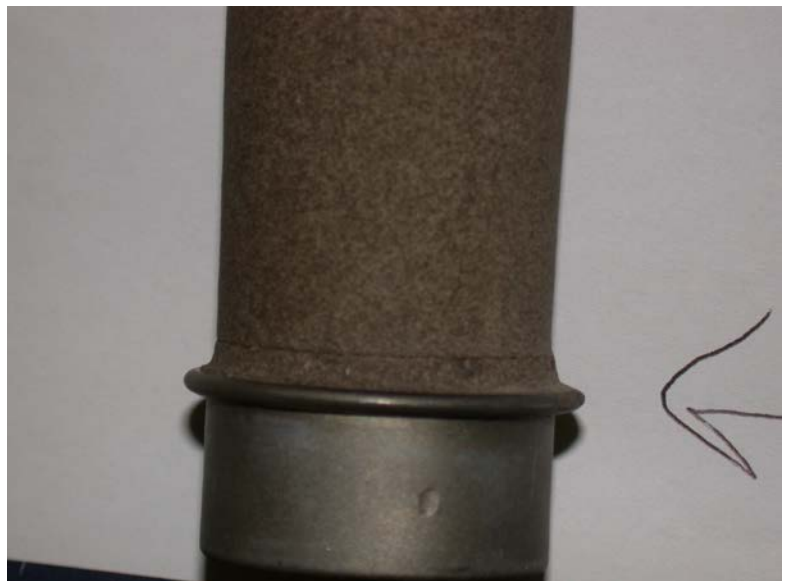
CHARGING CIRCUIT RESISTOR

During testing it was found that the positive circuit series resistor was open.

Closer inspection revealed a crack at each end of the ceramic coating. Since a spare resistor was on hand this problem was easily overcome and the machine was retested and closed.

It was thought that the cracks were caused during disassembly.
Another spare is being sourced.
