**AUSTRALIAN NATIONAL UNIVERSITY**  
**DEPARTMENT OF NUCLEAR PHYSICS**

**14 UD TANK OPENING REPORT # 109**

25<sup>th</sup> August to 5th September 2008

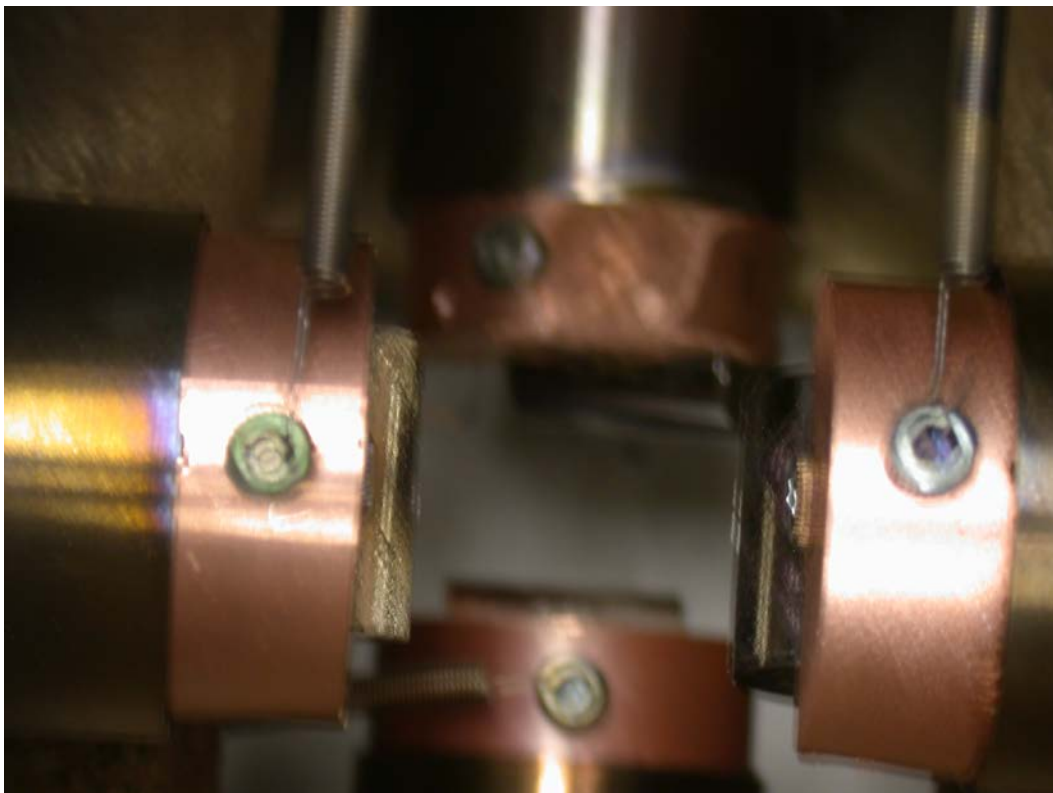
The High Energy slits were vented to atmosphere separately from the tube. The old slits were composed of a Ta rod silver-soldered to a copper block. Because they had been exposed to high beam intensity with the water-cooling off, two of the silver solder joints failed allowing one of the slit jaws to move one mm into the beam path.

The jaws were checked for radioactivity and were found to be emitting over 100 micro sieverts at their surfaces reducing to 10 micro sieverts at a distance of 30 cm. They were carefully removed using long pliers and wrapped in lead sheet for storage in the Radioactive Materials Locker.

Newly jaws, made entirely of tantalum, were fitted and the unit reinstalled in the high energy beam line.

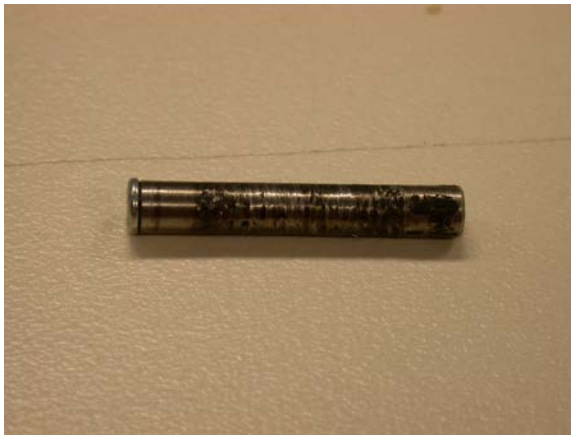
The pellet that measured 7.5 mm was removed and the pin was found to be scored to depth of at least 0.010" on the loaded side. The pin hole in the Teflon bush was elongated and the bush had deformed within the hole of the nylon link. The bush was also had several cracks through its thickness.

Worn Pin

It was obvious that Chain 3M was very tired at 77143 Hrs and, since we had a lower hour spare on hand, was replaced. There was some confusion about the identity of the spare but, after much diligent detective work, the correct identity was found, it is "L" at 59370 (56000) Hrs. Further investigation found another spare, Chain 1K also at 14700 that records had alluded to, but 3L had already been installed by then.

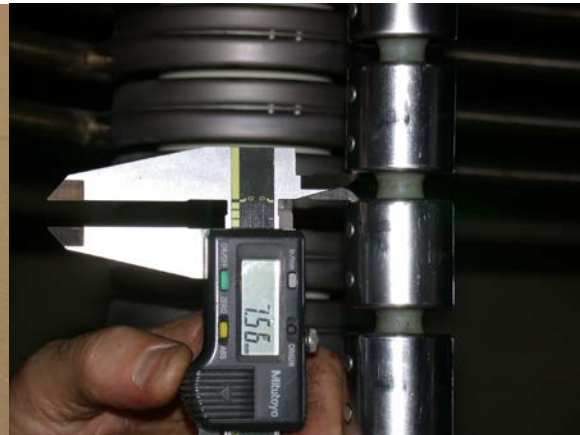
The worst of these was 7.5 mm while typically the gaps were generally greater than 6.5 mm. The widening of pellet to pellet gaps, from the 5.5 mm gaps in new chain, shows the cumulative effect of wear in the pins and pin bushes to be quite extraordinary and alarming.

Gap measurement

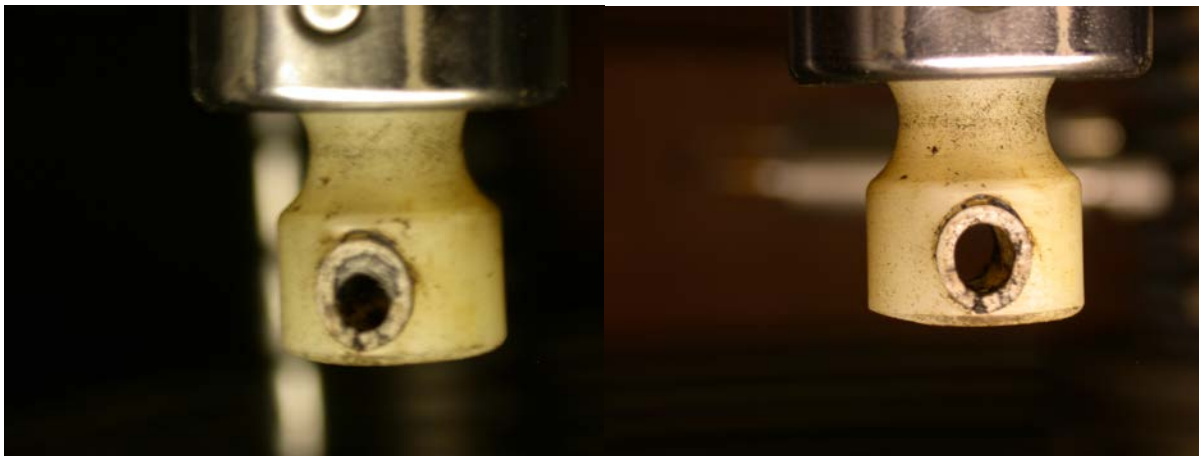
These photographs show an accumulation of material in the space on the unloaded side of the pin diameter. On right the material has been removed. Note the radial cracks in the bush.

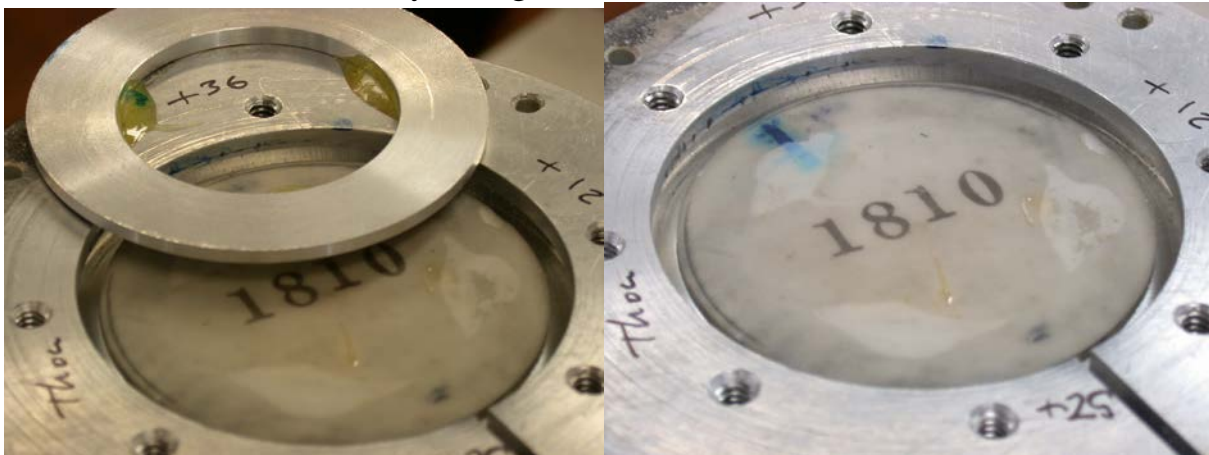
It was soon realised that one end cap on #1810 was loose and that the titanium electrode sprung the cap off as the end load was removed. This gave the impression that the post was approximately  $0.035''$  longer than it actually was when loaded.

The post #1810 must have been subject to an error reclamation strategy when originally manufactured. It was probably not accidental that it was placed high in the column where loads are at a minimum.

The actual aluminium end caps are unique in design and of a type not previously discovered in our machine. The normal end cap overlaps the ceramic to ensure transfer of load to the ceramic.

Since there would have been a fair amount of labour and materials already invested it was reclaimed by fitting accurate

aluminium spacers to each end. These spacers were attached to the ceramic using “Epoxy” and were machined square so that they would accurately transmit the casting loads between the castings and the post’s ceramic elements.

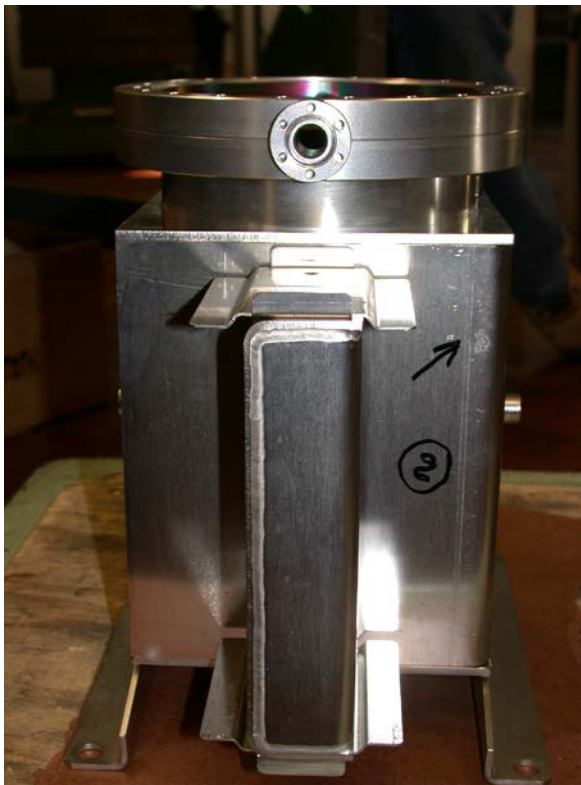
The terminal ion pumps were removed early in the opening so that reconditioning could be done in parallel with other work. As expected, they were very flakey consistent with 45000 hours of operation at  $10^{-6}$  torr. Most of their hard work occurred on their first operation so we expect much longer lifetime for the built pumps. The pumps were stripped down to empty shells and then acid cleaned, rinsed and baked. There was some trepidation whether the new elements were the correct ones. They indeed were perfect thanks to information from NEC, Gamma Vacuum and Stanton Scientific. NEC bought the pumps from Physical Electronics who were sold to Gamma Scientific though the design and origin is Perkin Elmer.

Body ready for cleaning.

The new elements were fitted, the magnets reinstalled and they were run in turn outside the tank using a spare power supply. They started almost immediately.

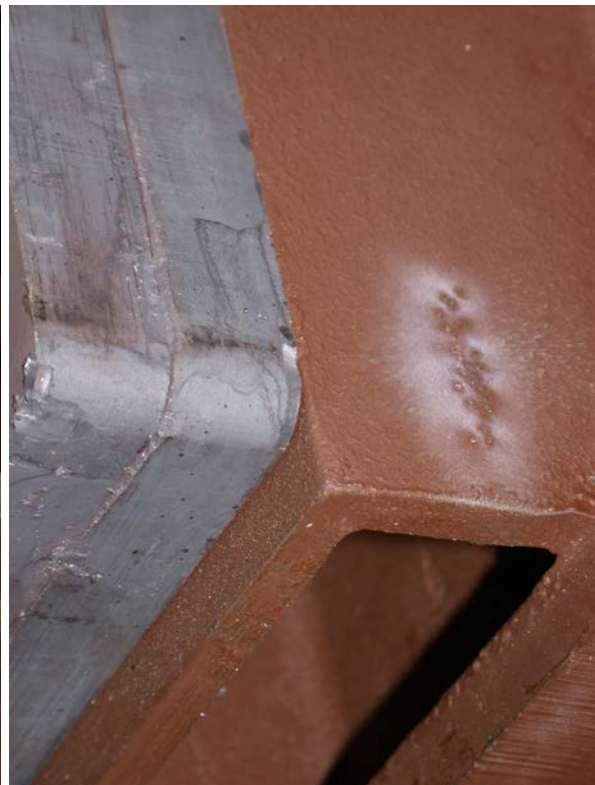
Note spark marks at 2 and matching marks On the body above.

The photos show spark activity between the return yoke and the stainless pump body. This is the case for both pumps even though they are in different positions relative to the surfaces in the terminal. The yokes are painted and may not have been in DC contact with the pump bodies. Paint was removed under the screw head on the attachment of the yoke to the body. We may remember this in 10 to 50 years when the pumps next need service.
