**AUSTRALIAN NATIONAL UNIVERSITY**  
**DEPARTMENT OF NUCLEAR PHYSICS**

**14 UD TANK OPENING REPORT # 110**

29th January to 19th February 2009

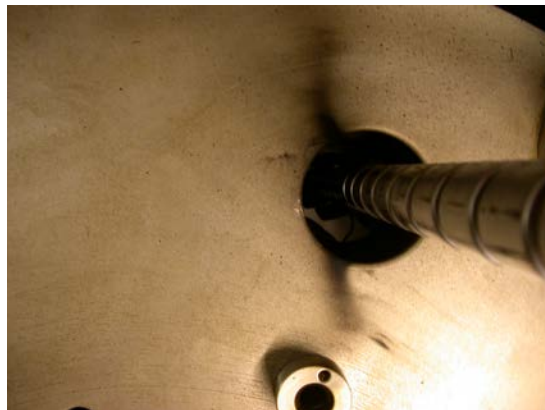
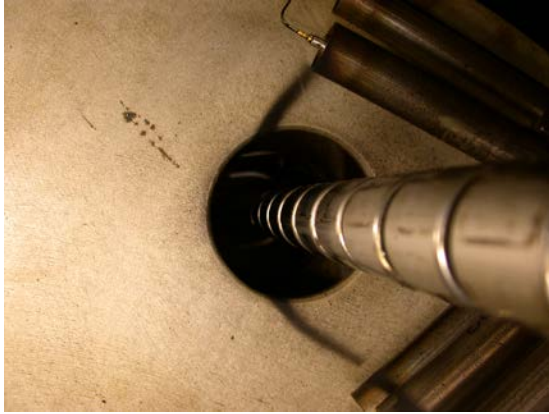
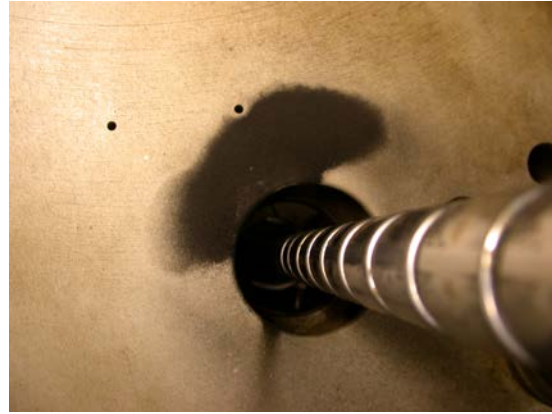
#### UNIT 15

- Unit 14 was rechecked in the usual way, after re-measuring, at 30 kV and found to be in the usual range of 7.2 to 7.4 micro amps per 11 gaps.
- Unit 15 had black dust deposits on the top casting at each chain upside position. The deposits are most probably trapped in an oily film. They appear to be deposited in a pattern influenced by electrostatic field as they are sharply defined in a particular pattern. The photos show the different pattern in each chain upside location.

The unusual patterns of black dust found at the top of unit 15 demonstrate the part electrostatic fields play in distributing particulates within the machine.

The photos are included for the record and in the hope that comments may be forthcoming as to what is going on here.

The orientation of the chain idlers was not found to be consistent, chain to chain, with these patterns.

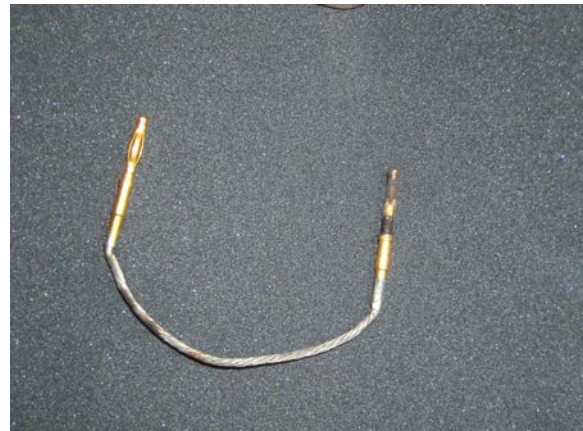
### RESISTORS

Spark energy strikes the resistor leads leaving a blackened spot. The spot flags the possibility of a high current having burnt the banana plug and mating socket in the resistor nut. The banana plugs are checked and replaced when there is any sign of degradation of the gold plated surface.

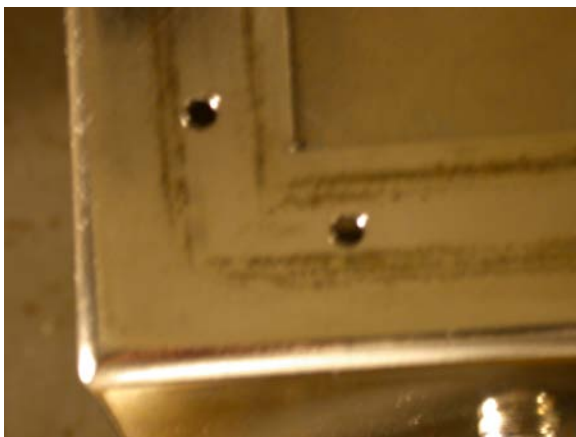
SPARK MARKS ON BOX FLANGE

- Toured 4 staff through the machine 12:00-12:45.
- The resistors were refitted to the mid section.
- It was noted that the HE Mid Section control box lid gasket had spark marks next to both the inner and outer edges. There was no sign of spark damage inside the box.
- Glynn Whitworth from the OHS Unit toured the machine.

The second stripper control had been stunned by a tank spark during the last period of runs. Once again, improvement of the spark protection was required. Apart from fitting Pi Section filters to the, previously assumed safe, last eight wires an open minded approach was required. The obvious strategies were implemented during installation and various not so obvious ones have been employed during several upgrades. This left very little scope for improvement. Closer inspection revealed sparking damage to the plating between the RF gasket and the control box body. Whilst it was not known that one of these, seemingly numerous, breaches of the shield caused the failure, it was an area that should be improved. To that end an RF finger stock gasket was chosen to replace the gauze gasket that had been originally fitted.

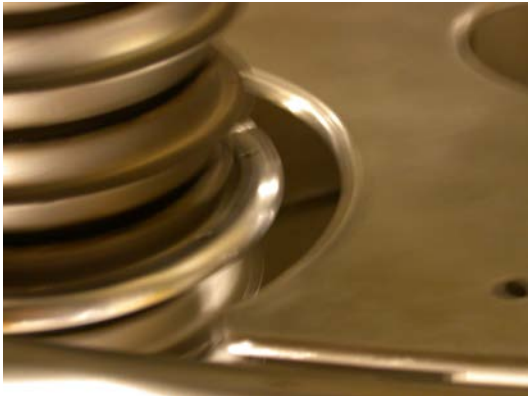
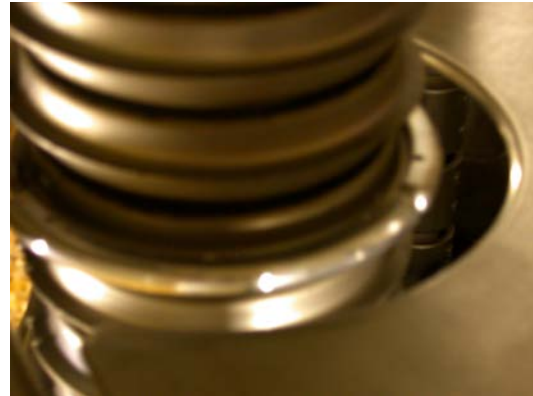
TWO SHOTS OF THE NEW EDGE RING AND RADIUSED CUT OUT

It was noticed that energy was most probably jumping from the first shorted post electrode over to the deck and from the deck to the control box lid where spark marks were also found the deck and the control box.

The original cut outs in the deck plates were not concentric and the gaps between them and the column posts varied.

- The new spark resistant radius rings were fitted to the column posts in the HE mid section. The modified deck parts were fitted and all aspects of the anti spark enhancements checked.
- One deck pedestal was removed and radiused to fit in with the new deck geometry.

It was decided to increase the radius and concentricity of the cut outs. Further, it was decided to add a smoothly radiused ring to the sharp column post electrodes to reduce and smooth field strength between these elements as shown in the photos below. It is hoped that these measures will reduce the incidence of spark energy reaching the deck and therefore the control box.

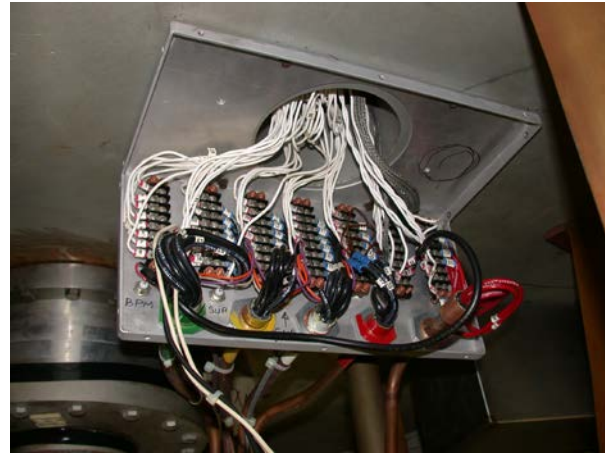
## TANK SLITS

There had been some confusion over the control command and the resultant position of the tank slits.

These were run from the console while observed from the platform. The wiring was found to be correct therefore the problem was thought to be caused by software.

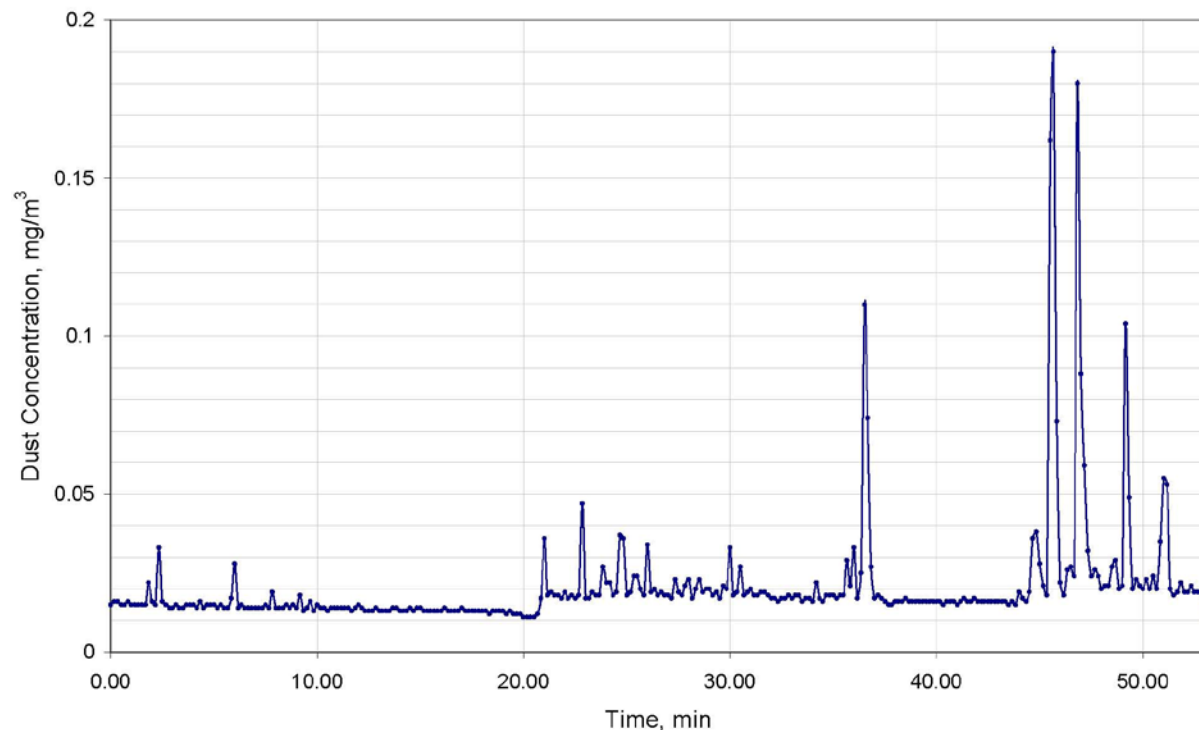
Zero to 20 mins shows background within the tank, no movement.

Note, a normal office would read approximately 0.01-0.02 mg/m<sup>3</sup>

The chart demonstrates just how free of airborne particulates the machine is.

The period, 20 min to 37 min was recorded while blowing air on the tank walls and demonstrates how clean the wall was during test.

The peak at 38 min was taken when blowing a wall recess, eg, view port.

The peaks at 46 min and beyond were due to blowing down Unit 26. Notice the substantial reduction of dust concentration from 0.19 at 46 min to 0.055 mg/m at 51 min as a result of continual blowing down of units.

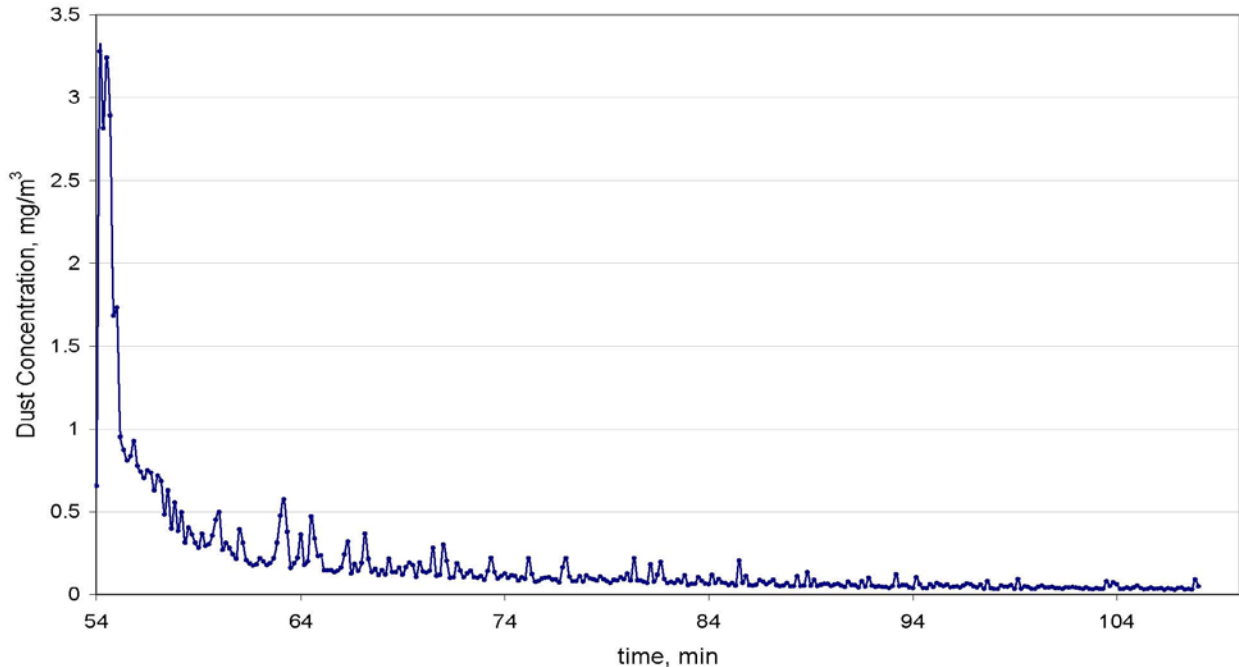
The high peak at the beginning records a high dust level caused when the equipment in the top of the machine, above the column, was blown down. The small peaks on graph corresponds to the blowing down of units. Between units the dust concentration reduced to background level. The dust concentration is higher in LE of the machine and lower in HE. This might be explained by the fact that HE section is exposed to oil mist from chains. The surfaces lightly covered by oil act as a trap for dust particles.

The dust concentration then fell as the blow down continued down the column to the last unit.

This reminds that dust accumulates on horizontal surfaces and amongst equipment that is not worked on as often as the column units so these should be cleaned as regularly as the column. Basically the entire dust load liberated from above the column dissipated during the blow down. No further significant peaks, above background, occurred during the blowdown of any of the units.

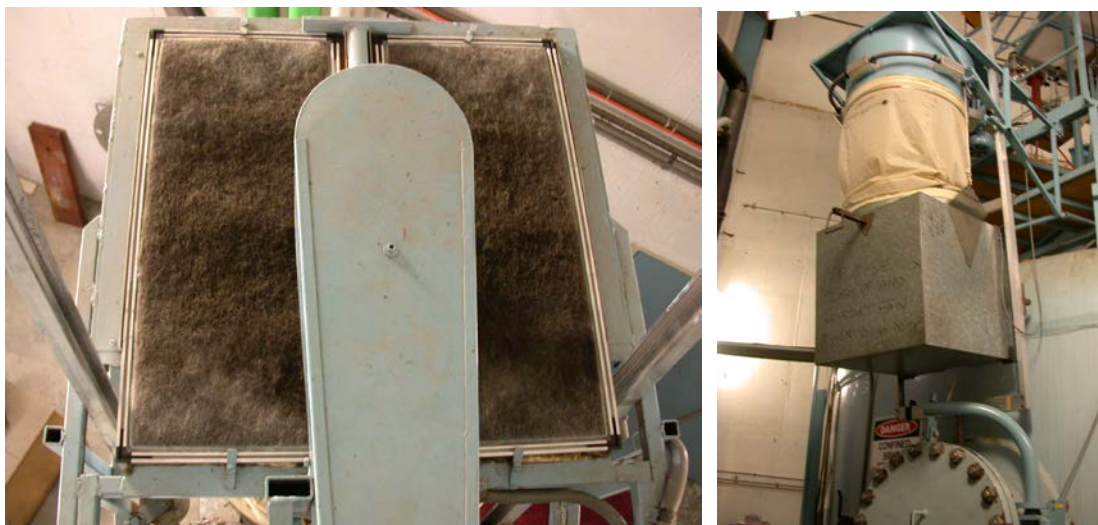
### **AIR CONDITIONING FILTER AT VENTILATOR INTAKE**

The above photos show the tank port ventilator that was made and installed in 1978. The fan unit is fixed and the plenum chamber is on rails that attach to the tank port when the machine is open. Sailcloth was used to make a collapsible duct. The plenum chamber is pushed up the rails, to allow staff access, and the fan is controlled by a micro switch at the plenum chamber lock bar.

The filter is air conditioning media found in local fan coil units and is only capable of removing fairly coarse dust particles. The colour of the filter demonstrates that significant air filtering has taken place.

Note the thick layer of dust on the fan belt shield.

Next opening, the dust monitor will be used to record the particulate background at each tank port.
