AUSTRALIAN NATIONAL UNIVERSITY
DEPARTMENT OF NUCLEAR PHYSICS

14 UD TANK OPENING REPORT # 111

21st August to 11th September 2009

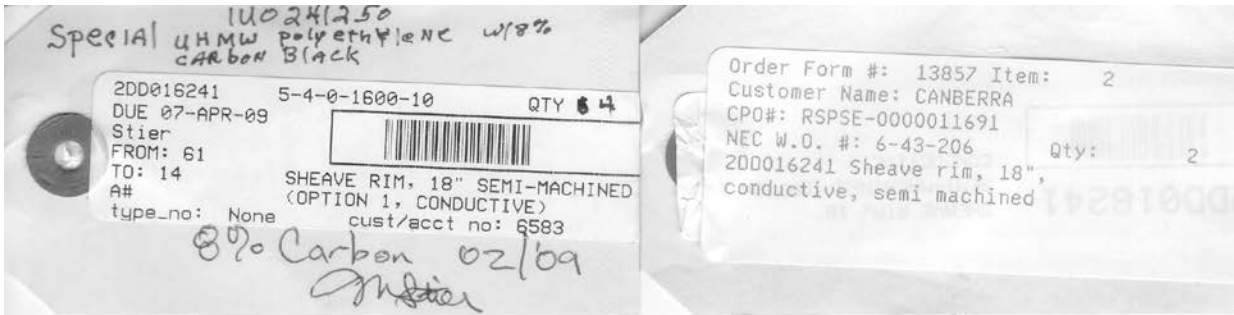
We purchased a pair of new chain wheel sheaves for position #2 to run with the new chain. The ID tag for these parts from NEC reads

IU0241250 UHMW POLYETHYLENE
W/8% CARBON BLACK.

These require mounting on the aluminium wheels and axle assemblies before final detail machining of the radius to match the chain pellets.

We had new spare chain wheels and axles ready and these were put into service in this location.

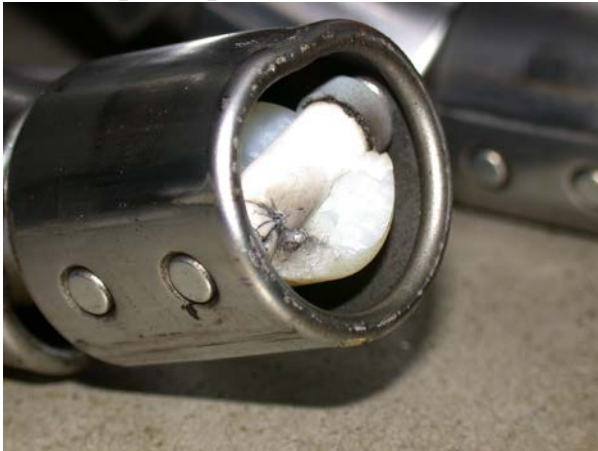
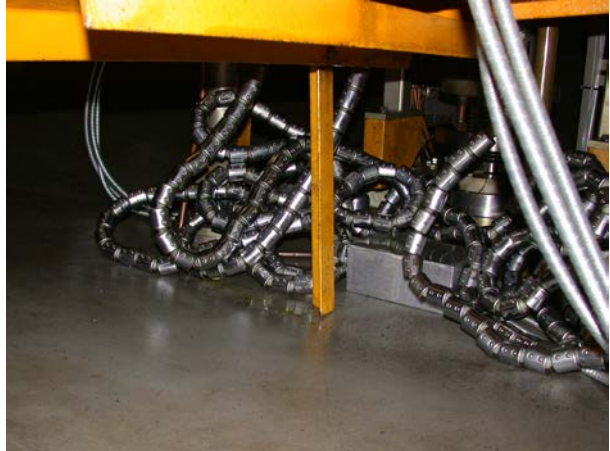
Chain #2 had failed.

The total hours on this chain was 69khrs. It would appear it had sustained a catastrophic spark event that fractured a nylon link.

Many pieces of broken chain were found down the column with the bulk in one piece laying in the tank bottom. The smaller pieces ranged from fragments of nylon links, pins with bushes, three and four pellet sections of chain.

The nylon stud of the up side charging inductor in the terminal was broken at the steel pedestal. Inductors top and bottom had sustained chain pellet impacts and these were dressed off smooth

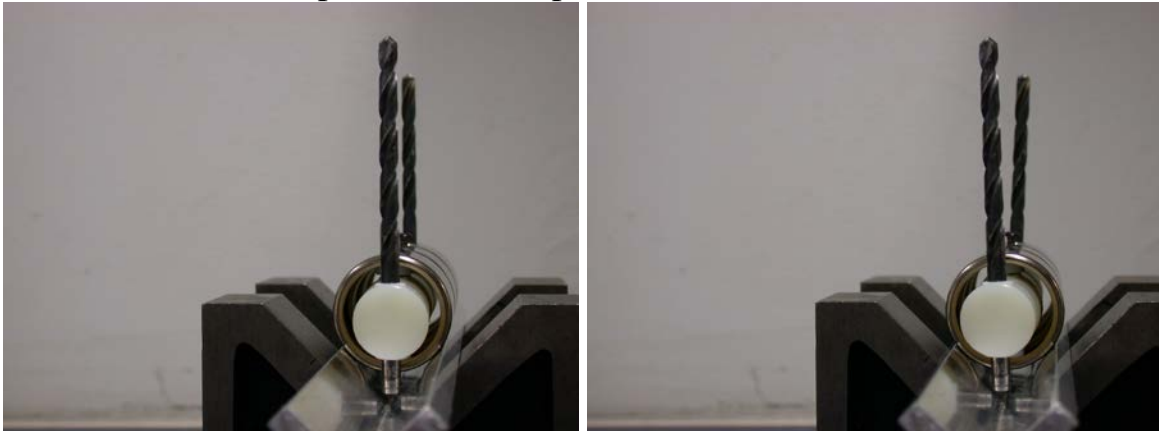
During the initial installation of the new chain there was a right handed twist of about 80 degrees in the free hanging drop from the terminal. This is evident in the assembled small sample of the three pellets removed to shorten this chain.

Images show pin axes (drill bits fitted) misaligned. Light rotational force applied then relaxed in both directions taking up the pin to hole clearances.

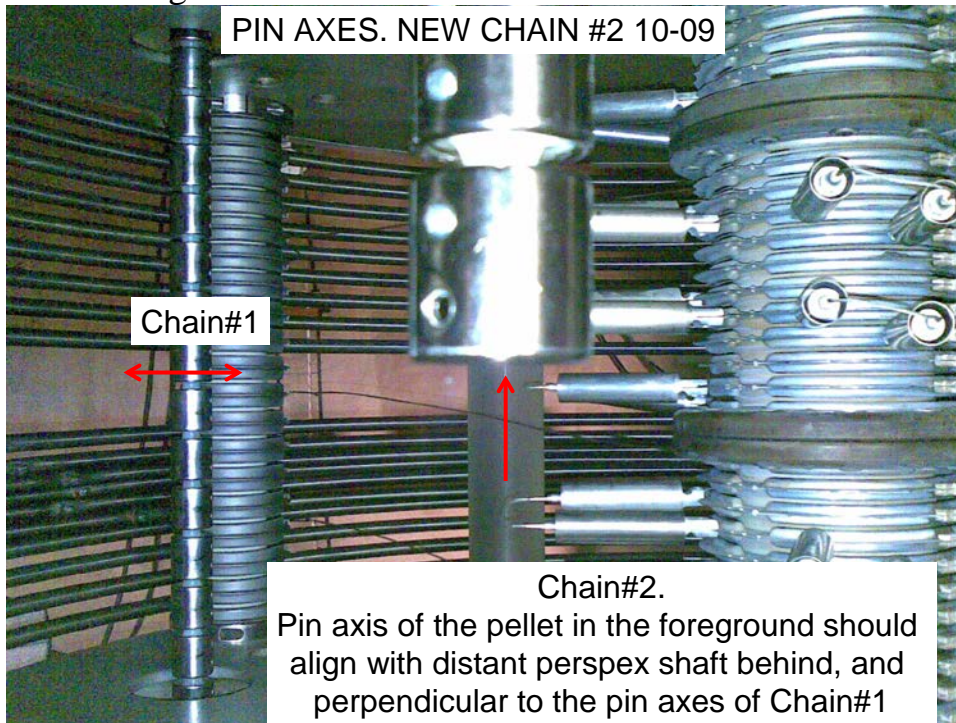
The residual twist after two night's operation was assessed. With the removal of a pellet pin and allowing one side of the chain to hang freely from the terminal there was approximately 45 degrees residual twist.

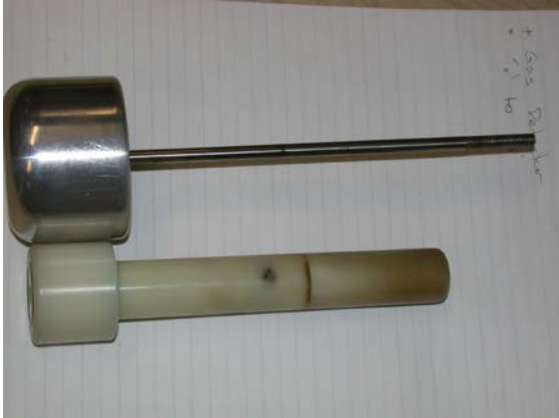
This incorrectly reports the spark through of the nylon *to be adjacent to the sharpish outer edge of the hole in the tank wall*. The spark through was actually within the length of hole in the tank wall. The outer edge of the hole is actually aligned with the brown stain below the spark damage.

The positive side 1" diameter nylon feed through had been sparked through between the central conductor and the tank wall.

The conductor is 1/4" diameter steel rod.

The in series 50Mohm resistor was found to be open circuit was replaced with a 25Mohm unit from NEC.

The new nylon insulator was fitted to the suppressor feed through.

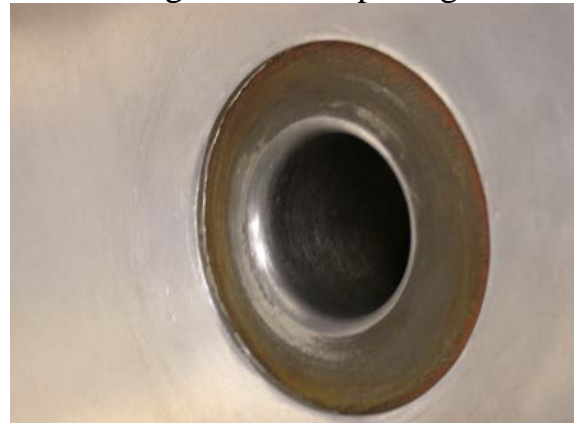
Refinishing done this opening.

During our disassembly of the feed throughs we decided to further improve the finish of the radius of the holes in the tank external wall. The previous radius work was found to leave room for improvement though hasn't been a source of spark damaging activity. We re-cut the radius with the same specially made tool but with some adjustment. The re-cutting was smoother and we paid greater attention to polishing the radius. We neglected to clean up the swarf and dust from this exercise and it caused problems later. See Initial Performance.

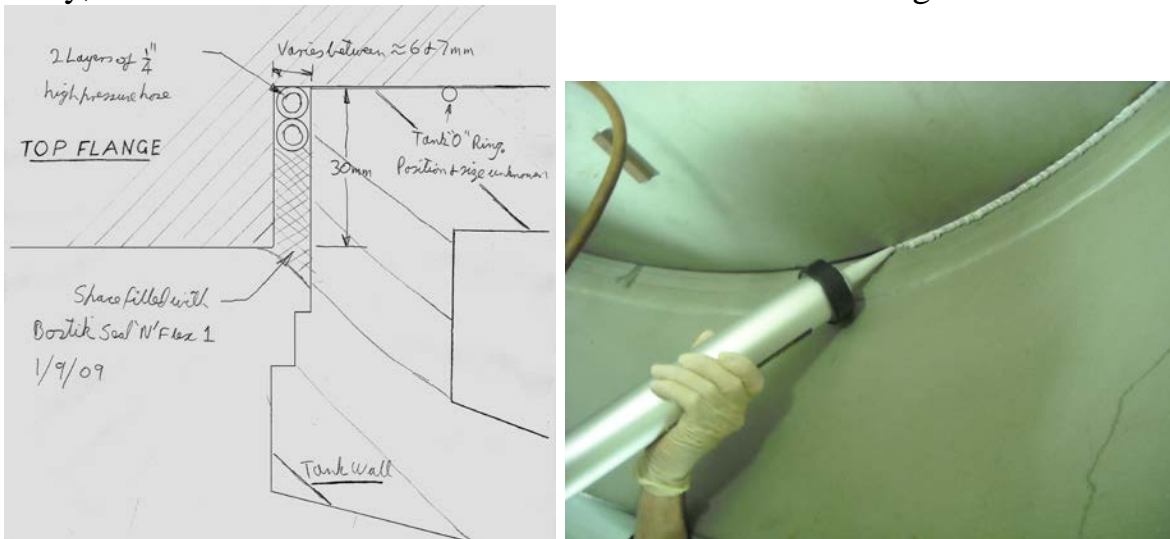
We have known of a SF6 gas leak on the top flange of the 14UD for some time.

The leak rate is not easily quantifiable and it is believed to be leaking past the o-ring.

Details of the gap at the top of the tank were gathered and it was decided to insert two pieces of nylon tubing before applying the sealant. The tube reduced the volume of the sealant required and also in the event of needing to cut the sealant away, we had a defined interface at which the materials change.

The two layers of 1/4" hose were inserted and the sealant applied and smoothed.

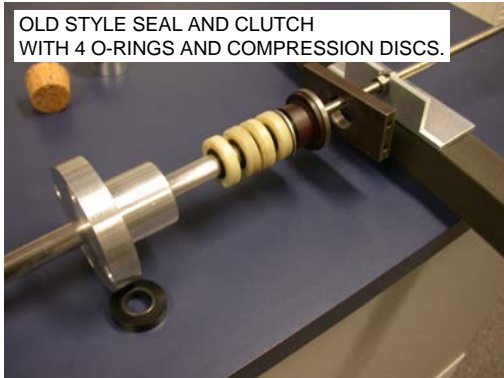
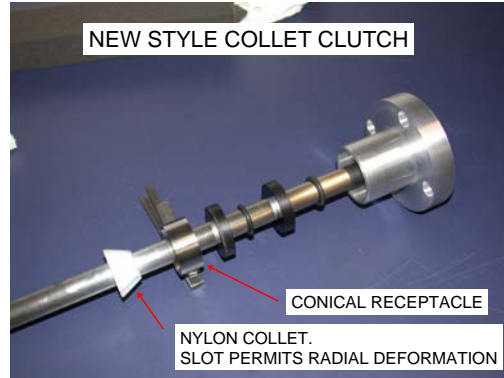
Experimenters are requiring more frequent shorting rod changes. This is causing greater wear of the o-rings within the clutch and sealing mechanism. This is evident with rubber pieces on the shorting rods. More lubricating oil can lead to the clutch function not resisting the force of the gas pushing against the rod. Cooper had a plan that included hardware to restrain the shorting rod to permit the removal of the clutch pack o-rings and compression discs without pumping out the accelerator.

A redesign of a significant nature was undertaken. It involved the removal of two o-rings and their compression discs to be replaced with a conical stainless steel receptacle of (50° inclusive angle) and a mating slotted nylon cone or collet that radially compresses to grip the shorting rods when the axial force is applied by the over centre clamp.

A slot in the cone allows oil lubrication to pass to the remaining o-rings below.

This is providing superior resistance to the displacement of the rods by the gas pressure with very free movement, in or out of the rods when the axial clamping force is released.
