**AUSTRALIAN NATIONAL UNIVERSITY**  
**DEPARTMENT OF NUCLEAR PHYSICS**  
**14 UD TANK OPENING REPORT # 112**  
16<sup>th</sup> November to 19<sup>th</sup> November 2009

**REASON FOR TANK OPENING**

This was an unscheduled opening due to a failure in the accelerator that prevented the machine being able to operate above 14.4 MV.

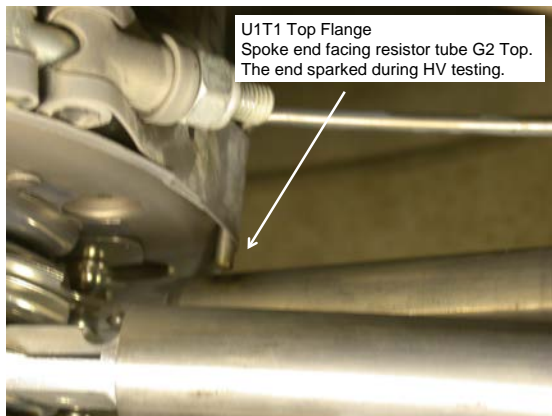
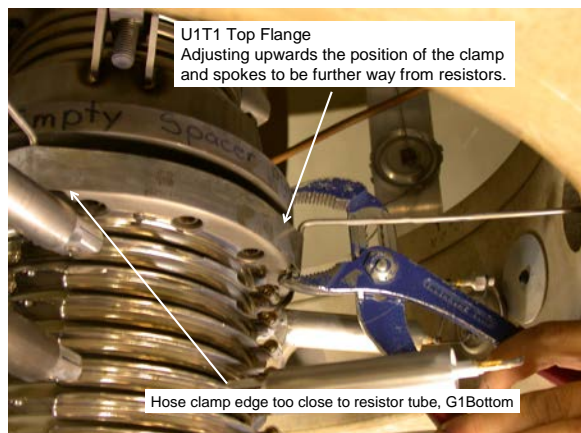
### ALIGNMENT CLAMP AND SPOKE SPARKING IN UNIT#1

The Unit #1, Tube #1 - The downward facing edge of the support spoke hose clamp on the tube top flange was sparking to the nearby protection tube of bottom resistor assembly on gap 1. It was sparking at 5.5 kV. We also saw at Unit#1, Tube #1, sparking between the clamped, bent end of one of the alignment/support spokes to the protection tube of the gap two top resistor. See picture.

Unit 1, Tube 1 - The alignment and support spokes for the tube have a 90° bent leg clamped to the tube flange with a hose clamp.

One of the downward facing ends of a spoke was facing the top resistor tube of the resistor pair across gap two. Spark breakdown would occur between the spoke end and resistor tube at ~5.5 kV in air.

A second location for sparking was the edge of the hose clamp. This would

spark at ~7kV. Both these issues were rectified by moving the clamp and spoke ends upwards away from the resistors by squeezing with multi grip pliers. A measurement survey of the position of the tube flange was done before and after adjusting the clamp position. No discernable change in the flange position occurred.

In operation any discharge across these components would contribute to an irregular voltage gradient in this unit.

- The three other column posts in Unit#1 due end cap problems were swapped out.
- The position of the tube alignment spoke clamp and spoke ends on the Tube #1 top flange were adjusted to provide greater clearance to neighbouring tube resistors.
- It was noticed within the resistor assembly of the Unit #2, Tube 1, Gap 4, top resistor that the resistor spark cap was slightly eccentric in its protection tube. The resistor end nut was loosened and spark cap reset using the setting tool.
- The LE end of the machine was wiped clean.

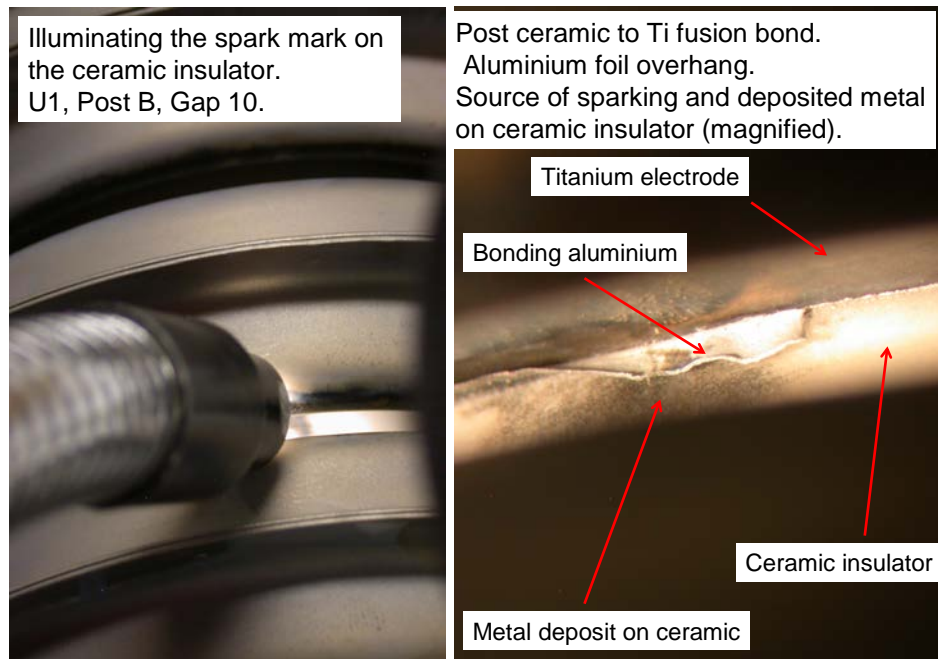
#### COLUMN POST - SPARK DAMAGED INSULATOR, UNIT #1

- By close visual inspection a black metallic like mark on a column post insulator was noticed on Post B, Gap 10. This was believed to be the problem limiting voltage across Unit #1.

A spark mark in Unit#1, Post B, Gap 10 was found and investigated.

Viewing this mark and the nearby area under magnification found that there was a remnant of aluminium foil from the fusion bonding of the ceramic insulator to the titanium electrode. The aluminium foil edge projected towards the opposing titanium electrode. Spark activity was evident from the al foil with a burnt metallic deposition on the surface of the insulator.

The spark activity across this gap would explain the reduced capacity of U1. This post was replaced with a serviceable spare.

This post was replaced.
