AUSTRALIAN NATIONAL UNIVERSITY
DEPARTMENT OF NUCLEAR PHYSICS

14 UD TANK OPENING REPORT # 113

7th June to 20th July 2010

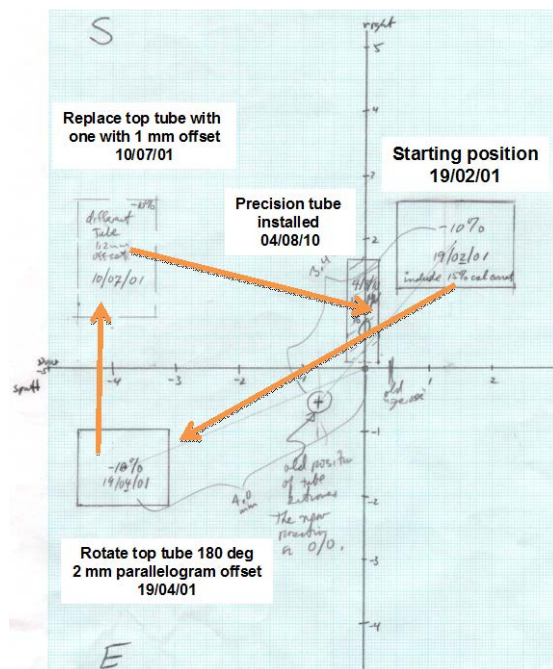
The first tube was then replaced in July 2001 with one with a 1mm eccentricity.

This resulted in a change of the beam position, but did not move it any closer to the geometric axes.

Post opening tests show the new precision tubes have significantly changed the position of the beam entering the accelerator to be much closer to the geometric

axis. Disappointingly, the expected improvement to the beam transmission through the accelerator does not match favourable change in the beam position.

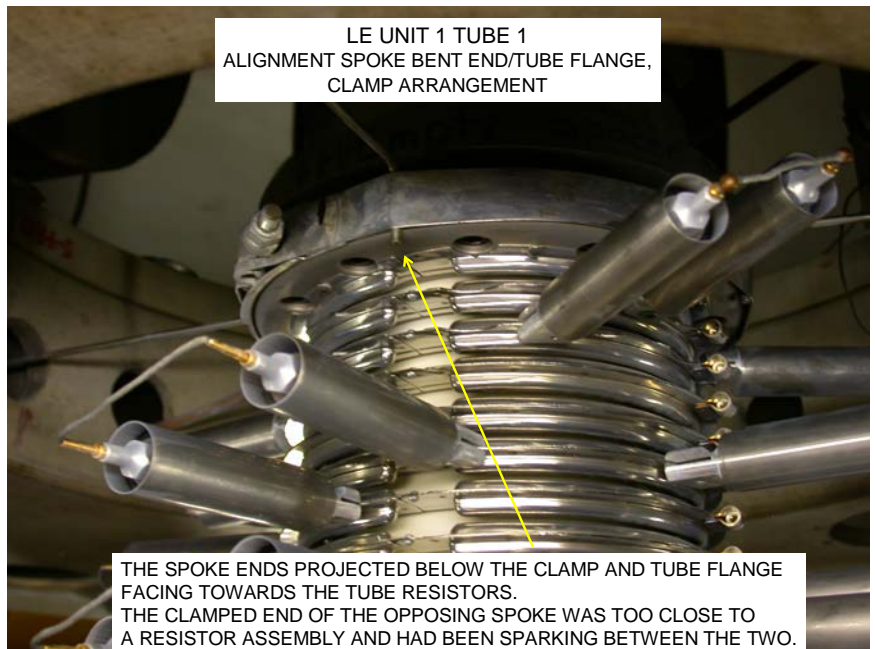
The Unit1 Tube 1 arrangement is different. The alignment spoke attachment to the top tube flange of the first tube in Unit 1 is clamped to a single tube flange only. The clamp is positioned symmetrically over this single flange and the typical spoke end projects below the tube flange. The downward facing spoke end in one position, around this tube, had been too close.

This allowed spark discharge to the resistor assemblies mounted across the first two gaps, although, possibly only during abnormal column or terminal voltage discharges.

At this location the bent spoke end was shortened by ~5mm.

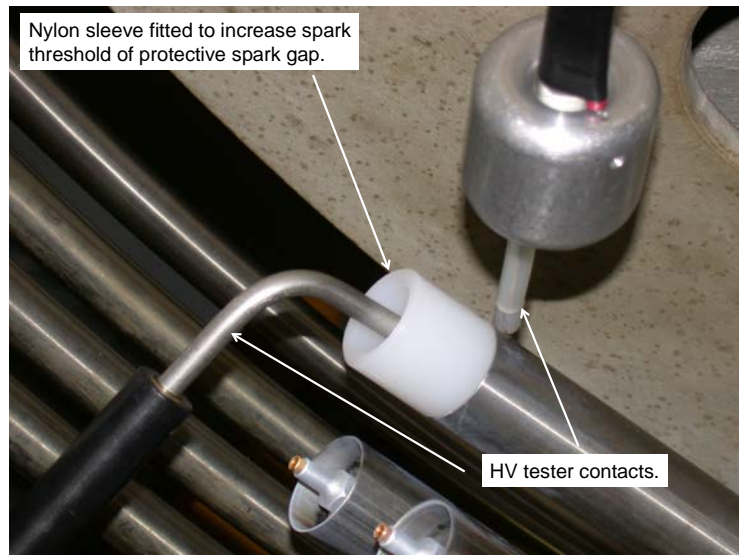
We chose to conduct individual resistor testing of the resistors in the U26 T3 group. They tested with acceptable values no worse than a 1% deviation from their specification. Some individual resistor testing was done with the resistors still fitted to the tube.

We had a maximum deviation from the specified value of +3.2% and - 11.3% for the tube resistors of which the worst five were replaced and for the column resistors a deviation of +8.55% and -1.52% of which two were replaced.

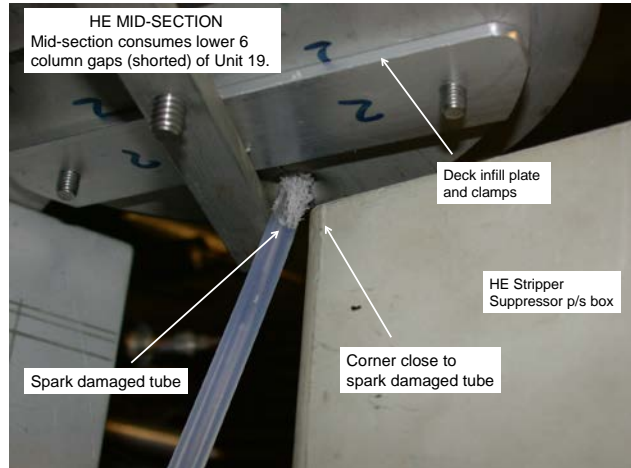
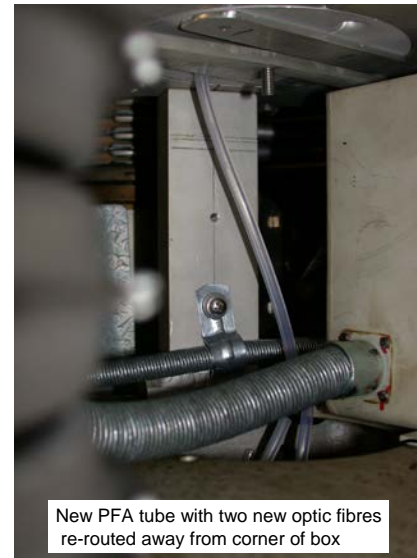
We found spark damage to the PFA tube in the HE mid-section.

The communications system was still working without any noticeable problem. The fibres were suspected of being damaged, so they were replaced with new ones. The old fibres were used as "pull throughs" for the new fibre. Temporary joints were made by gluing with superglue and covering with

The new fibre was drawn in up to the mid section to an existing Swagelok joiner in the casting at the bottom of Unit 19. The temporary joint was now cut. This offered a discontinuity of fibre at the mid-section to allow the removal of the damaged PFA tube. A new piece of PFA tube was fitted, bridging one Unit (U19). Nylon Swagelok connectors were used to make joins within the protection of the castings.

The end plugs were glued and polished in the terminal and the tank bottom.

At the terminal a small torch was taped to the end of a fibre to confirm the transmission/receive ends were correct in the bottom of the 14UD. All systems were tested thus completing this task.

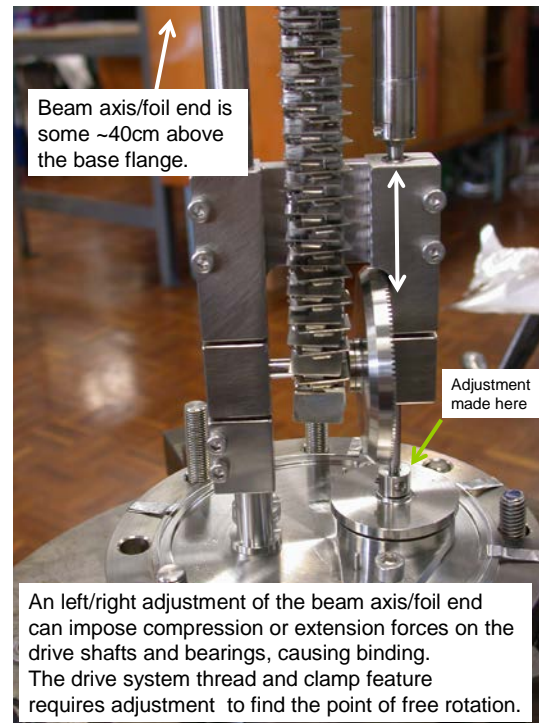
Fortunately, we found a problem with the second stripper before it was reinstalled in the machine. The problem was not evident whilst loading new foils on the previous day. The 2nd stripper mechanism was found to have sufficient drag to actually skip poles of the magnetic drive coupling.

It was thought that there was an adjustment made to displace the end that presents the foil to the beam axis during the last foil replenishment in 2006. Making an adjustment like this will either compress or tension the bearings on the drive line side of the column structure and the tension must be relieved by later adjusting the drive coupling.

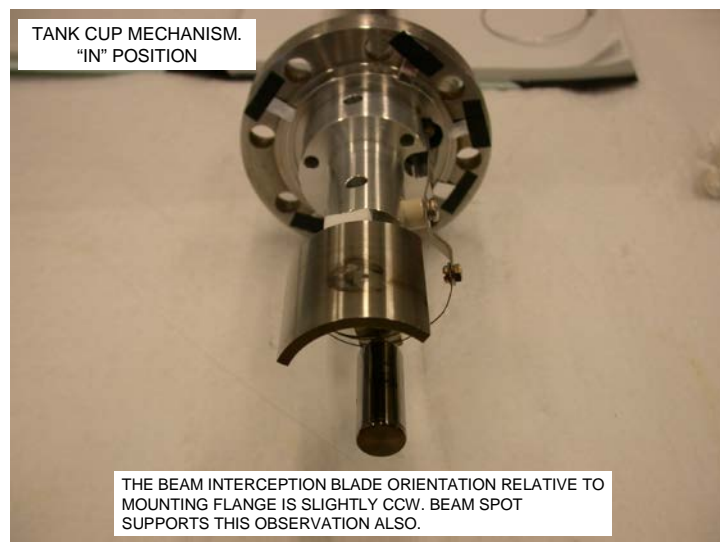
THE TANK CUP

The tank cup was examined to confirm the beam interception blade (cup) was mounted correctly to intercept the whole beam.

The rotational relationship of the vane part of the Tank Cup was slightly wrong (~10degrees). An adjustment was made to this by removing the pneumatic cylinder that also carries the external six pole magnetic coupling. The magnet is only held to the drive shaft by a centre bolt. Loosening this bolt allows a rotational adjustment to be easily achieved.

Weisser and others examined the beam spots on the cup and it was decided that the position of the cup element could also be better centred across the beam

axis. This was achieved by fitting a new spacer 0.060" longer than the existing one.

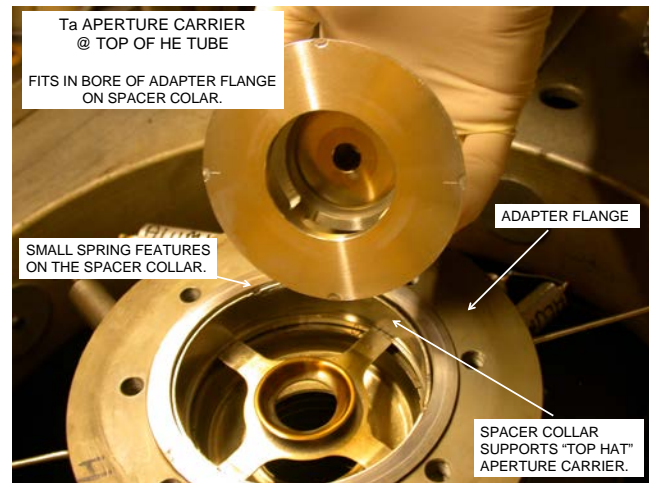
The bellows bottom flange fastens to a short adapter on the top of the HE tube. The bellows to adapter flange combination captures and aligns an aluminium carrier for a Ta aperture.

The carrier shape is like a “top hat”. The thin flange of the top hat was slightly loose in the bore of the adapter. To rectify this, the thin flange was pinched at 4 points on its periphery to expand small (dia ~8mm) tags. The tags could be machined true and to a slightly larger radius which better matched the counter-bore in the bellows flange. Axial clearance is taken up by the small raised fins on the supporting collar.
