# 14 UD Tank Opening Report

## 117A/B

5<sup>th</sup> July to 17<sup>th</sup> – August 2012 (A)  
20<sup>th</sup> to 24<sup>th</sup> – August 2012 (B)

Department of Nuclear Physics  
Research School of Physics and Engineering  
Building #57, The Australian National University  
Canberra ACT 0200

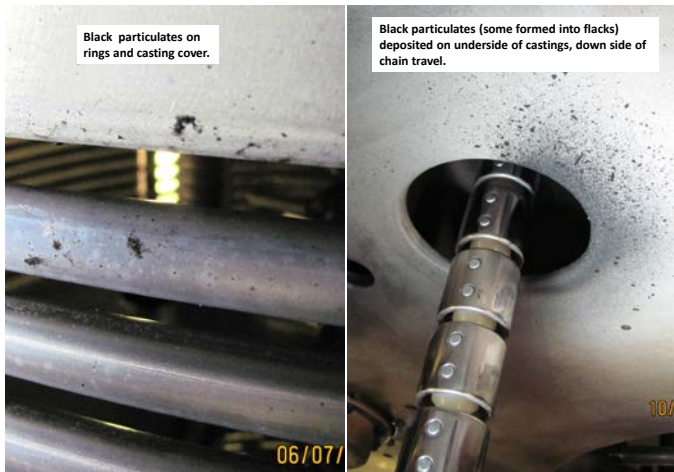
- A lot of black dust or flake particulates were noted in the HE end. These looked to be chain wheel sheave plastic transported by the three chains. Black accumulations were mostly on the underside of the castings of the down side of the chains and largely at the castings with chain stabilising idlers and petal arrangements. The up DC idlers and generally all the terminal inductors had some deposits as well.
- The terminal lower spinning was lowered and supported at the casting of unit 18.
- The terminal chain wheel curved contact surfaces were inspected. Position #1 smooth, both sides. Position #2 outer is smooth, but inner surface has spark erosion. Position #3 outer is smooth with a little erosion on the inside.

BLACK PARTICULATES FROM CHAIN WHEELS, TO#117A

A lot of black dust/particulates were noted in the HE end. Wiping the surfaces of the HE rings, lower terminal spinnings, the tank wall with a cloth or bare hand would gather black particulates.

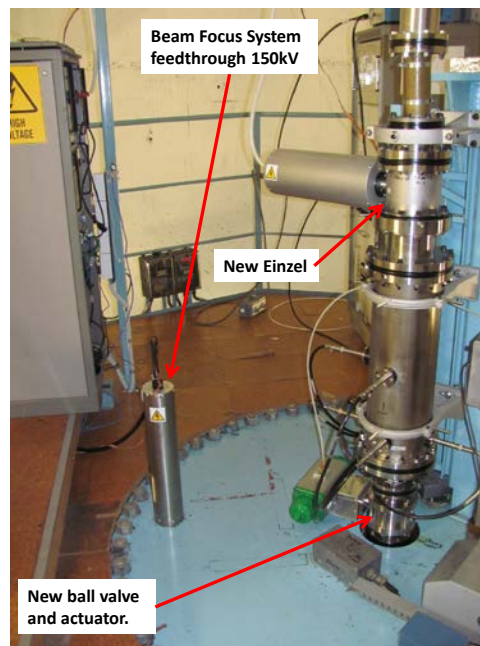
TOP OF TANK (LEVEL 4.5) –  
NEW EINZEL, BALL VALVE AND BEAM FOCUS SYSTEM F/T.

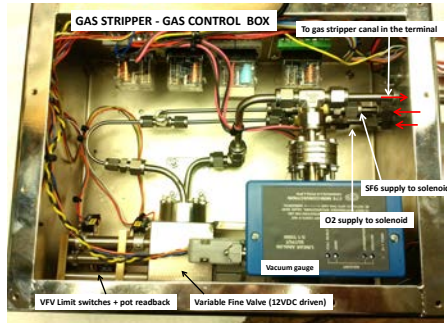
Various configurations of leak testing were performed and it was determined that we had a leak between the solenoid valve and the box bulkhead fitting of the O<sub>2</sub> gas inlet.

We pulled the box out again to investigate at the bench. The leak was reconfirmed at the bench with the same response time. Using bagging and taping techniques around the subassembly of concern, we isolated the leak to be the thread of the Swagelok screwed pipe fitting (torr sealed into the solenoid), the Swagelok tube connection or the solenoid body. It was also confirmed using the leak tester that this original solenoid valve leaked through and was not complete barrier in the system anyway. "Toss it in the bin".

GAS STRIPPER BOX - SHOWING PIEWORK FOR BOTH O2 AND SF6 DURING TO#117A

More swearing and we quickly decided rather than bury more time into the investigation of the exact leak location we would eliminate the solenoid and its fittings with a piece of tube in its place.

The piece of tube was fitted. The same taping up of the box, admitting helium and waiting for a response technique was used. No leak was found and the box was reinstalled. Leak testing of the installed assembly was now completed, without any leak as well.

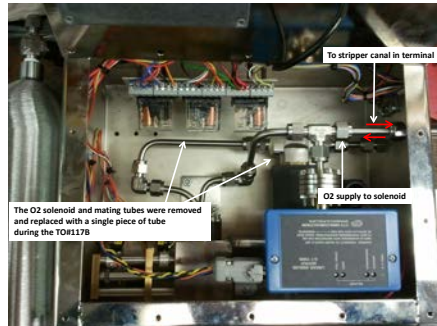
GAS STRIPPER BOX - PRIOR TO MODIFICATIONS DURING TO#117A and B

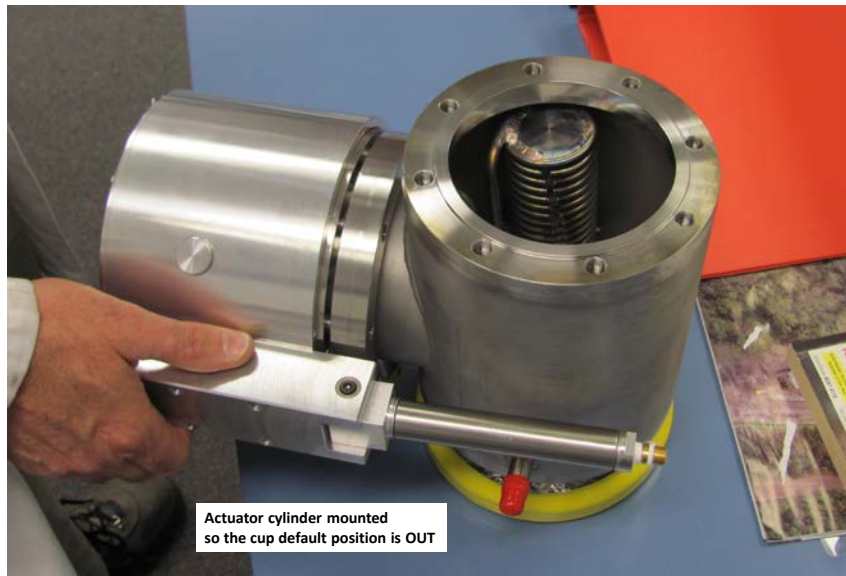
The terminal faraday cup bolts to the top of a short piece of 4" beam tube. These two pieces fit between a pair of bellows above the HE tube and below the terminal lens. The beam tube piece was an existing piece, with its own support system, but it was now 9" shorter to accommodate the new cup. The support structure required extending by 3.5" to position the tube clamp at the correct height on the shortened tube piece.

TERMINAL FARADAY CUP – WITH ANU WIRING ENCLOSURE

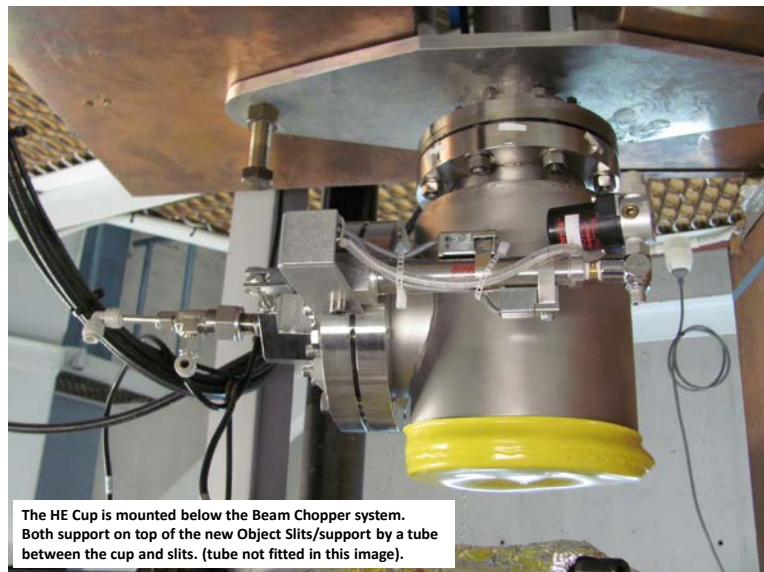
This unit was fitted as delivered from NEC. There is no ANU RF protection enclosure fitted and it is configured to default to the "in" position.

HE FARADAY CUP

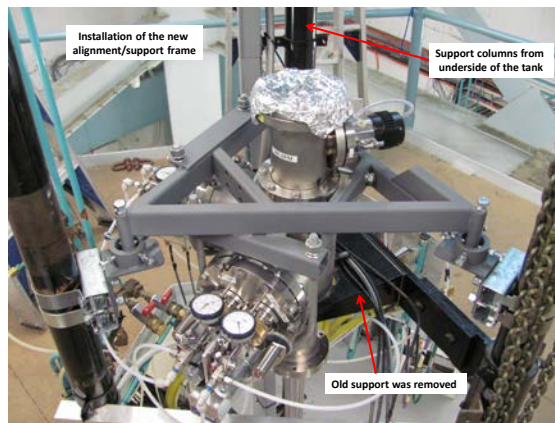
This unit from NEC is physically large and our pre-tank opening view of how it would be installed was quickly changed. It also provides support for the beam tube, HE cup as well as the chopper housing and RF boxes above. A new support frame was designed, manufactured and installed in a quite a short time. The age old principals of three points of support and adjustability in X, Y and Z to facilitate alignment where incorporated.

HE OBJECT SLITS (NEC BDS6 #2EA038701) AND NEW ALIGNMENT/SUPPORT FITTED DURING TO#117A
