Australian
National
University

14 UD Tank Opening Report

#118

25 October – 23 November 2012

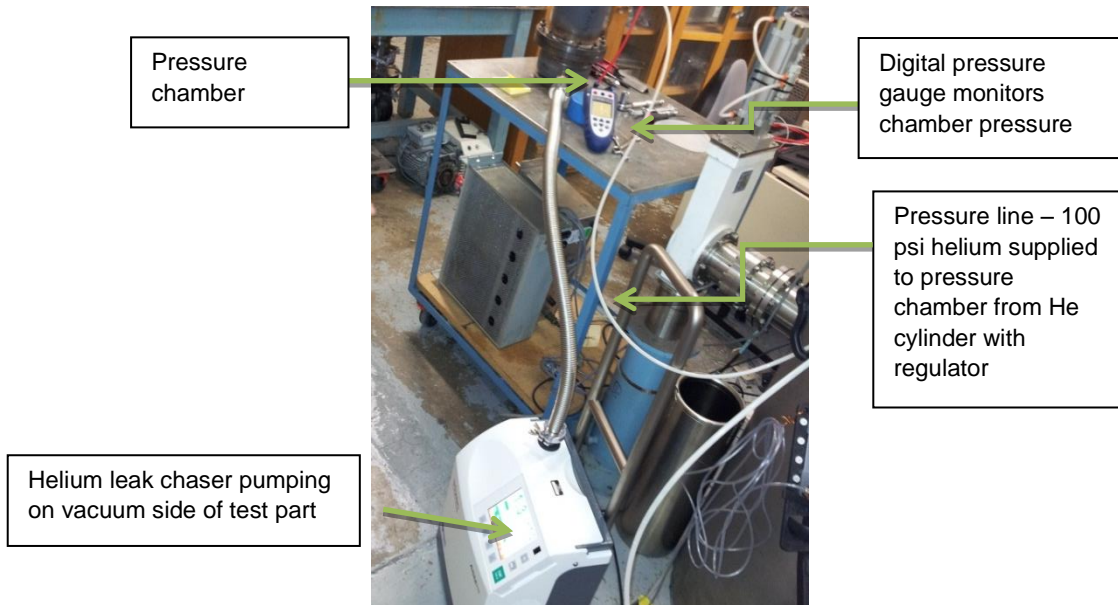
Figure 2 Helium leak chasing of gas stripper parts in pressure chamber

Similar result for leak chase in open position with outlet capped so we believe the valve was leaking through both the body-to-bellows gasket and stem tip. On disassembly of valve we found that the gasket material was a plastic (not listed in current parts for these valves) and the stem tip was PCTFE. After venting the accelerator tube we could also leak chase the stripper isolation valve. Similar leak rate was observed for this valve.

New 4BK Swagelok valves were available so we pressure tested one of these straight from the box. These valves have a PTFE-coated 316 SS gasket and a PCTFE stem tip. At atmosphere as designed these valves were fine, $\sim 10^{-10}$ leak rate, but at pressure leaked up to $\sim 10^{-8}$. We decided to try and tighten the body-to-bellows gasket. Nut moved with out too much force about a quarter of a turn. This valve and another three new valves (with extra tightening) all passed testing and were ready for installing on the stripper system.

Box was reassembled and drowned in helium and tested all okay. Returned to the machine and reinstalled with the new valves.

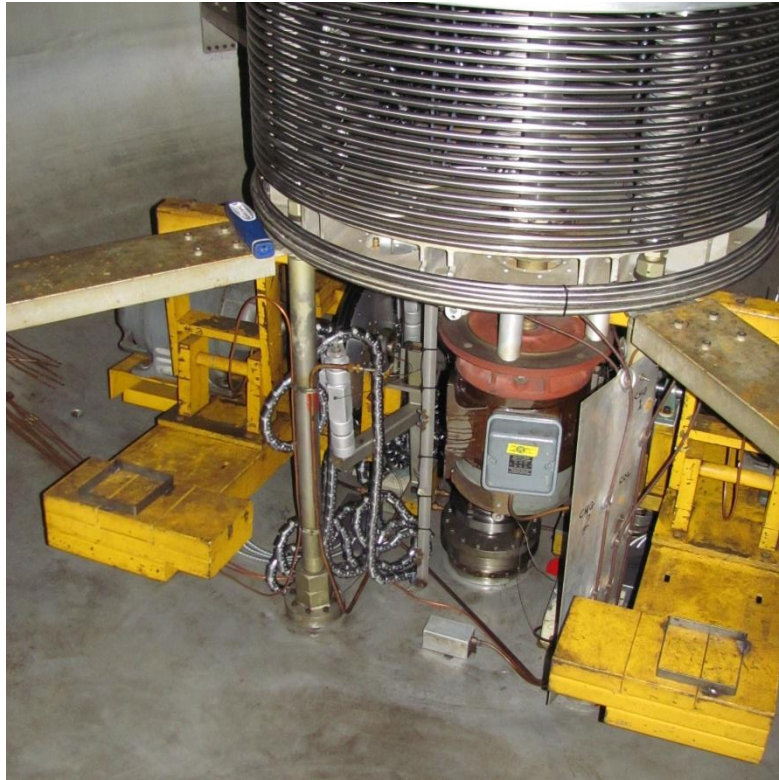
Figure 3 Location of broken chain #3

- Most of the chain was gathered at the bottom of the tank and in U25.
- There was a clean break across the link waist, with one half of the broken link remaining attached to the chain, while the other half was broken into pieces, which were later found in castings.
- The link pin remained attached to the pellet.
- A six-pellet long piece of chain was found in the terminal
- Casting Idler petals at U16 were found to be scoured by broken chain, were removed.
- Found top half of broken chain in U23
- One damaged petal in U21
- Damaged petal set in U25

- Shim stock replaced on terminal pulley #3.
- Broken chain replaced with a nickel plated chain (#30) that had been previously installed in the 14 UD but removed during TO #114 due to lip-to-lip spark damage.
- New studs were fitted to inductors in terminal, at position #3.

- The scoured casting idler petals at U16 were removed (replaced/refurbished).
- Chain #3 inductors under at tank base were adjusted.
- Chain #3 was found to require shortening by 1 link.

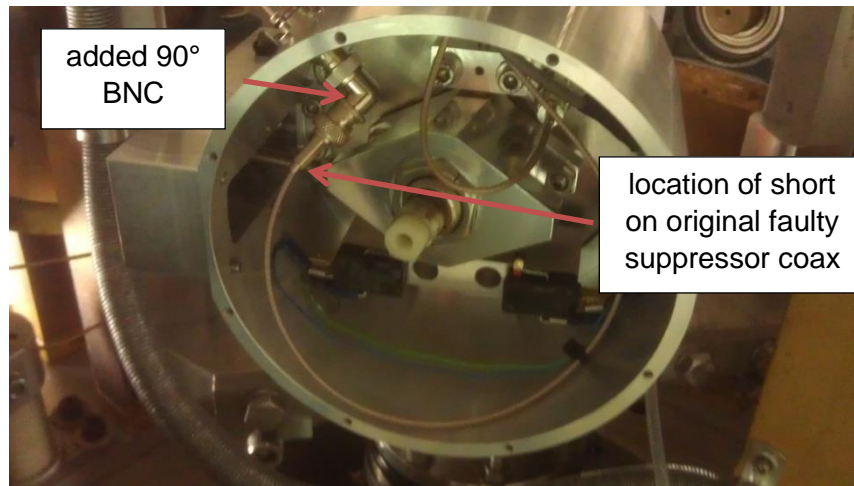
Figure 5 Tank cup housing after suppressor coax replaced

Prior to the tank opening, it was evident that the tank cup suppressor supply was shorting out and blowing many fuses. The short was traced to the RG 306 coax BNC connector on the inside of the tank cup housing. Moving the RG316 coax around would create and break the short. This cable had been assembled by EU.

A new coax cable was assembled by EU and an additional 90° BNC connector was installed in an attempt to relieve strain on the coax cable. The new wiring was tested and operates without exhibiting an electrical short.

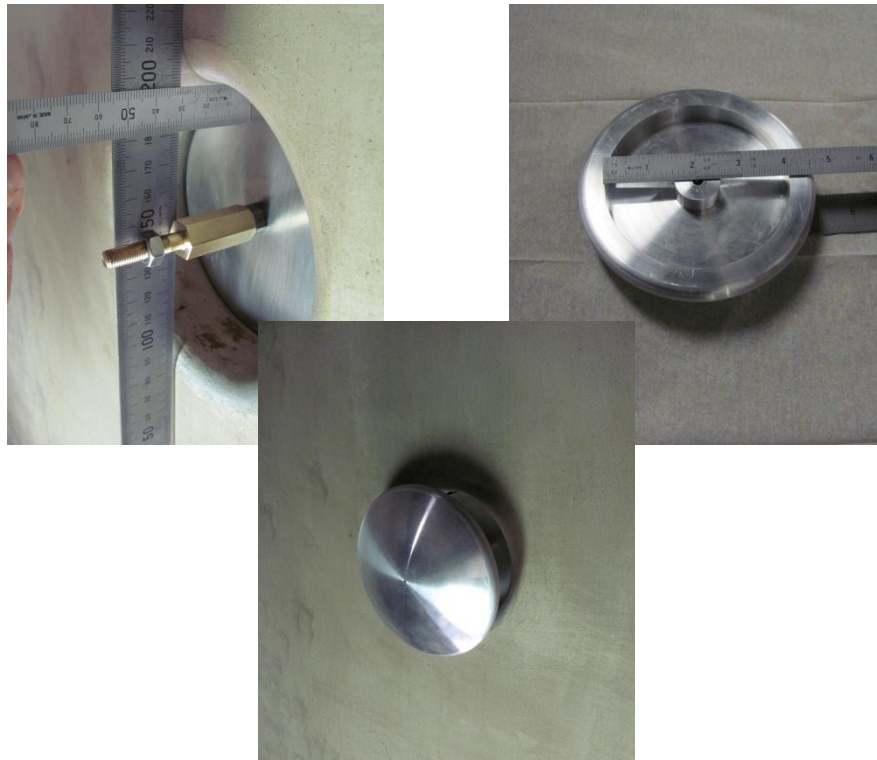
Figure 7 Modified CPO electrode install

A previous attempt to adjust the gain of the NEC CPO amplifier showed that even with the gain set to maximum, we got about an order of magnitude less voltage than the 1 V per 500 V at the terminal required (CPO manual).

In order to increase the probe-terminal capacitance and therefore the output of the CPO amplifier, a new CPO probe was constructed. The new CPO probe has a dome shape to increase the surface that sees the terminal and is also placed 25mm from the tank wall, unlike the old CPO plate.

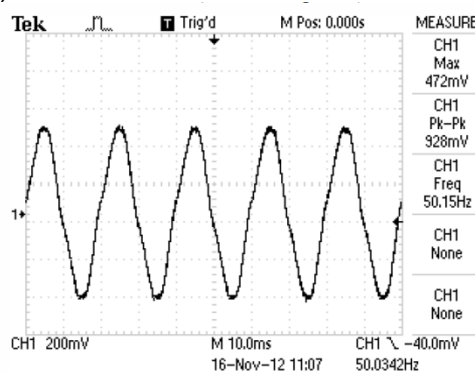
Figure 8

This shows a 0.93 Vpp voltage.

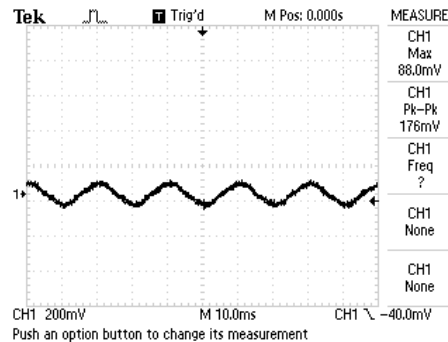
Figure 9

Channel B (old CPO probe) shows a much lower voltage (0.15 Vpp):

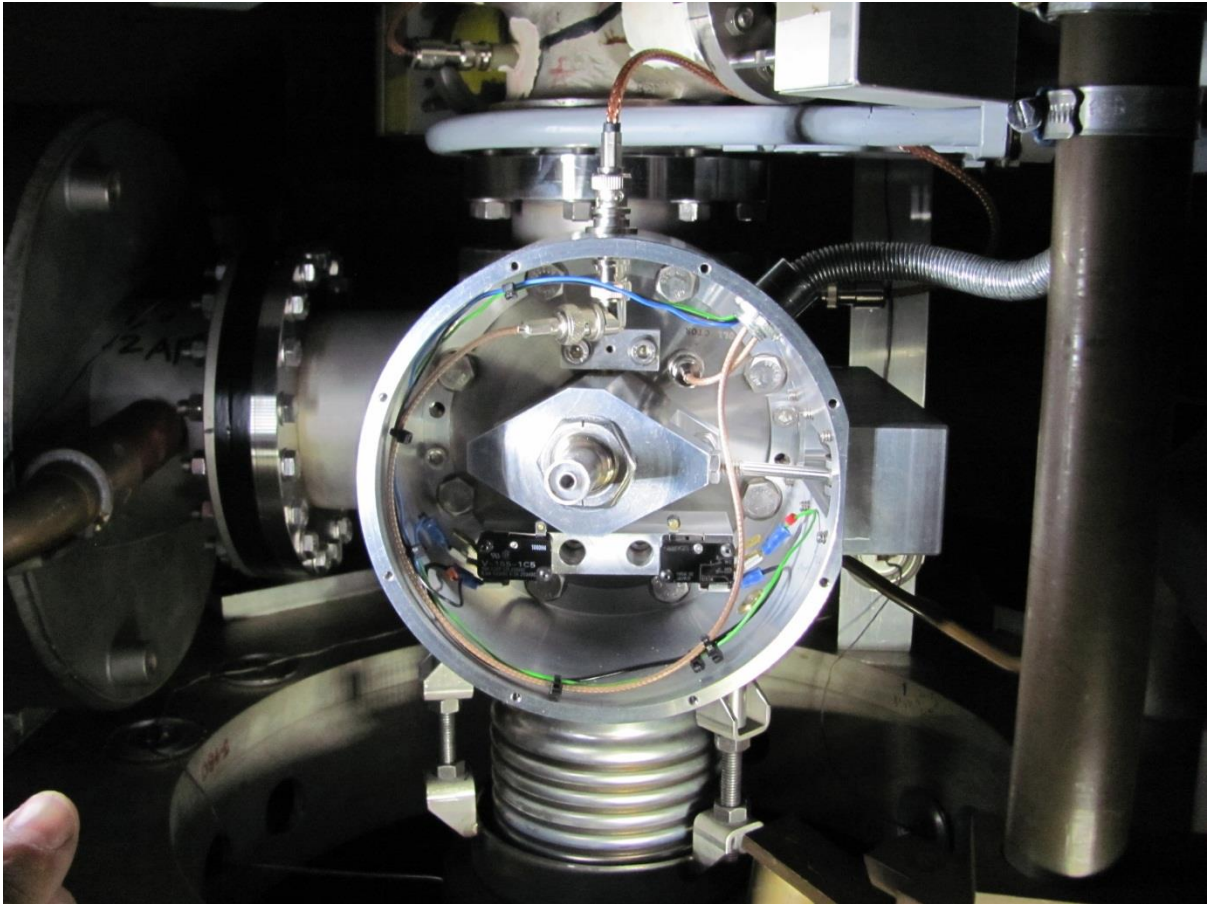
Figure 10 Actuator box and cylinder before modification to default "OUT" position

It was necessary to re-open the 14UD on the 23/11/2012 as the machine was rendered inoperable from this fault. On inspection there were no apparent causes of the internal leak, all external plumbing was inspected and found to be operating correctly. The SF6 supply regulator for this cup was adjusted down in pressure (80psi over atmosphere) for testing purposes, we continued to test the operation and found no faults what so ever, all joints and plumbing were checked and found to be leak tight under atmospheric pressure.

A possible theory for the leak, after the 14UD was filled was considered – There was a possible issue with the pneumatic actuator seal being exposed to tank pressure (from the outside), while the cylinder pressure was at atmosphere, this could have affected the way the seal seats on the shaft, as it was taking pressure from the side not designed for it.

The modification to change the unit to default position "OUT" was considered, and while we did not have any "smoking gun" evidence for the leak, it was agreed at the time, it was worth changing the operation of this cup. In the event of another leak/actuator failure, it would leave the cup in the out position, and the machine would still operable.

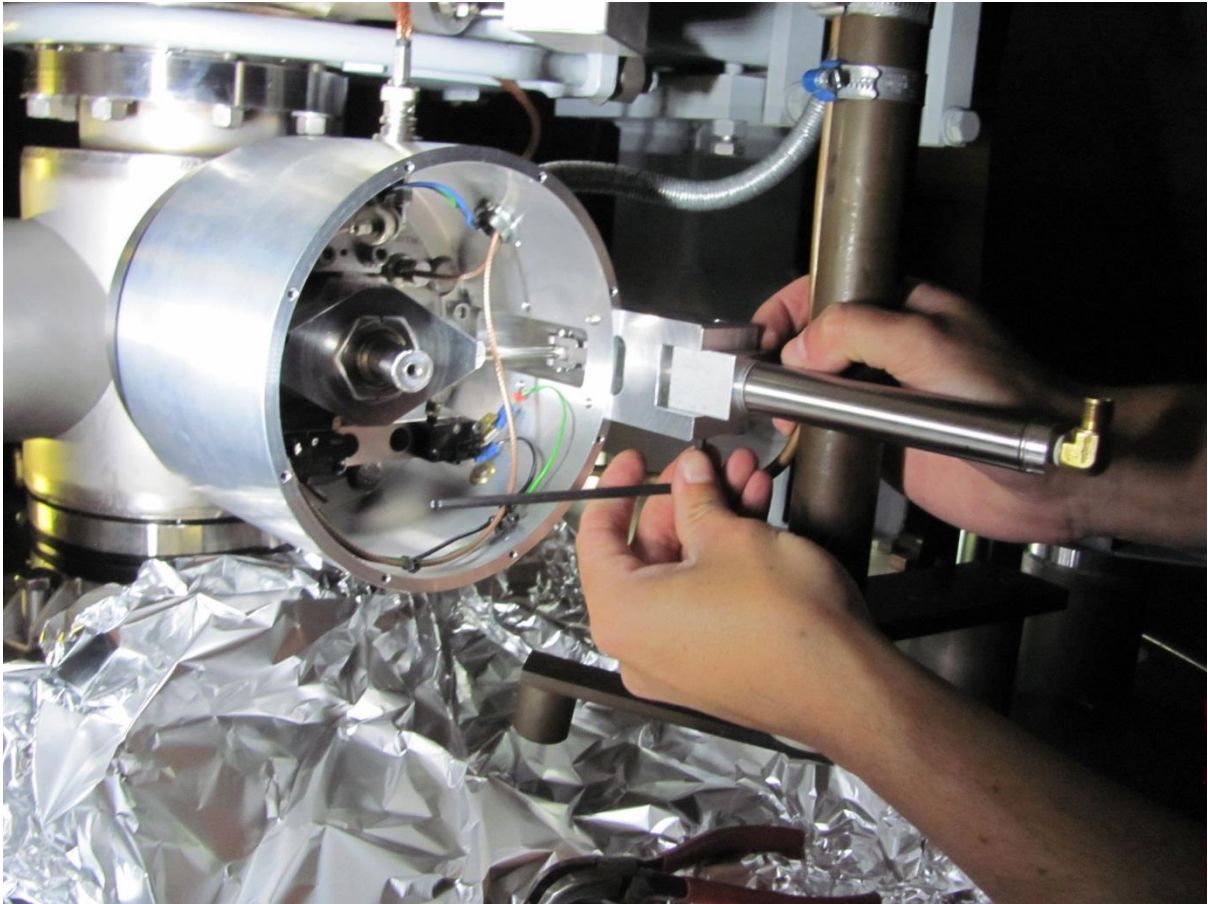
Figure 11 Actuator assembly now acting on the opposite side of the swing cup lever

While carrying out this change the 1/4" copper tube running to the cylinder required re-routing, there was minimal but adequate clearance between the shorting rod tube and pneumatic cylinder as shown below

The design of the linkage and actuator assembly that operated the cup, was such that we were able to swing the pneumatic cylinder and outer actuator housing 180 degrees, to act on the opposite side of the swing cup lever, in turn having the opposite reaction.

Testing of the cup after mods proved successful, and has continued to work effectively while under tank pressure, however it would be beneficial to keep 100-120psi in the cylinder while adding gas in the tank, this will ensure the high-pressure side of the actuator seal is seeing more pressure than the outside of it, keeping the seal seated correctly.
