Australian  
National  
University

# 14 UD Tank Opening Report

## #121

6 January – 26 February 2014

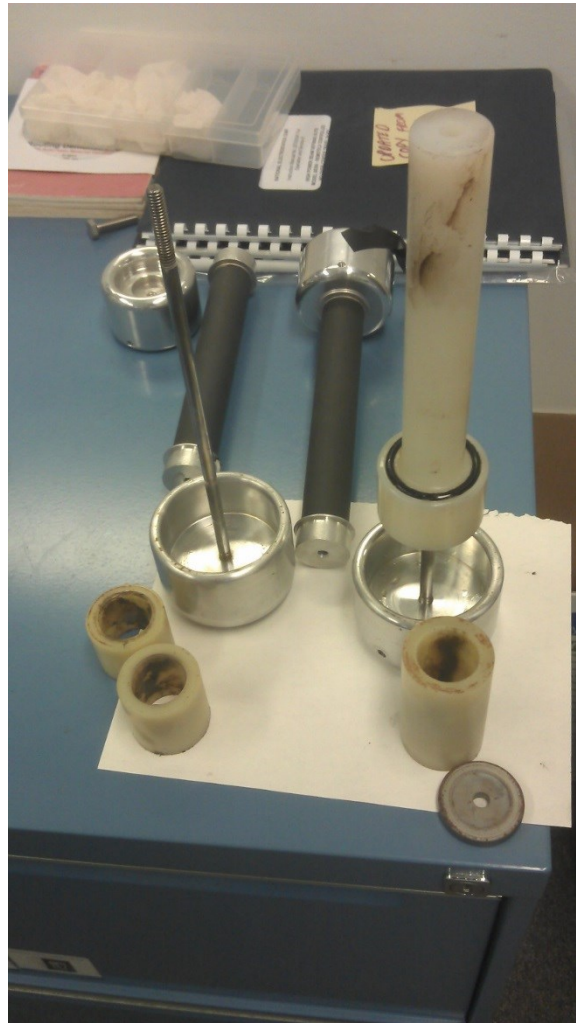
Three of the charging system standoffs at the bottom of the tank were damaged by arcing as can be seen in Figure 4. A stock of spares was available to replace these. It was also an opportunity to redesign the wire connectors that go on the end of these stand offs to enable them also act as spark gaps in an attempt to protect the nylon. The new design is shown in Figure 7. The design can be improved even further based on classic spark gap concept. It will be done in the future if required.

*Figure 4 Damage on charging system feed thrus*

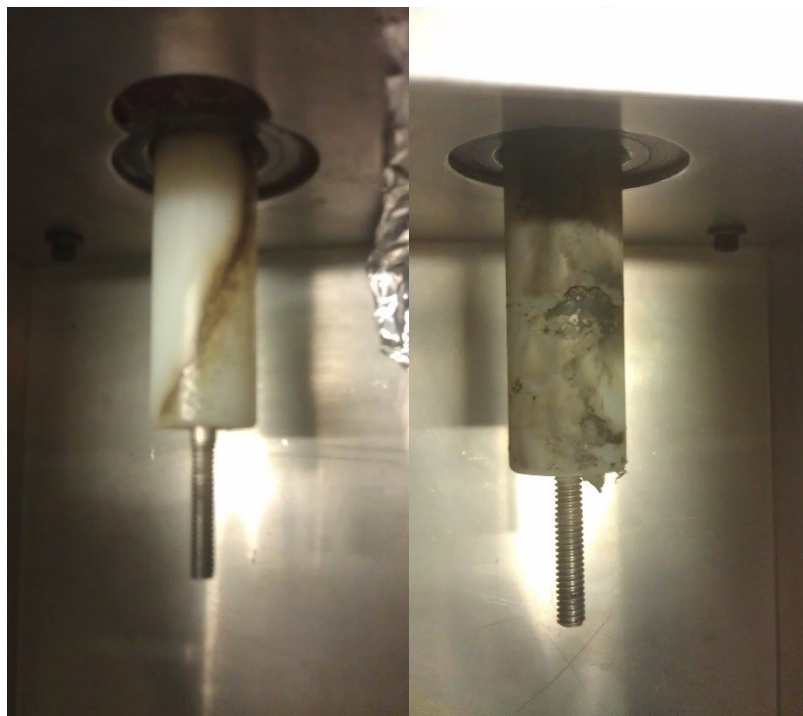
- Replaced corona needles with a new assembly. Some needles on existing assembly were severely worn.
- Removed and examined charging system feed throughs and found much gungy black grease on the positive feed through, a definite large track mark on the negative supply feed through and some tape on the negative supply feed thru *inside* the box. Yes. Tape. However, the track marks are in the grease only and the Nylon feed through clean up nicely. They will likely be reused. Also, the feed throughs were a little difficult to remove and it may be that the dimensions have changed during service, which would be interesting.

After issues with the charging system, the nylon feed throughs and the standoff at the bottom of the tank were inspected and/or removed. The silicon grease used on the nylon feed throughs was blackened, with a track mark through the grease on one of the two. This can be seen in 2 and 3. The main nylon components cleaned up well and were reused. However, new cylinders were machined. When the feed throughs were reinstalled, no silicon grease was used.

*Figure 5 Damage to -ve (left) and +ve (right) charging system feed thrus*

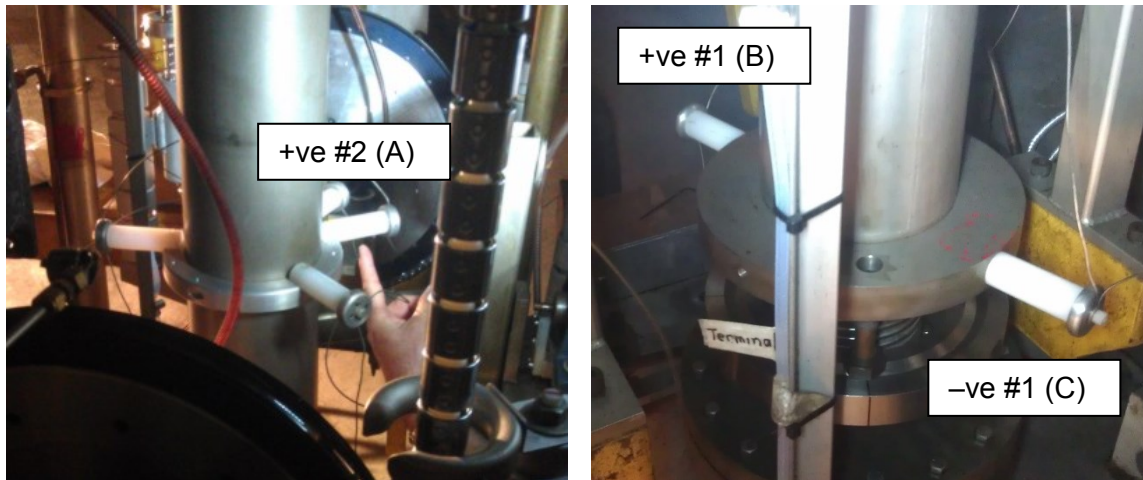
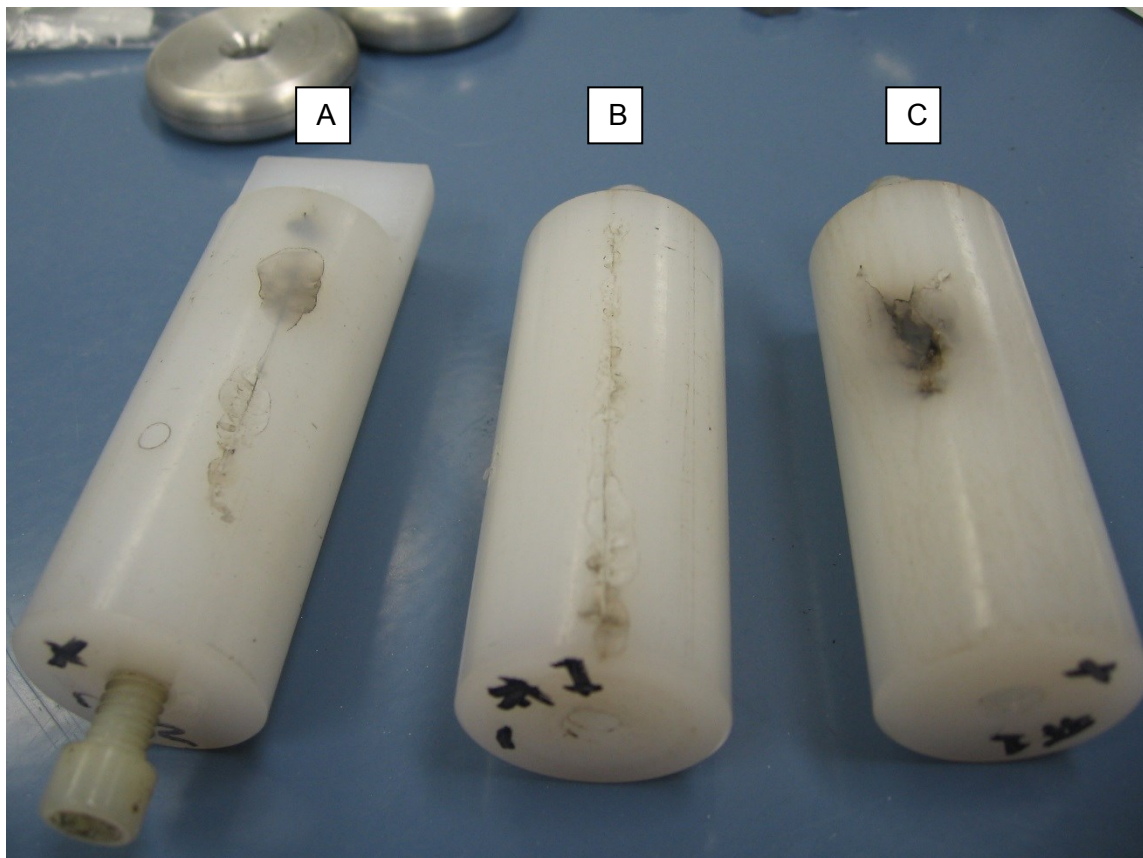
- The motor leg to floor distance was remeasured after the initial chain installs. Chain #1 was 47 mm and chain #2 was 95 mm.
- Removed three of the charging system distribution nylon stand offs from the bottom of the tank. Two showed destructive track marks along the surface from metal end to ground and one showed a more localised destruction (see section 4). There was definitely a release of nylon debris.
- Cleaned up the bottom of the tank and the inductors. Checked the alignment of the inductors at the drive end.
- Cleaned the terminal.
- Inspected unit 15 due to abnormal current readings during entry 30 kV HV tests. Tube 3, gap 1 resistor lead was damaged by spark activity (frayed and black). Further inspection revealed that post C is damaged, with ceramic flakes coming off gaps 9 and 11 and two hairline cracks extending between the top and bottom of gap 18. End result: ☹

Figure 6 (a) Location and (b) details of arc damage on charging system distribution nylon stand offs

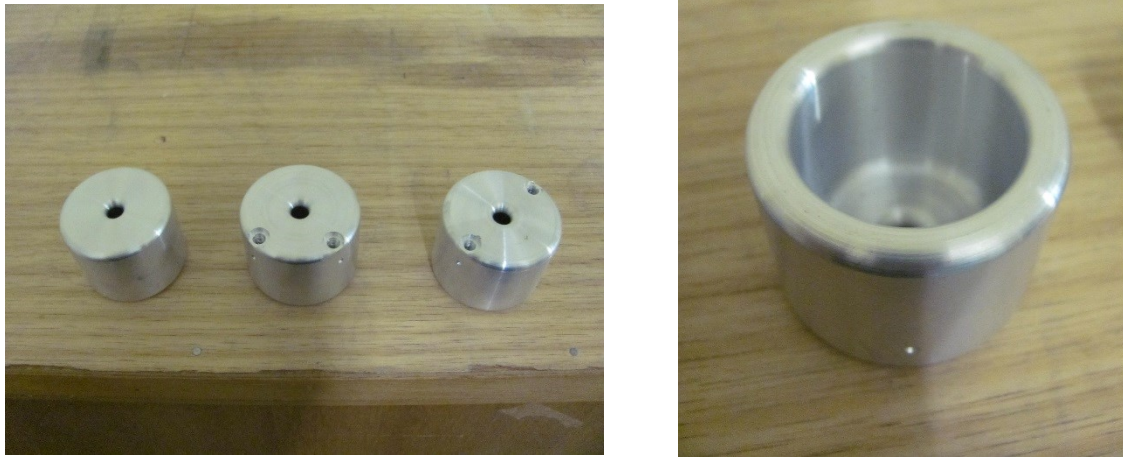
*Figure 7 New charging system standoff wire connector/spark gap design*

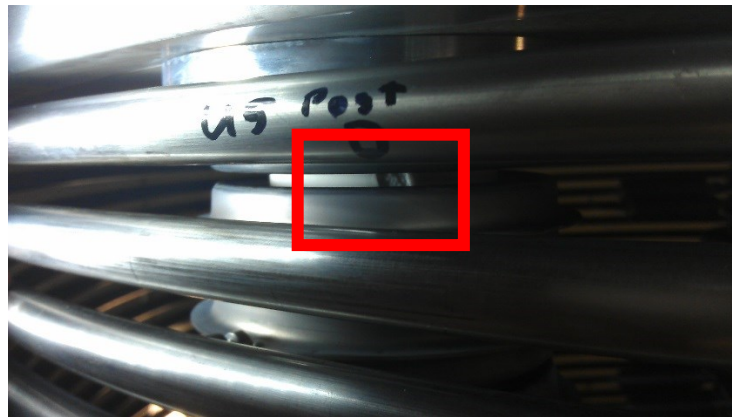
- Began unit by unit inspection of posts and made it through from unit 1 to unit 5. Found:
  - Unit 5, post D, gap 1 had ceramic flakes missing
  - Unit 5, post B, gap 4 had multiple cracks in ceramic

*Figure 8 Ceramic damage unit 5, post D, gap 1*

- The unit 5, post "D", # 282 was swapped out and replaced with a serviceable used post # 265 (no shim required).
- Post # 282 separated into two pieces once the post was released of its fasteners and the compressive load of the column. The failure was at the bond at the top of the

second ceramic. This failure is immediately below the visible crack that initially caught our attention.

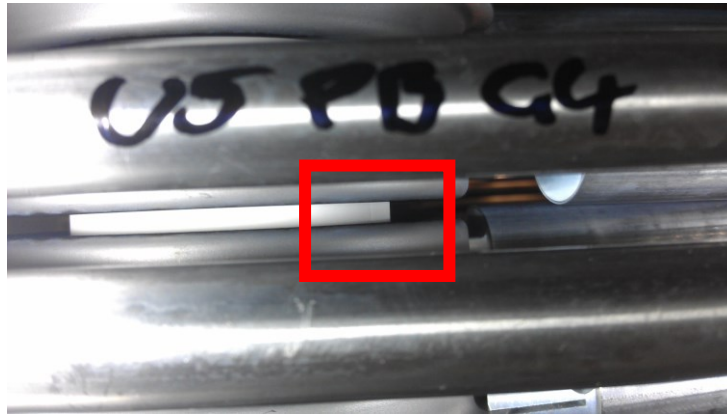
*Figure 9 Ceramic damage unit 5, post B, gap 4*

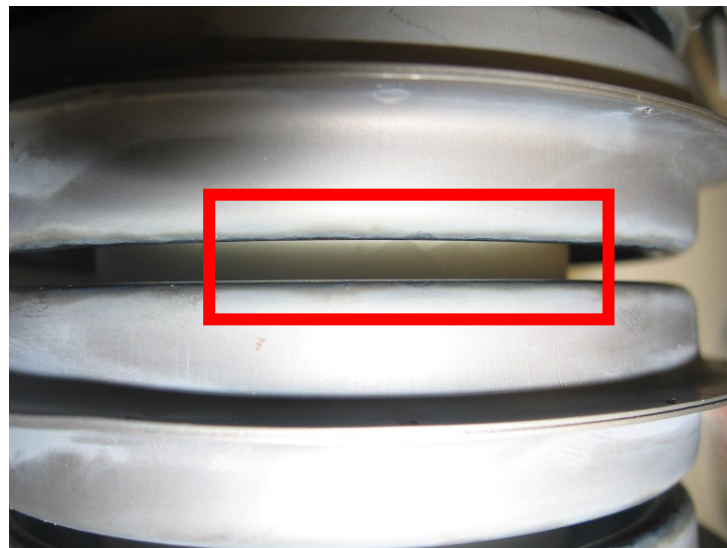
- Found leakage current of 8  $\mu\text{A}$  @ 5 kV through unit 3, tube 2, gap 2
- Found leakage current of 4  $\mu\text{A}$  @ 5 kV through unit 12, post C, gap 13. Upon further inspection, found cracking at about a 10 or 11 o'clock position.
- Found resistor lead across unit 19, post D, gap 8 was spark damaged and blown out of the bottom resistor. Top plug was still inserted, but damaged. Replaced both resistor nuts with new, marked nuts and a new lead.
- Removed post 2045 from unit 12, position C and replaced with serviceable, tested, post marked with a star (no number). This post has epoxied end caps.
- Replaced resistors across unit 3, tube 2, gap 2 with dummy resistors (shorting the gap). Also replaced top post resistor with a dummy on gap 8 to compensate.

*Figure 10 Ceramic damage unit 12, post C, gap 13*

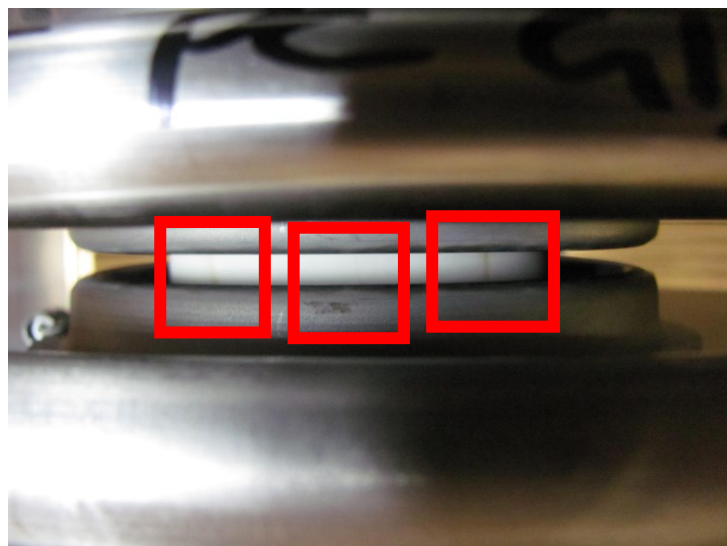
- Unit 25, post C, gap 12 had cracks
- Unit 25, post C, gap 16 had multiple cracks that were dirty, suggesting arc activity
- Unit 28, post C, gap 13 needs to be looked at again.

*Figure 11 Ceramic damage unit 25, post C, gap 16*

- Units 5 and 6 were cleaned, stringer attachments checked and closed.
- The unit 25, post "C", # J1 was swapped out and was replaced with a serviceable spare #340

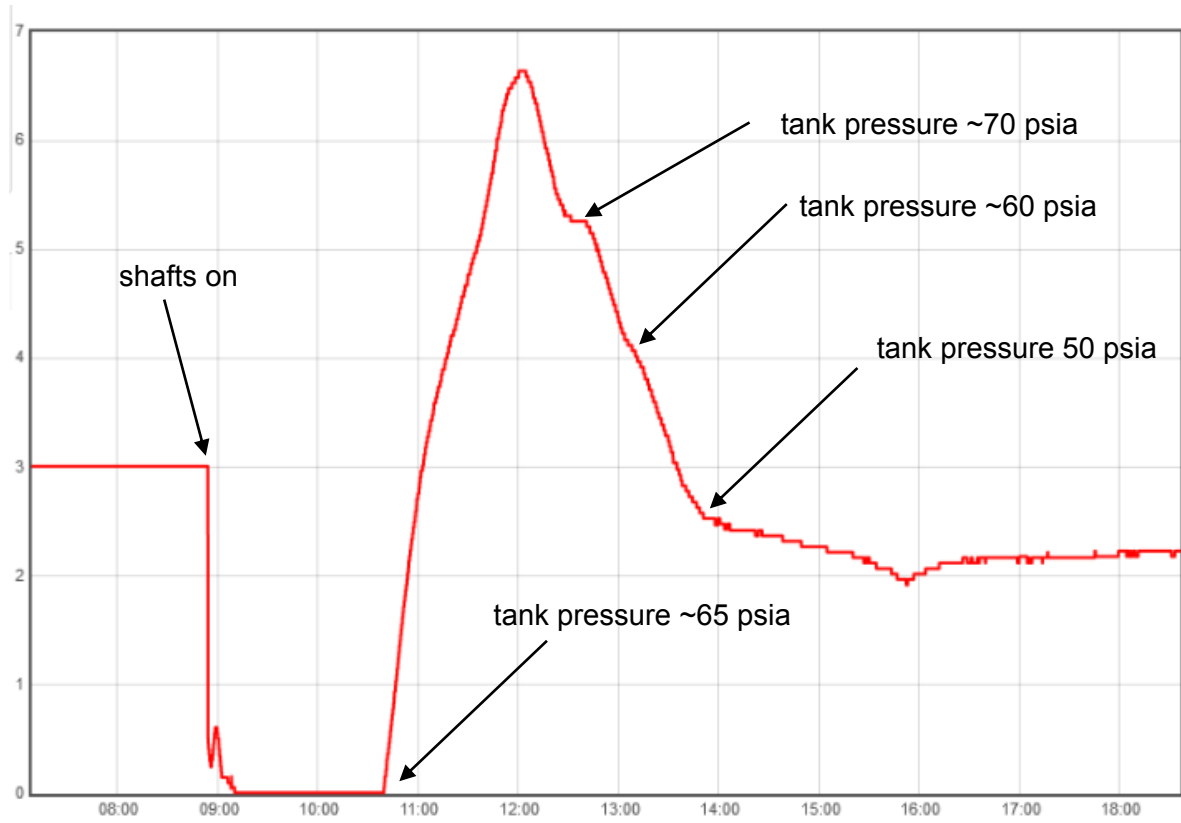
Upon gas up of the tank, all was going well until the tank pressure reached approximately 65 psia, at which time the gas stripper pressure began to rise (see Figure 13). It reached about 6.5 mT with the tank pressure at about 80 psia. Thus, we had failed in our attempt to repair the leak in the gas stripper system and in fact, had somehow made it worse. Plans were made for another tank opening as soon as possible.

Figure 13 Indication of gas stripper leak during SF<sub>6</sub> gas up
