14 UD Tank Opening Report

#123

8th July – 31st July 2014

Department of Nuclear Physics
Research School of Physics and Engineering
Building #57, The Australian National University
Canberra ACT 0200

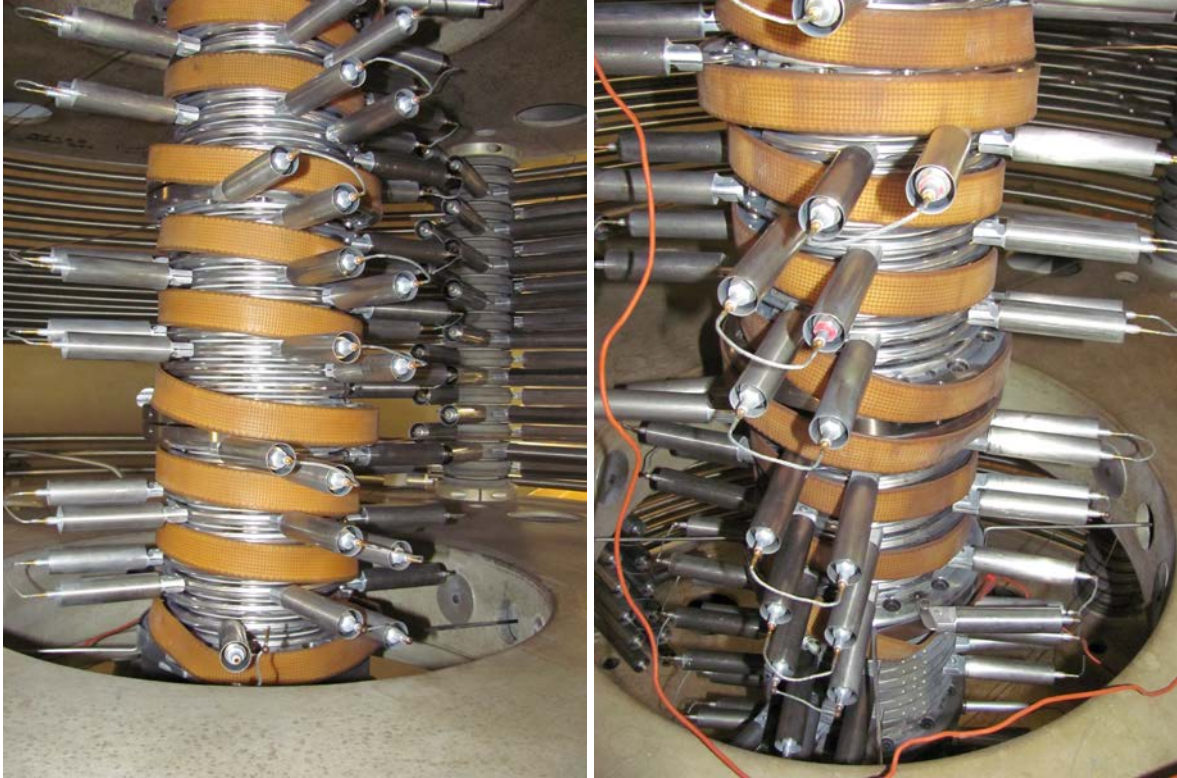
Figure 1 Heater tapes wrapping the accelerator tube ready for “baking”

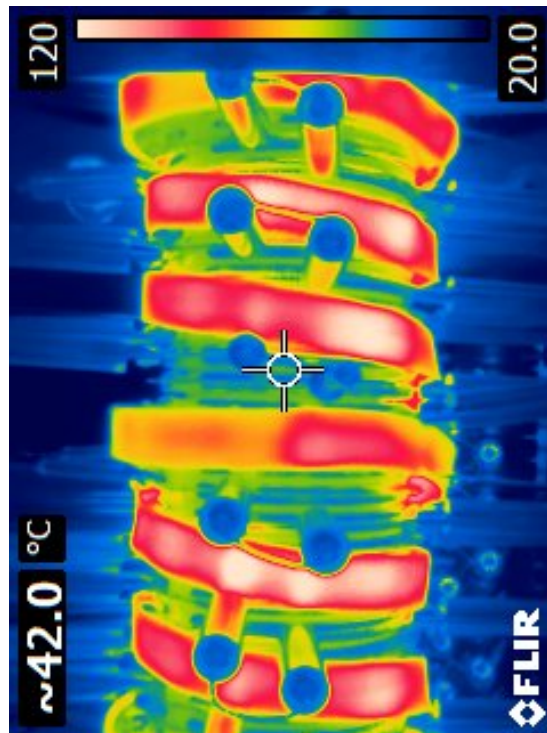
We typically warmed up the tubes up to 110 – 120 °C and kept at this temperature for 16 – 18 hours. The heating power to the tape was controlled by manually adjusting the supply voltage through a controller. The temperature of the tubes and resistors was measured with Infrared Thermometer model QM7226 and with the thermocouples secured to the bare metal. Temperature mapping was also performed with a FLIR thermal imager as shown in Figure 2. During bakeout, vacuum excursion typically occurred during the first hour. Initial vacuum was 4×10^{-8} Torr rising up to 3×10^{-7} Torr and gradually reducing to 8×10^{-8} Torr at the end of the process.

Figure 2 Thermal imaging of active heater tapes in during baking of units 13 and 14

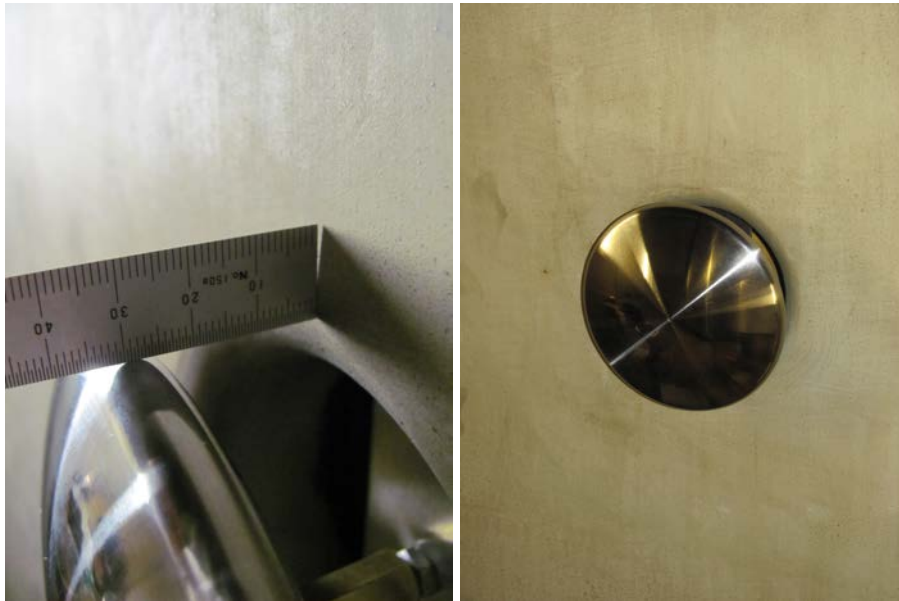
During this tank opening, we were able to install one stainless steel version of the mushroom-type CPO electrode as shown in Figure 2 Stainless steel “mushroom” CPO electrode. This was installed in the CPO position that is on the left of the door at level three.

Both electrodes were mounted 23 mm from the wall (measured from the back of the CPO electrodes), which is as far back as the stainless-steel electrode could be mounted owing to the shallower thread depth on the mount hole.

Figure 3 Stainless steel “mushroom” CPO electrode

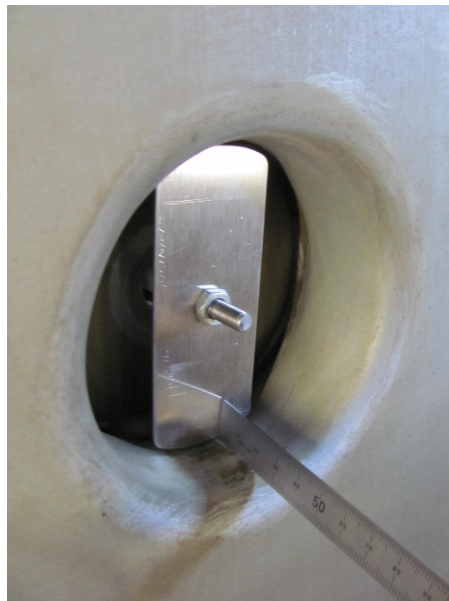
The sparks gap designed to be installed with these mushroom CPO electrode were originally circular. These were not very convenient to remove. Thus, they were shaved off on two sides as shown in Figure 3. This shape still provides the small spark gap at the top and bottom while making removal simple.

Figure 4 Modified spark gap behind mushroom-type CPO electrode

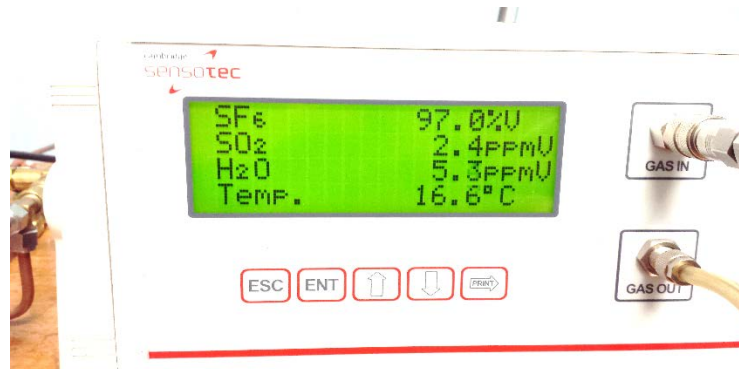
Figure 6 SF₆ analysis taken before pump-out of 14UD on 7th July

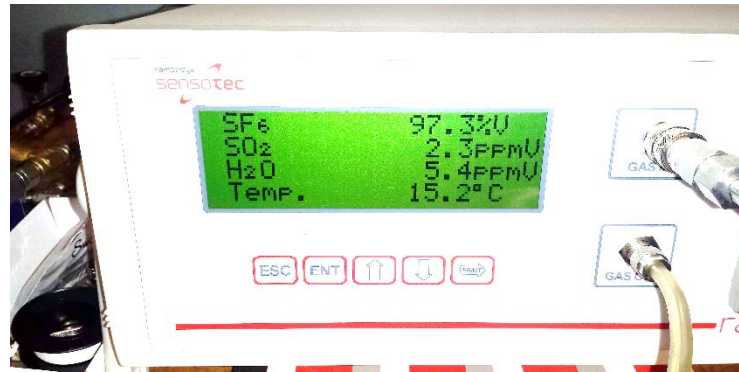
Figure 7 SF₆ analysis after reactivation of drier and gas-up of 14UD on 5th August

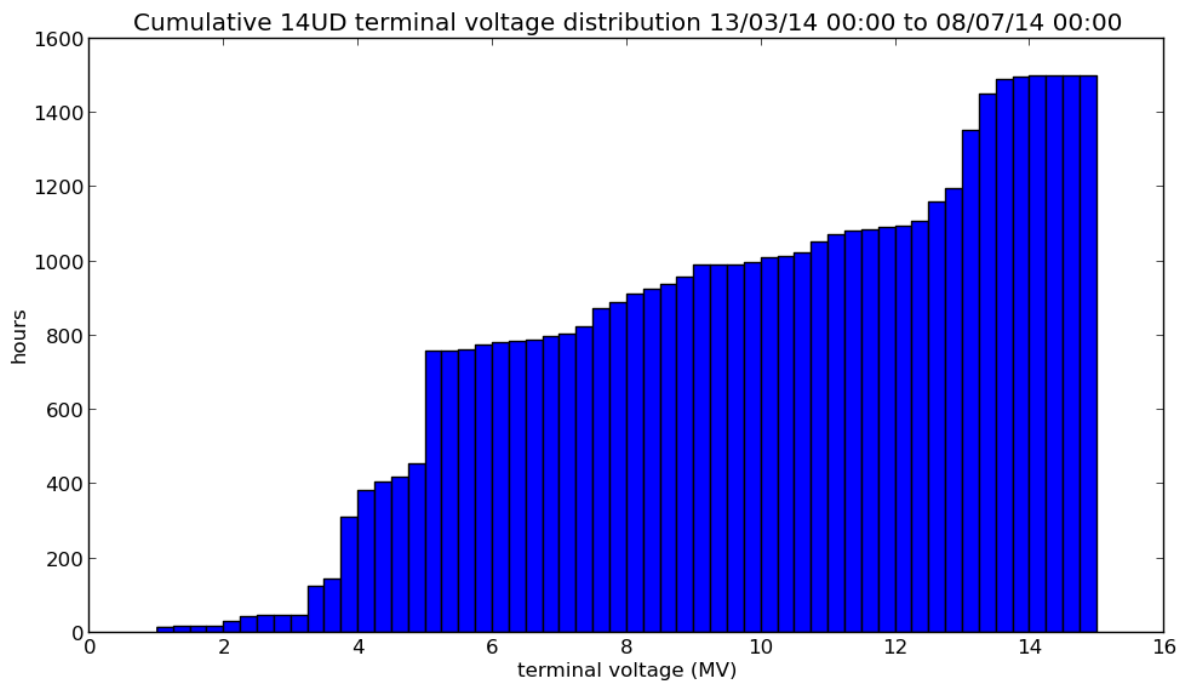
Figure 8 Cumulative terminal voltage distribution for period of operation from the end of tank opening 122 to the start of tank opening 123
