14 UD Tank Opening Report

#124

14th May – 12th June 2015

Department of Nuclear Physics
Research School of Physics and Engineering
Building #57, The Australian National University
Canberra ACT 0200

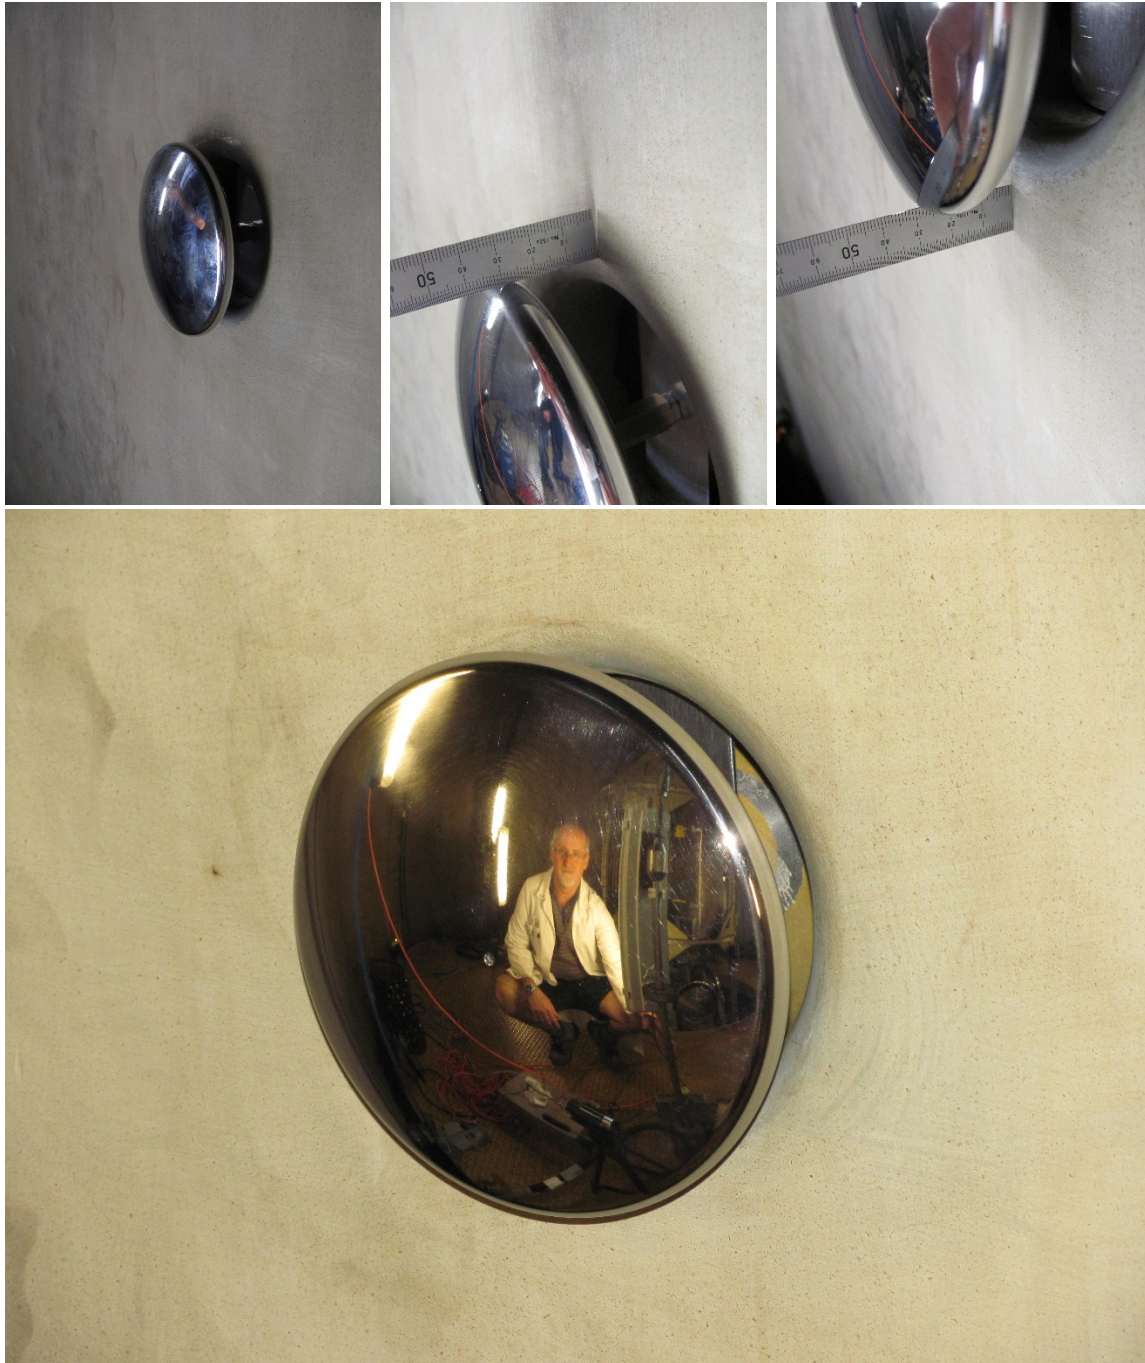
Figure 1 Second stainless steel CPO electrode

As discussed in tank opening report 123, one stainless steel CPO electrode had been installed. During this tank opening, there was some concern that the weight of the electrodes were placing undue stress on the tank feed throughs

The already installed stainless steel electrode was removed and sent for modification to reduce its weight. The modifications entailed removal of as much material as possible from the back side of the electrode. A second new, “light” stainless steel electrode was also produced and installed. Note that due to a mix up, the thread on the two CPO electrodes is not the same. One is UNF and the other is UNC.

Mounting of one of the electrodes is shown in Figure 1.

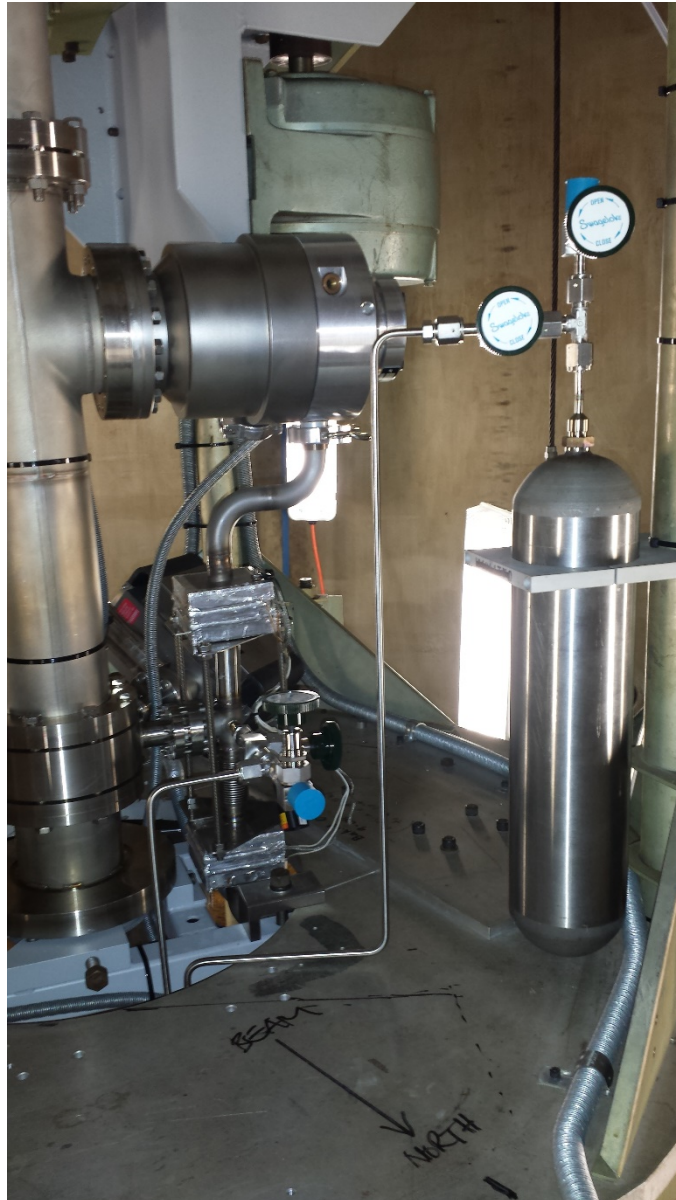
Figure 2 Gas stripper system with new VCR connections

The gas stripper was rebuilt due to various issues reported over a number of tank openings. It was felt that there was a leak into the stripper system and that previous attempts to address this by changing the valves to welded-body Swagelok type valves had not fixed the problem. It was also felt that O_2 stripper gas was detrimental the conditioning of the acceleration tube and that a change to N_2 was required.

The objective was to eliminate all Swagelok compression-type connections from the entire gas stripper, replacing them with welded components or VCR-gasketed connections where

necessary. The entire system from the storage volume to the turbo backing manifold was upgraded or replaced.

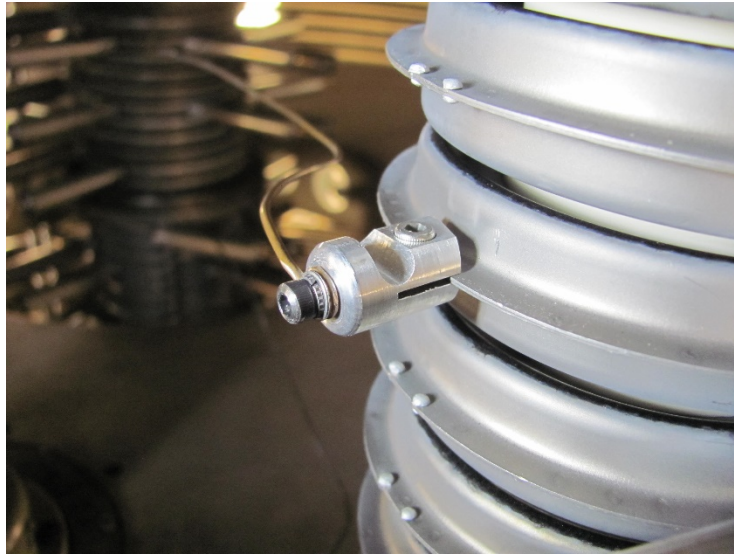
Figure 5 Unit 20 stringer two attachment using a turned down resistor end clamp

- Unit 20, post end of stringer two rivet mounting was loose. The suspicion was that we had tried to just tighten this previously, but now decided on permanent fix. Used a resistor-type clamp as just described for unit 19/high-energy midsection.

There were two instances in this tank opening requiring reattachment of stinger or wire to posts. These are shown in Figure 2 and Figure 3 and are based on thoughts discussed in section 5 of tank opening report 120. In both cases, we had previously tried repairs such as re-riveting the existing clamps, but the deterioration of the rivet holes on the post meant that we had to do better this time and fix both once and for all. The attachments are simply resistor end clamps that have been turned down to a reasonable diameter.

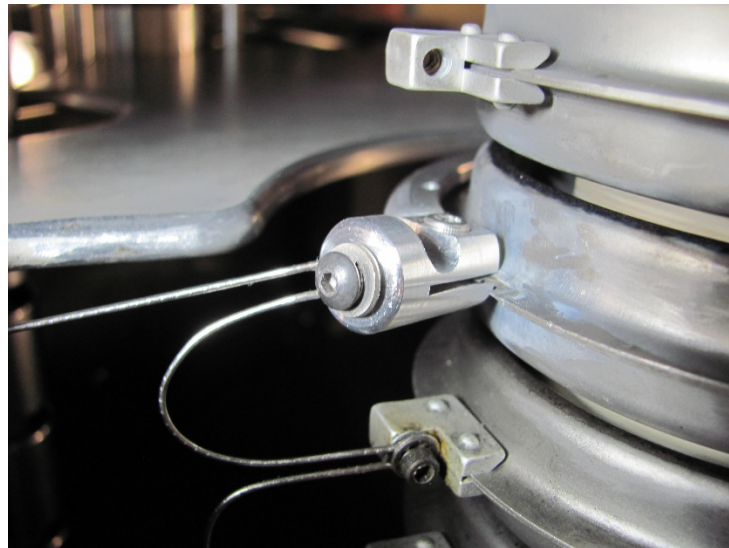
Figure 6 Unit 19/high-energy midsection grounding loop attachment

- One of the unit 19/high-energy midsection top grounding loop rivet attachments on a post had come loose. There was insufficient material to re-rivet, so clamp attachment based on resistor mounting (similar to that described in section 5 of tank opening report 120)

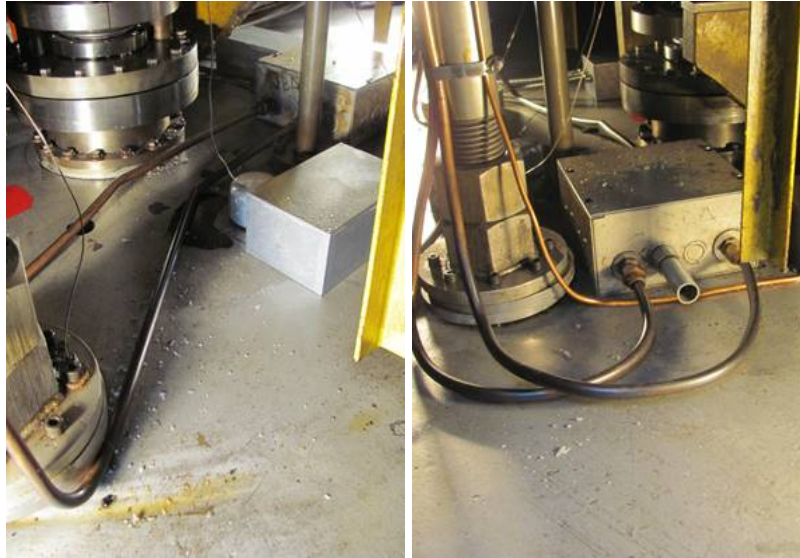
During the initial inspection at the bottom of the tank, shards of nylon were found littered about as shown in Figure 2.

Figure 7 Nylon shards littering the bottom of the tank from exploded charging system standoff

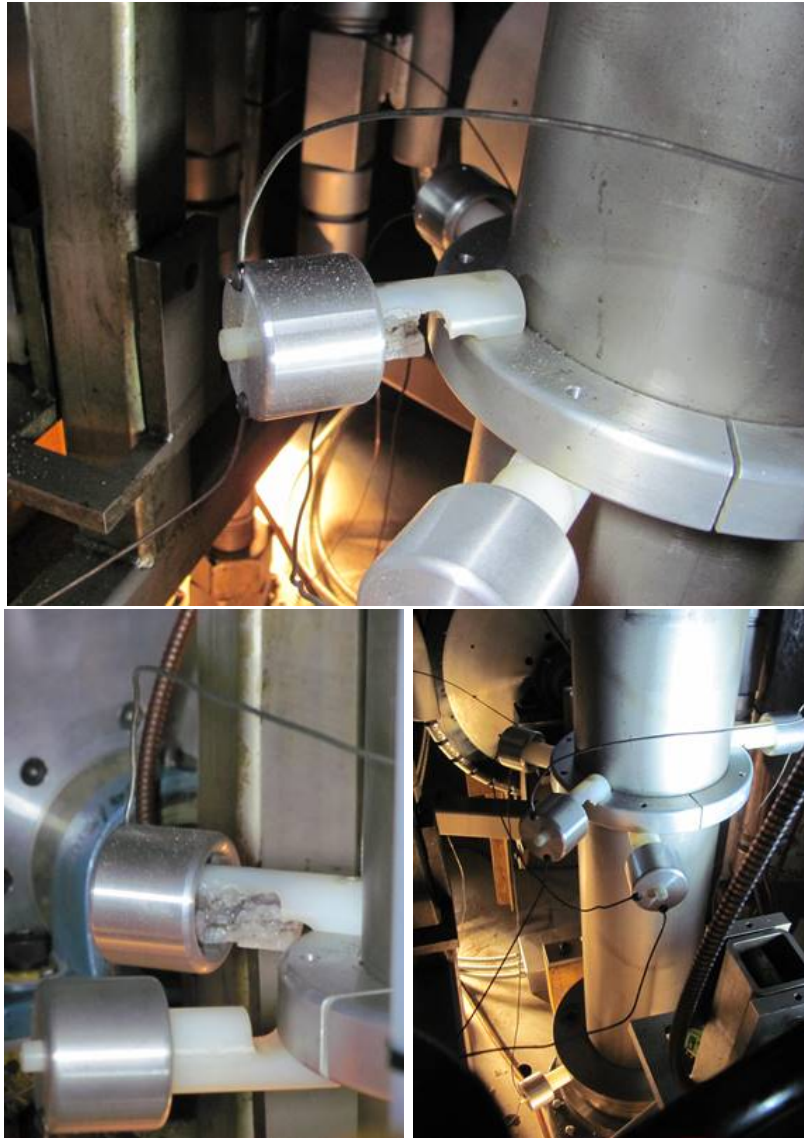
Closer inspection showed that the nylon debris was due to an “up” charging system standoff insulator “exploding”. The “down” charging system insulator standoff was also damaged to a lesser extent. The failure was not shown up by initial electrical testing as both damaged insulators maintained enough structural integrity to keep the aluminium caps insulated and in place (see Figure 8).

The damage appeared to be caused by sparking from the aluminium mounting collar, through the nylon to the aluminium cap. In line with standard insulator protection, it was decided to introduce a metal to metal spark gap (of approx. 3mm). For the new standoff, existing caps were utilised along with a new nylon spacer and new aluminium mounting bracket. This is shown in Figure 9.

Figure 8 Damage to nylon charging system standoff

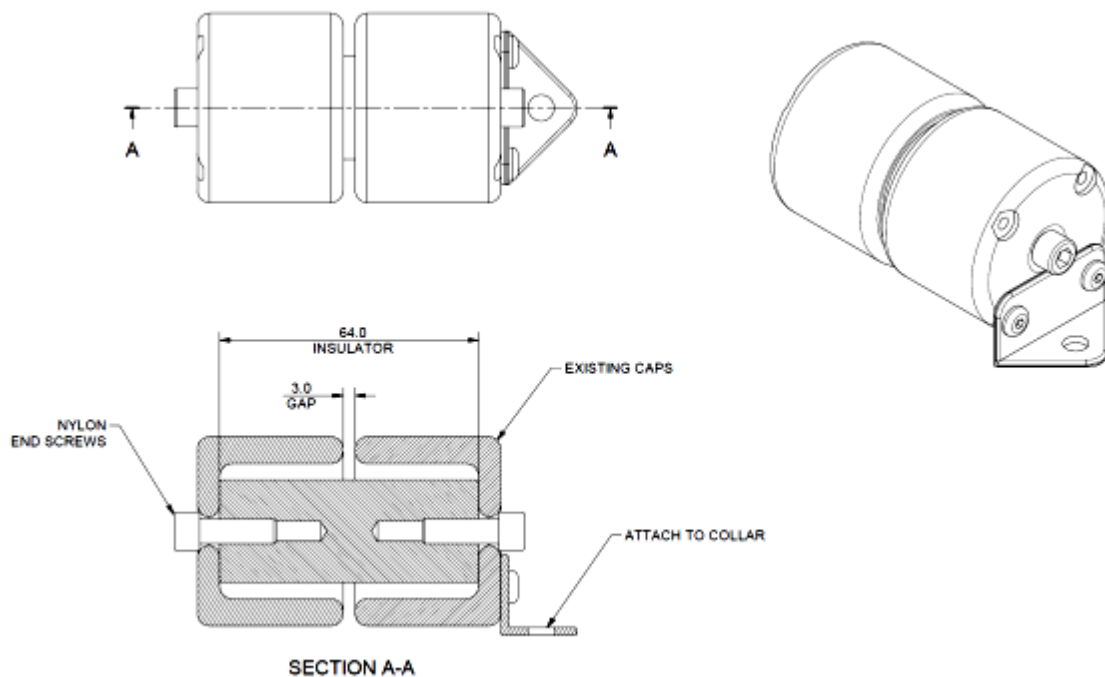
Figure 9 Modified charging system standoff with spark gap

It was also decided that the arrangement be rewired. For both the “up” and “down”, the wiring now comes up from the “mushroom” on the bottom of the tank to an intermediate standoff then to the new spark-gapped standoff where it is then distributed to the 3 “up” or “down” inductors. This minimises the number of standoffs required and is simpler to follow than the old daisy chained arrangement.

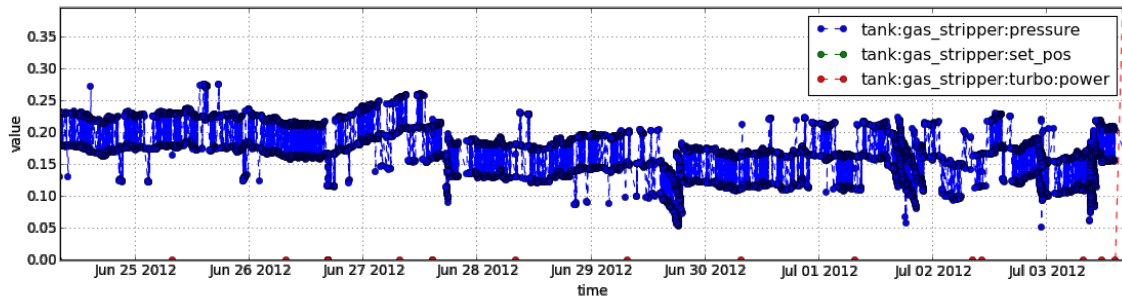
Figure 11 and Figure 12 compare the gas stripper system base pressures over time (shaft alternators on and gas valve fully shut) from before any work was done on the gas stripper system to after the system was reconfigured to use welded and VCR pipe joins. This shows that performance is as good or better. That is, the process was a success!

Figure 11 Gas stripper base pressure before tank opening 117 (untouched system)

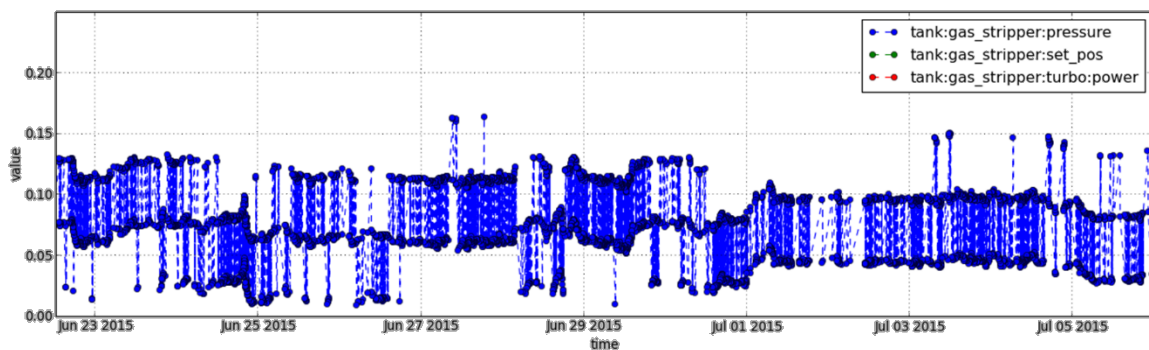
Figure 12 Gas stripper base pressure after tank opening 124 (VCR and welded system)
