Australian
National
University

14 UD Tank Opening Report

#125

15th February – 17th March 2016

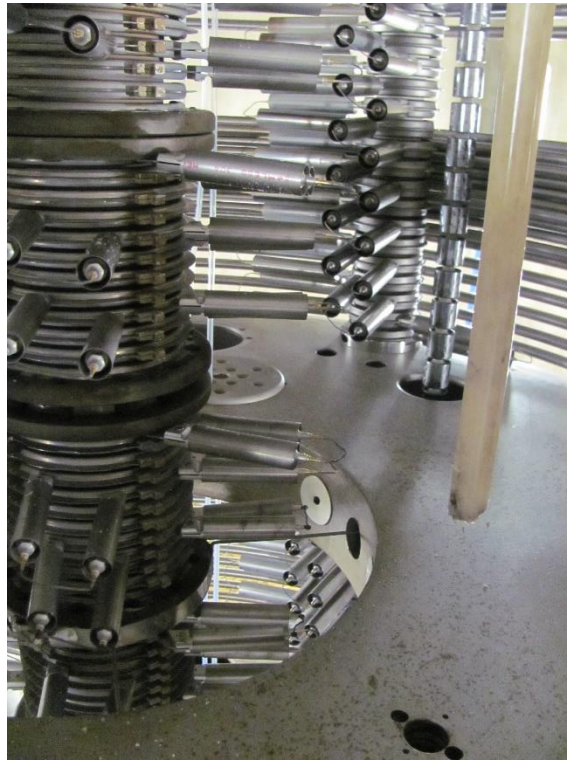
While removing shorting rods from the high-energy end of the 14UD before the tank opening, it became apparent that a nylon shorting rod was broken. It was assumed that this was due to spark damage during the LINAC run of late 2015. Upon entering the tank, we found a shattered nylon shorting rod in unit 21. The undisturbed rod is shown in Figure 3-1. Shattered nylon shorting rod in unit 21. There was much nylon debris scattered around the high-energy end of the machine, from the terminal all the way down to the bottom of the tank. Some of this debris field is shown in Figure 3-2 with the extent of the shattered section shown in Figure 3-3.

Figure 3-1 Shattered nylon shorting rod in unit 21

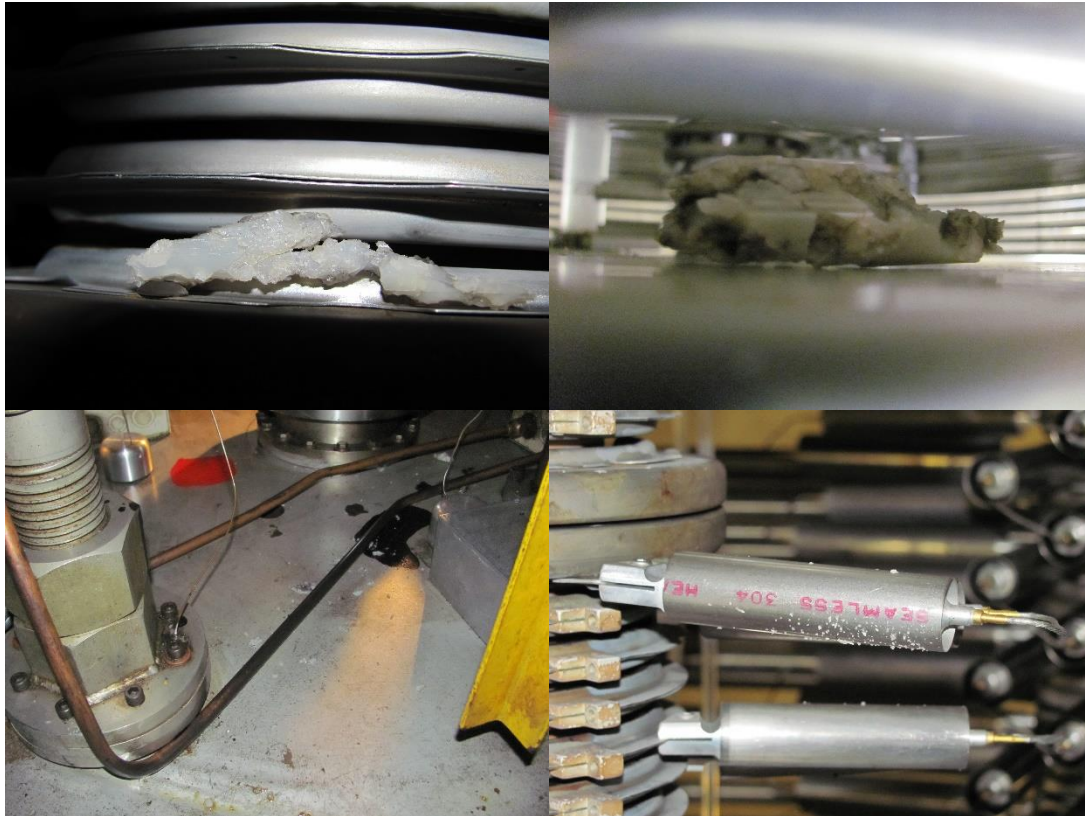
Figure 3-2 Debris field from shattered nylon shorting rod

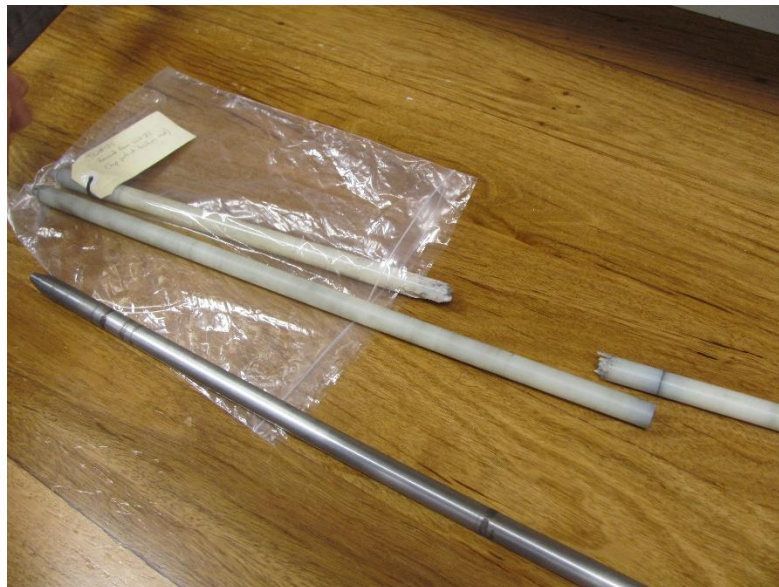
In addition to the shattered nylon rod, the single steel shorting rod that had been shorting unit 19 was also damaged, as shown in Figure 3-3. There was severe spark damage at the shorting rod spring contact points. This damage could not be polished out or repaired, so it was replaced with a different rod (the entry “bullet” is actually its own small rod that can be placed on the end of any rod). The replacement rod had a ring machined in the back to indicate that it is the last rod when inserting and removing shorting rods (as did the damaged rod).

Figure 3-3 Comparison of shattered nylon shorting rod with good rod to show how much of the rod shattered. Also note the severe spark damage to the steel shorting rod at the spring contact points.

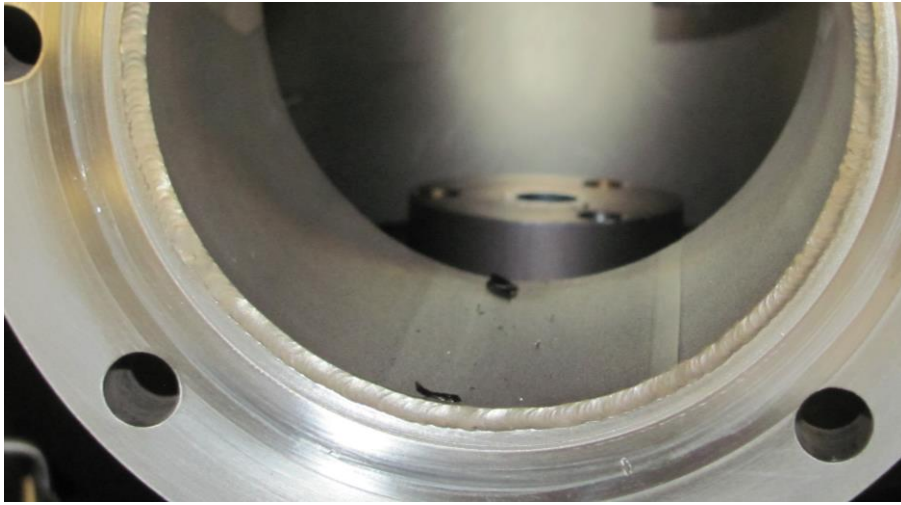
The foil changer assembly was removed from the HE stripper while it was in place. Immediately debris could be seen on the bottom of the foil changer port.

Figure 4-3 HE stripper debris

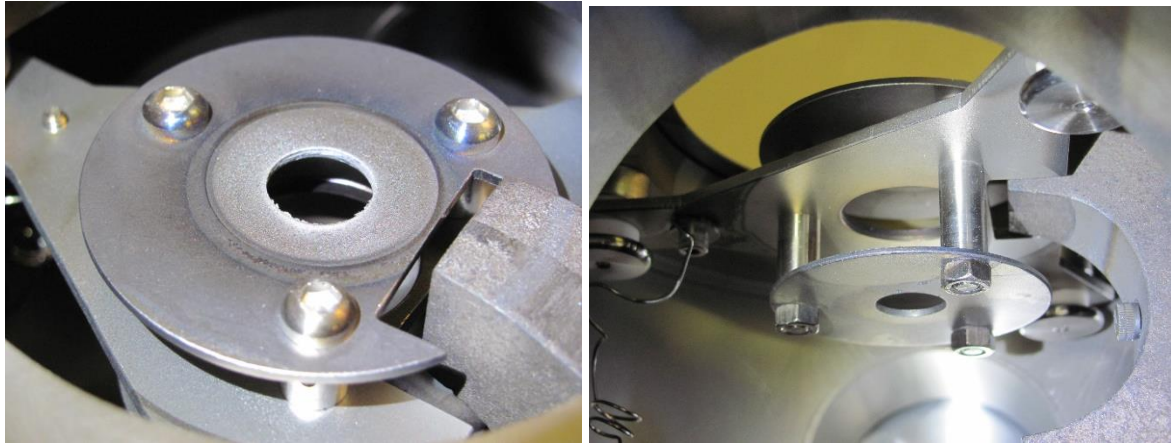
It was noted that the top suppressor aperture of the HE stripper had a sputtered area of about 25mm around its 12.5mm hole and this may be the source of a lot of backstreamed electrons. It was also noted that the set of 3 suppressor apertures are all biased to the same voltage. The suppressor arrangement was perplexing and further investigation will need to be done to understand how it works (or doesn't) and if it can be improved.

Figure 4-5 HE stripper apertures

A new tantalum aperture was ordered from the workshop. This aperture was wire cut so it was cleaned in Nitric Acid (20% for 10 minutes) then rinsed with de-ionised water and dried with nitrogen to remove any deposits on the cut surface from the wire. The aperture was installed in the stripper assembly and the old aperture was removed and stored in the radiation area due to its 20uSv/hr reading.

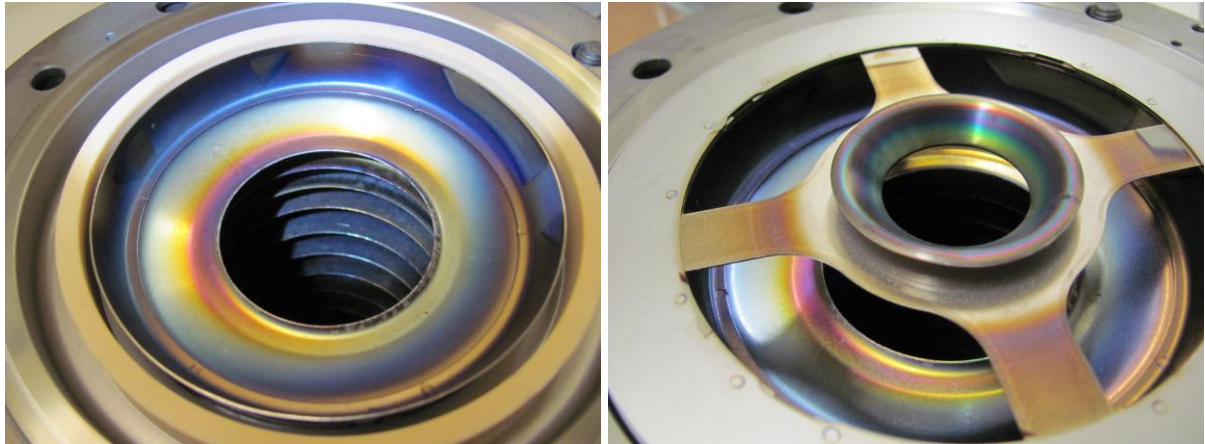
The removed tube sections were inspected. The tube immediately above the HE stripper was very brightly discoloured, thought to be from backstreaming of stripper electrons.

Figure 4-7 U19 Tube 2 discolouration (above HE stripper)

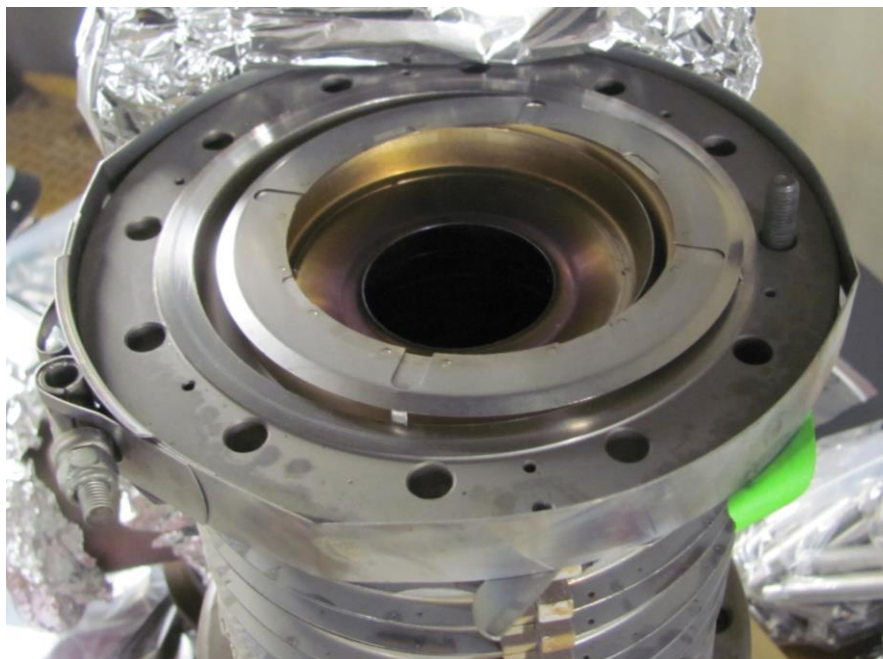
As suspected, the tubes below the stripper contained debris from broken foils.

Figure 4-8 U20 Tube 1 (below HE stripper)

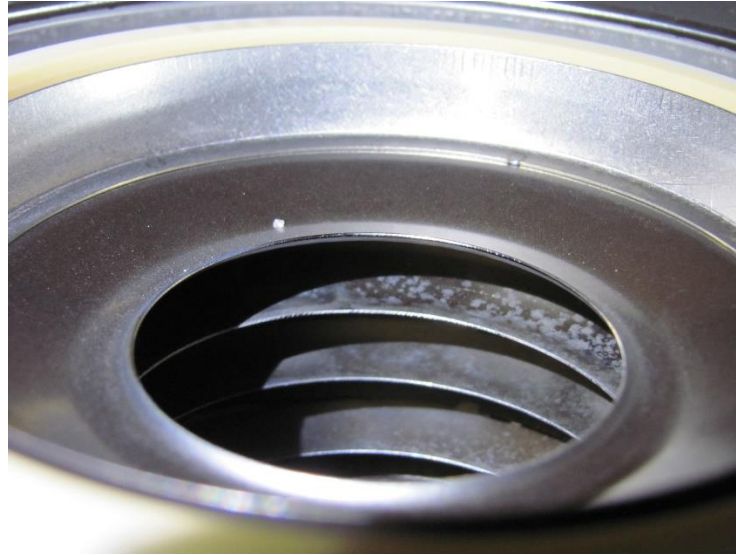
Figure 4-9 U20 8 Gapper

Tubes immediately above and below the removed sections were also inspected. The downstream tubes exhibited white marks on the electrodes. The cause of these marks is unknown. The U20 8 gap tube also had a small white piece of something sitting on the top electrode. Originally it was thought to have already been there when the tube was exposed, but the consensus later was that it was nylon debris from the shorting rod that must have fallen in during the tube removals.

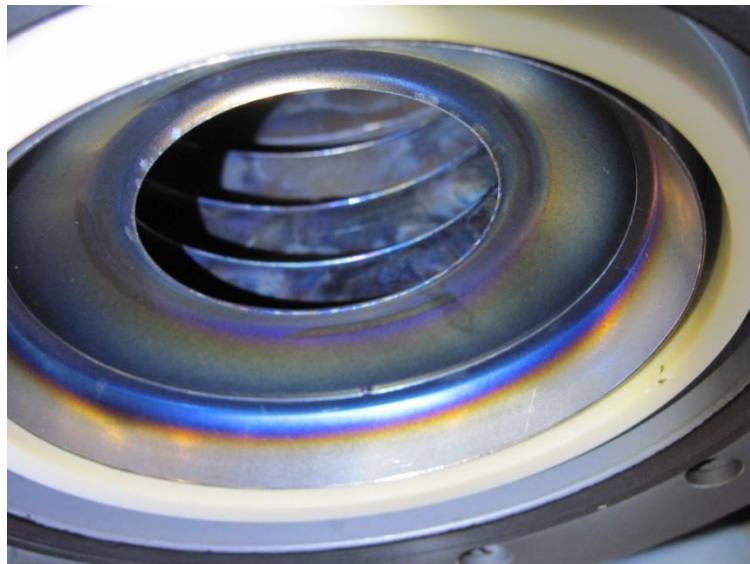
Figure 4-10 U18 8 Gapper

The tubes above the removed sections still showed discolouration on the electrode surfaces, consistent with the theorised bombardment of backstreaming electrons from the stripper aperture and foils.

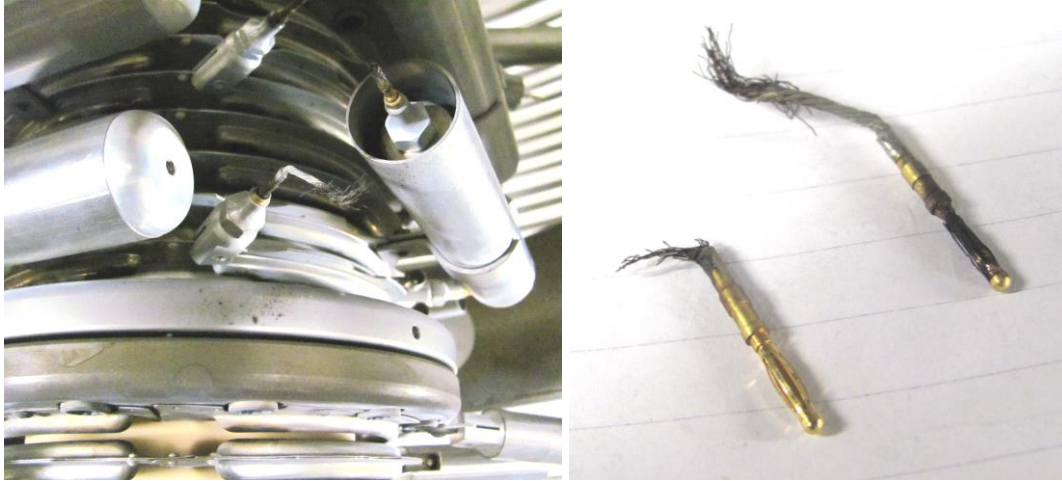
During the entry High Voltage testing, an abnormality (ticking?) was found in unit 13, tube 4. On retesting, sparking was noticed across gap 7 and led to the discovery of a blown resistor lead.

Figure 5-1 U13 T4 G7 blown resistor

The discovery was unusual in that the blown lead did not hamper the machine performance, indicating that either it occurred just before the tank opening, or there was a good enough corona across the gap to mask the problem (though no indication of higher levels of breakdown product in the area).

Prior to reinstalling, the resistor was tested and found to be good (32uA @ 20kV). New nuts were installed on the resistor assembly and dummy to accommodate the new lead. The spark gap also had significant spark damage and was cleaned up prior to reinstalling.

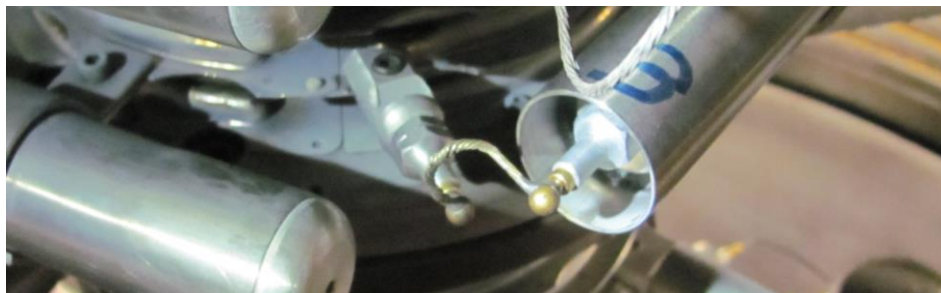
Figure 5-2 Replaced resistor lead

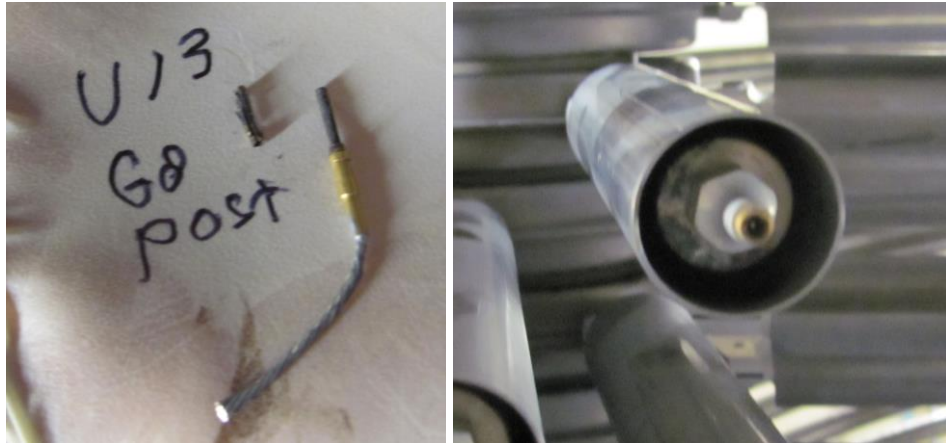
During cleaning and inspection on U13, it was noticed that the banana plugs on Post B Gap 8 were black and damaged. The plugs were very loose (poor connection) but were extremely difficult to remove as the ends felt like they had expanded and could not pass back through the nut. The plugs broke in the process of removal, leaving part of the plug still inside the nut.

Figure 6-1 U13 PB damaged banana plug

The nuts and lead were replaced and the resistors reinstalled.

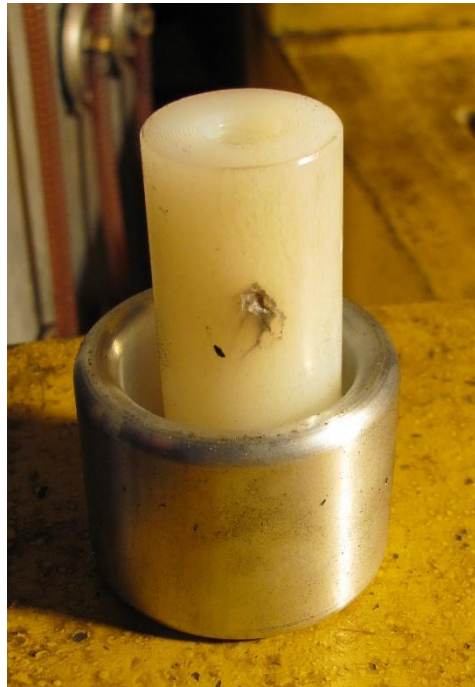
During TO#124, damage was found to two charging systems standoffs. It was thought that creating a spark gap on the first standoff in line would protect the rest of the line. Evidently, the exposed nylon standoffs are still vulnerable, with the un-sparkgapped suppressor standoff exhibiting damage from a large spark. For this tank opening, this standoff was replaced with a new nylon standoff, however it may be wise to introduce a spark gap in the future on the two remaining exposed standoffs.

Figure 7-1 Supressor standoff spark damage

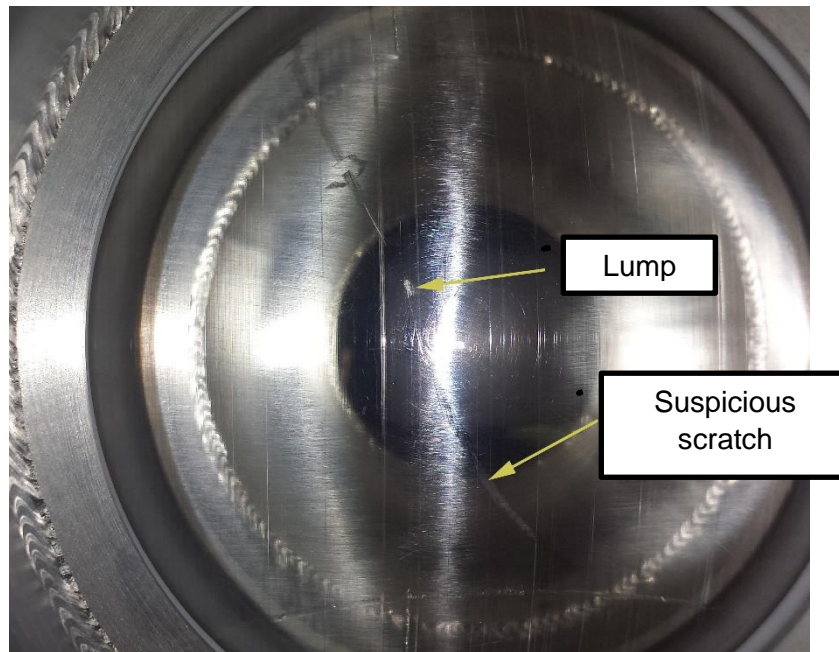
On inspection there were scratches on the ball and there was also a defect – like impact damage/weld spatter? – which would be damaging the Teflon seals when opening/closing. A new ball was ordered from A&N.

Figure 8-2 View of ball surface damage

Valve was reassembled with new parts.

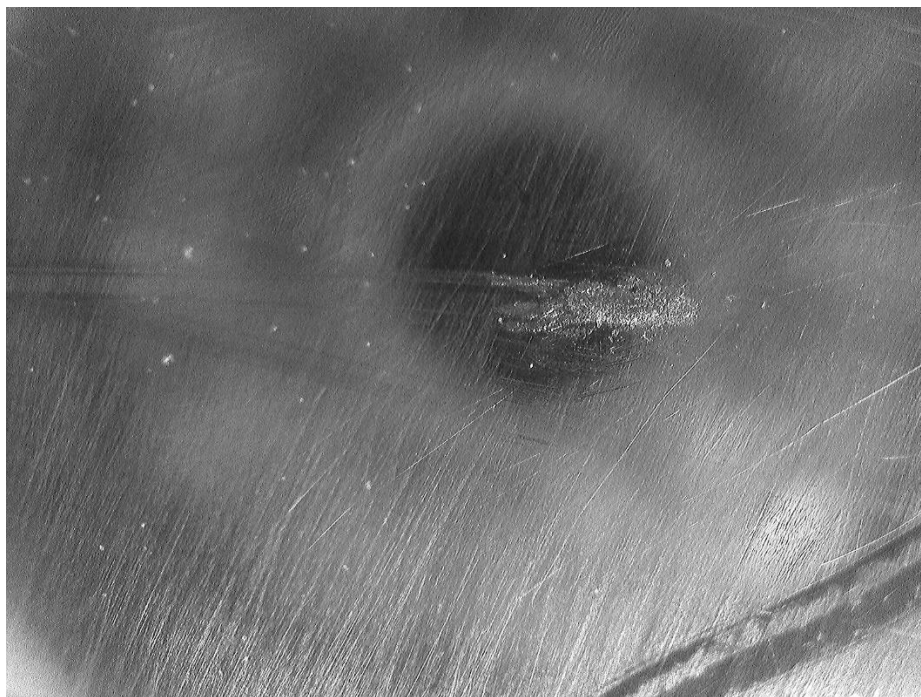
Figure 8-3 Microscopic view of ball surface damage

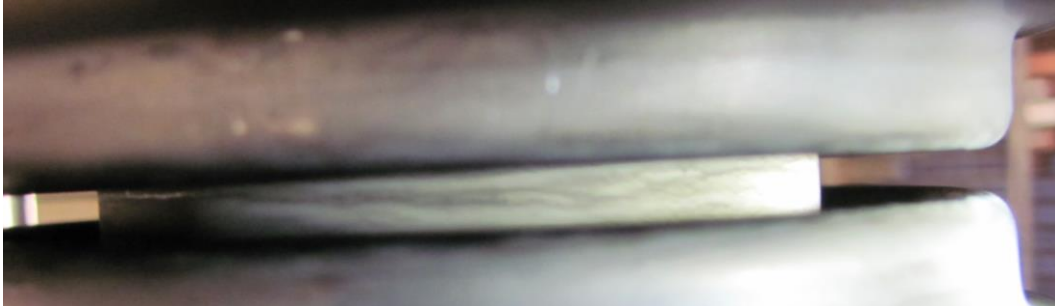
- U10 Post A G12: black trace
Post C G18: black trace across insulator
- U14 Post D G1-3: bad looking ceramic

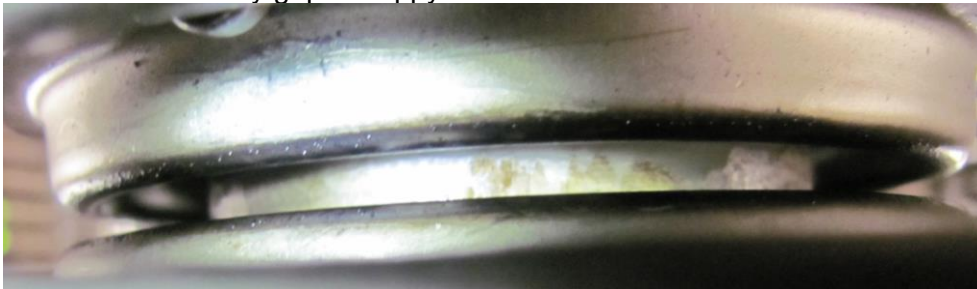
- U16 Post B many gaps: crappy

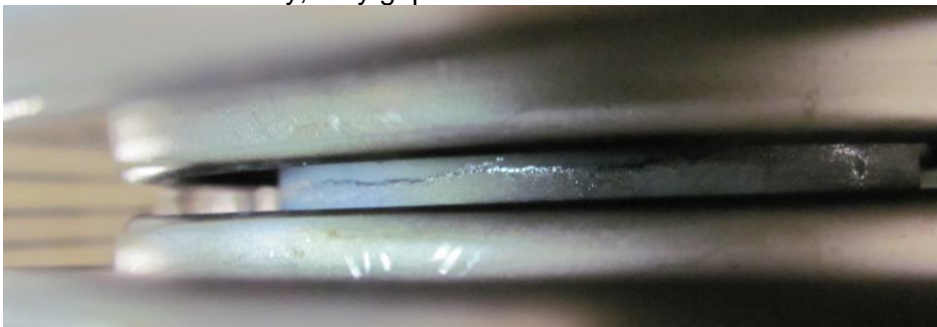
- U17 Post B G2: Oily, dirty gap

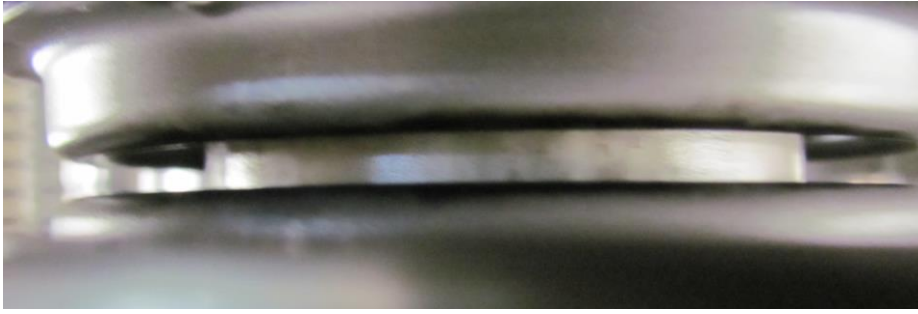
- U18 Post B G17-18: dirty

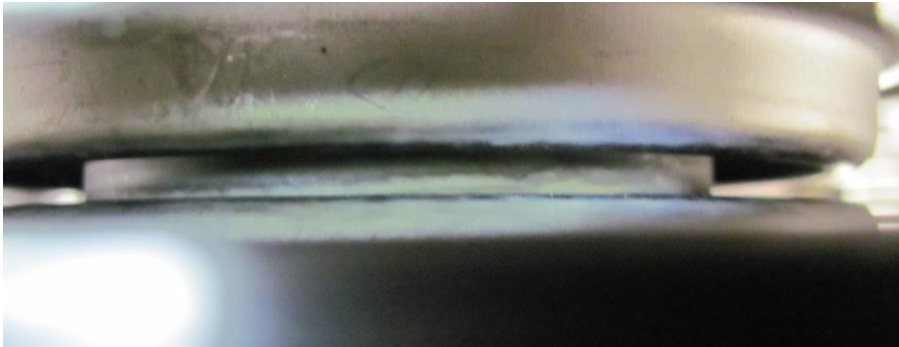
- U19 Post B G1-3: circular marks

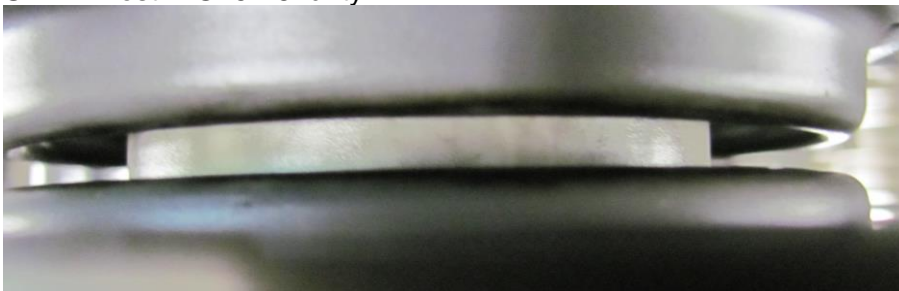
- U22 Post B G15-18: dirty

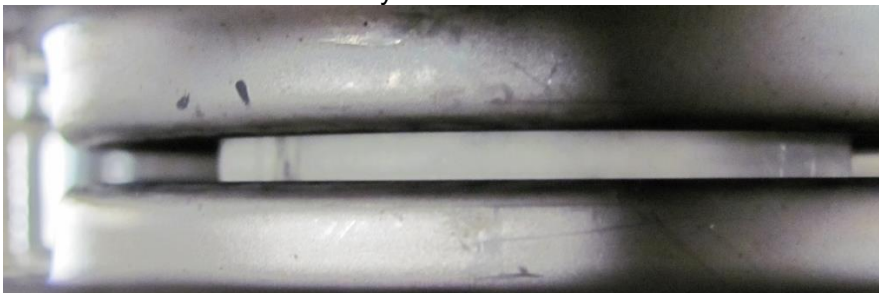
- U25 Post A G1-2: a bit dirty
- U27 Post A G2-3: a bit dirty

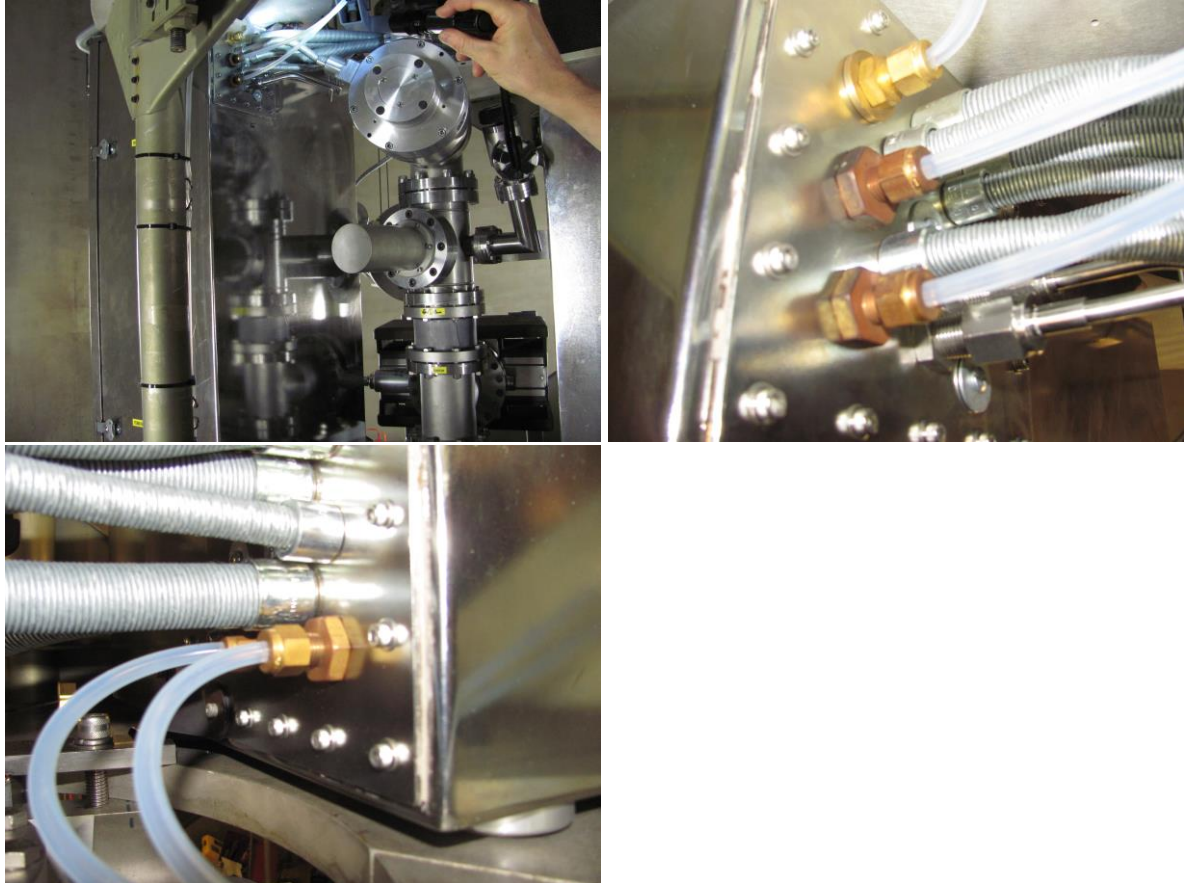
When inspecting the terminal, it was noted that most of the brass Swagelok fittings on the back of the electronics boxes were discoloured brown. The fittings seem to be in good condition otherwise, with no apparent change to their integrity. It is not known if over what period this has occurred or why it has occurred (reaction with SF_6 ?), but it was thought that it should be noted if any issues with these fittings were to arise in the future.

Figure 11-1 Brass fittings discolouration.
