Australian
National
University

14 UD Tank Opening Report

#126

19th May – 13th June 2016

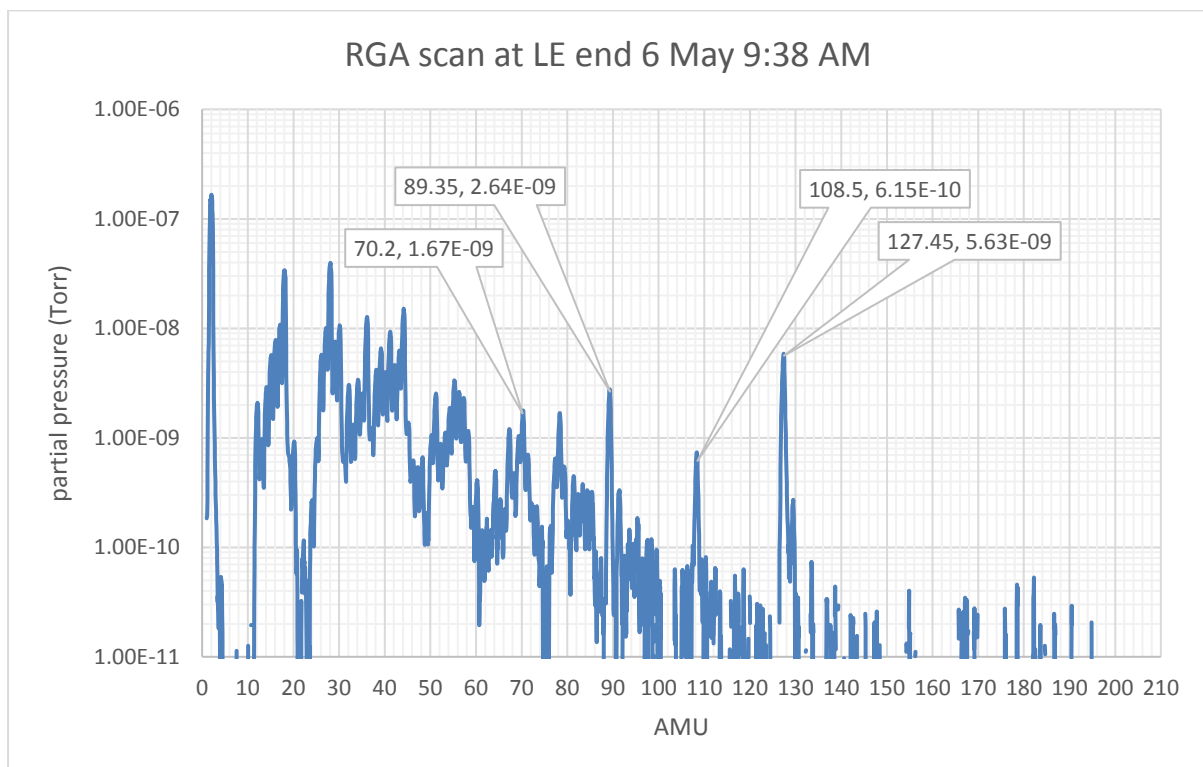
An RGA scan was taken at the low-energy end of the machine after the shafts (and hence all ion pumps in the acceleration tube) were off overnight and the 300 l/s ion pump at the top of the tank was switched off for ten minutes. The resulting scan is shown in Figure 1 and an unmistakable signature of SF₆ is evident.

Figure 1 RGA scan taken at low-energy end of the machine after shafts were off overnight and the 300 l/s ion pump switched off.

The suspicion was that there may be SF₆ leaking through one or more of the flanges of the acceleration tubes installed during the recent tank opening 125. While the bolts were torqued to NEC's specification and helium leak testing was performed, nothing was rechecked after baking the tubes. Furthermore, flanges of other tubes may have been disturbed since a significant part of the column moved during the procedure.

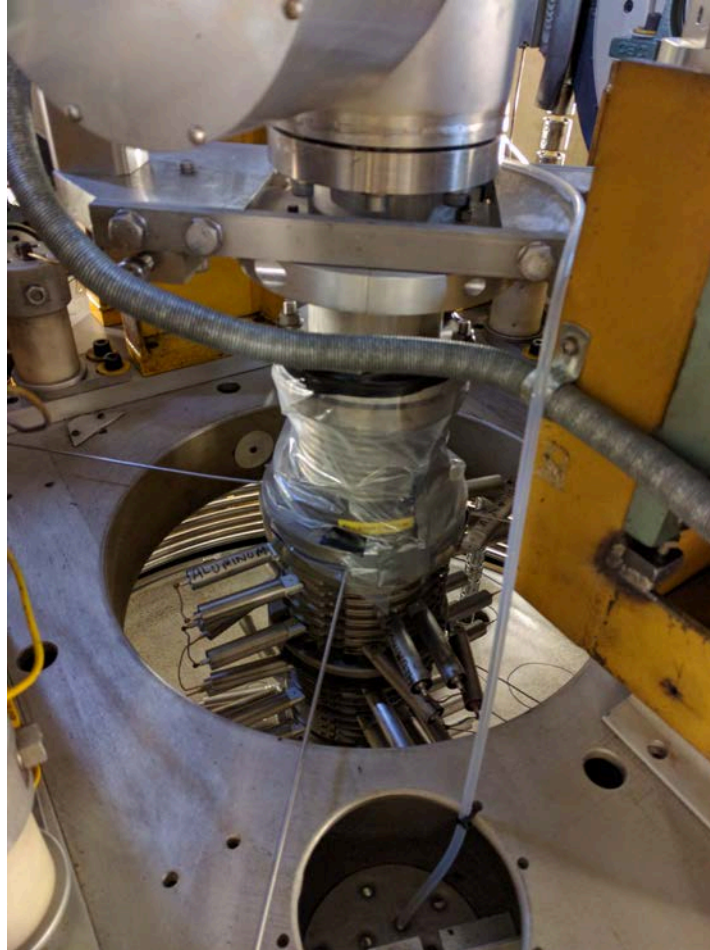
reaction from the top flange but peaked at 6.4×10^{-8} mbar·l/s at the lower flange. We found the leak.

Figure 2 shows the bellows in the lower section of the terminal where the leak was found. The bolts on the leaking flange were torqued up to 160 in·lb (18 Nm), after which no leak was seen above the base leak rate of $1.3\text{-}1.4 \times 10^{-9}$ mbar·l/s.

Figure 2 Terminal bellows in which a leak was found through the bottom flange

- Checked the torque on the hex socket bolts on the bellows/aperture and reached 130 in·lb (15 Nm) before any moved. Torqued all up to 160 in·lb (18 Nm).
- Redid leak test on taped up flange. No definite response, but not yet willing to call it good. Turned all pumps on to clear helium and get a lowest possible baseline before retesting in the morning.

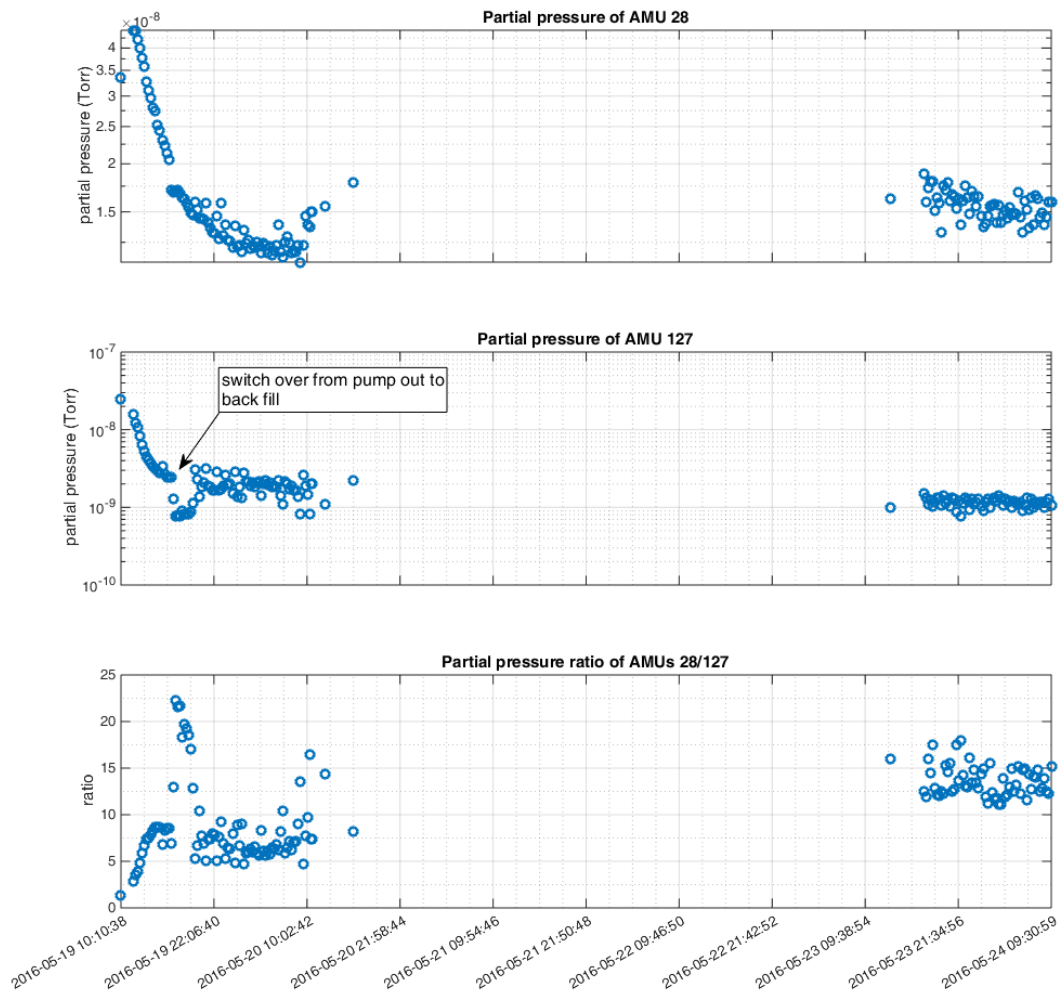
Figure 3 shows the N₂ and SF₅ (main peak in SF₆) partial pressures and their ratio during gas out and the first three days of the tank opening. The total pressure improves as the tank pressure reduces, but there is an immediate dip in SF₆ that coincides with the change over to back fill with air. The later increase has no obvious explanation.

With the shafts and therefore the tube ion pumps off, the SF₆ levels settle to a relatively constant level, even three days after the tank is opened.

Figure 3 Partial pressures of N₂ (AMU=28) and SF₅ (AMU=127) starting from gas out of the 14UD.

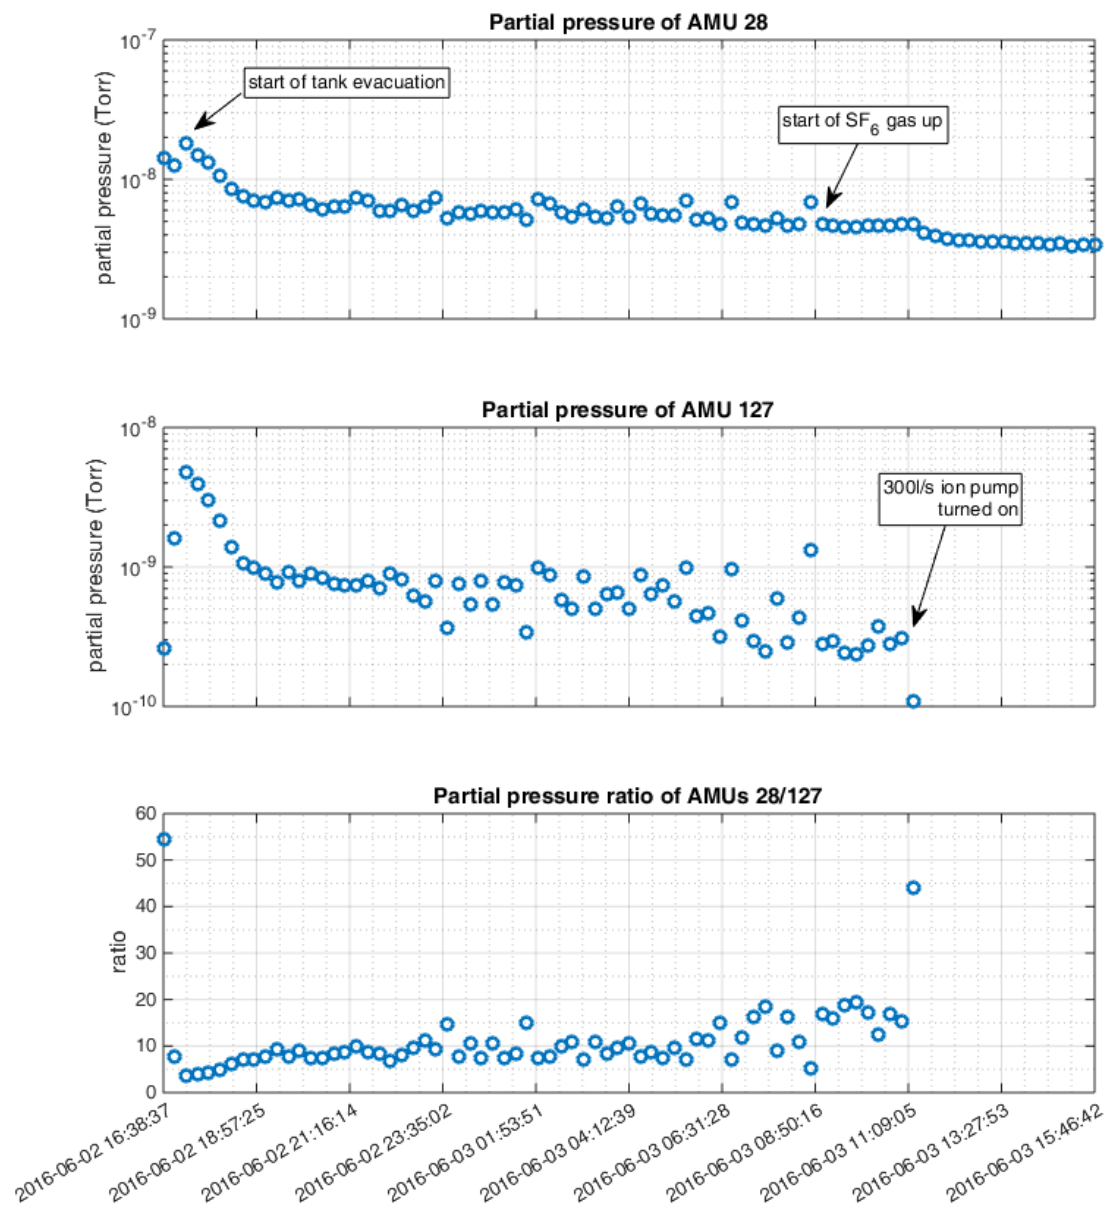
Figure 4 shows the SF₆ levels during gas up, with the aim being to ensure that the SF₆ levels do not increase during gas up as the tank pressure is increased. However, the 300l/s ion pump between the acceleration tube and the RGA was inadvertently turned on at about

11:00 am on the 3rd of June, which completely wipes out any SF₆ that the RGA may see. So, up to a tank pressure up to a little above atmosphere, there was no ingress of SF₆ into the acceleration tube.

Figure 4 Partial pressures of N_2 (AMU=28) and SF_5 (AMU=127) starting tank evacuation through to gas up with SF_6 until ~13 psi.

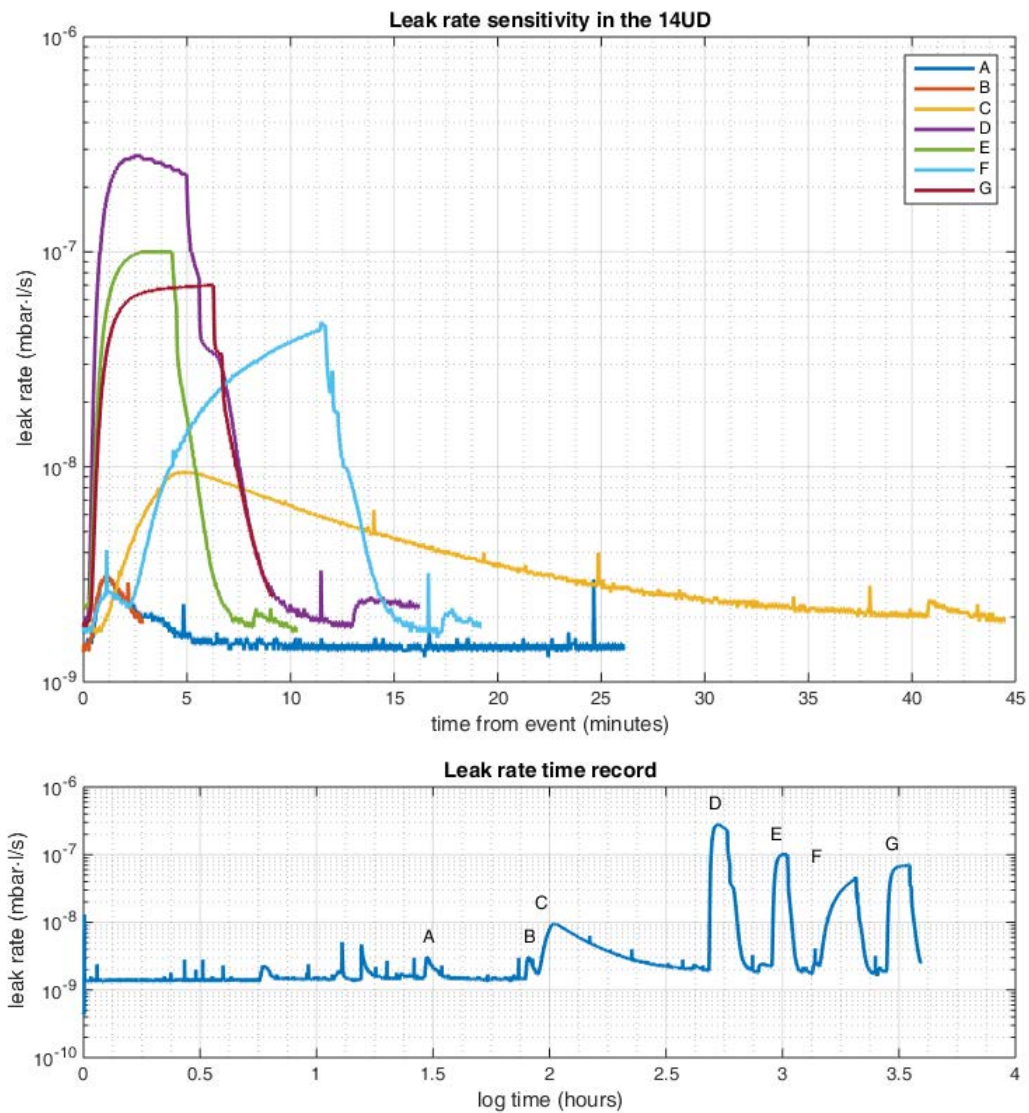
There is a burst when the calibrated leak rate valve is opened, which likely accounts for the differences between configurations D and G, which are nominally the same. The time

between D and its preceding event/configuration is greater, giving more time for a buildup of helium from the calibrated leak.

Leak testing should be performed with pumps off for maximum sensitivity, although the tube vacuum should be observed, as it did deteriorate to low 10^{-6} Torr during the test.

Figure 6 Leak rate sensitivity tests in the 14UD with helium leak detector on the back of a turbo at ground level and a nominal 2.9×10^{-7} mbar-l/s calibrated leak at level 5, for configurations/events A through G listed in Table 1. Peaks for each event/configuration indicate point at which calibrated leak was valved off.

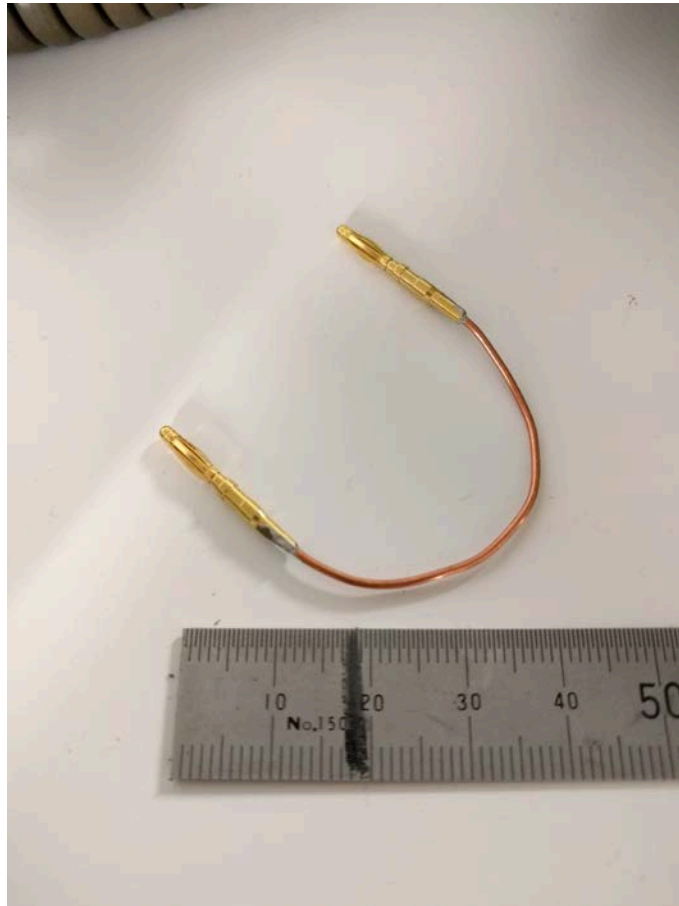
Historically, tinned braided copper wire has been used to manufacture resistor leads. This style of lead has been service in the machine since resistors replaced corona points. However, there are issues with blown leads and misshaped leads that create sharp edges that encourage corona activity. This tank opening was an opportunity to test an alternative.

Figure 7 Prototype resistor lead made from 1mm diameter hardwire copper

Standard, 1mm diameter, hardwire copper was sourced as an alternative for resistor leads. The copper wire was cut to 65-70mm lengths to replace the existing flexible resistor lead design. Forty-six new leads were manufactured using the new hard wire, one of which is shown in Figure 7.

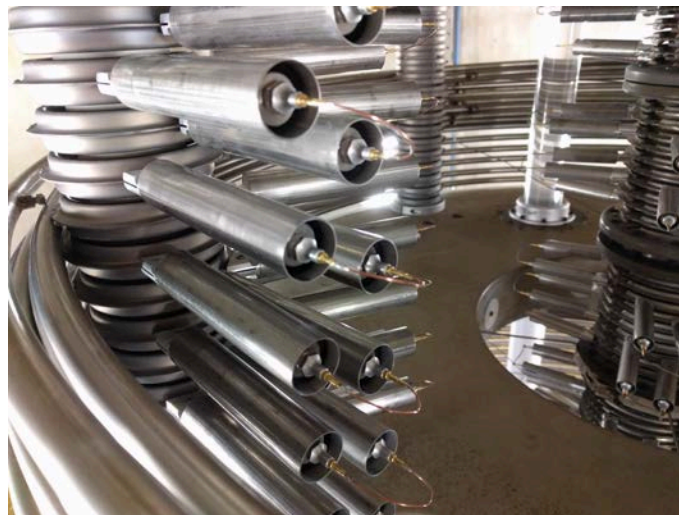
Figure 8 All post resistor leads in unit 4 were replaced with hardwire copper leads

All post resistor leads in unit 4 were replaced with hardwire copper leads, as shown in Figure 8, and their performance will be monitored over time.

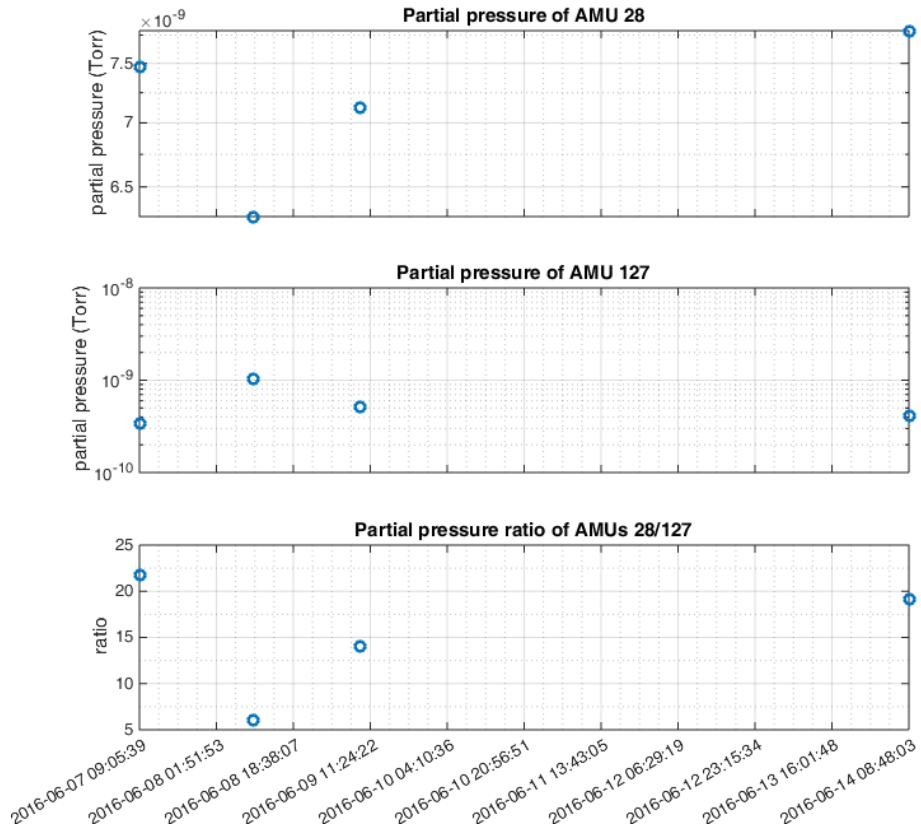
A slow and steady conditioning campaign was run from 6th of June until the 13th of June, beginning with units 22 to 28 shorted. The SF₆ levels were monitored via the usual RGA scan at level 4.5. Figure 10 shows the change over time¹.

Figure 10 SF₆ levels during the week of conditioning
