14 UD Tank Opening Report

#127

1st February – 23rd February 2017

Department of Nuclear Physics
57 Garran Road
Research School of Physics and Engineering
The Australian National University
Acton ACT 2601

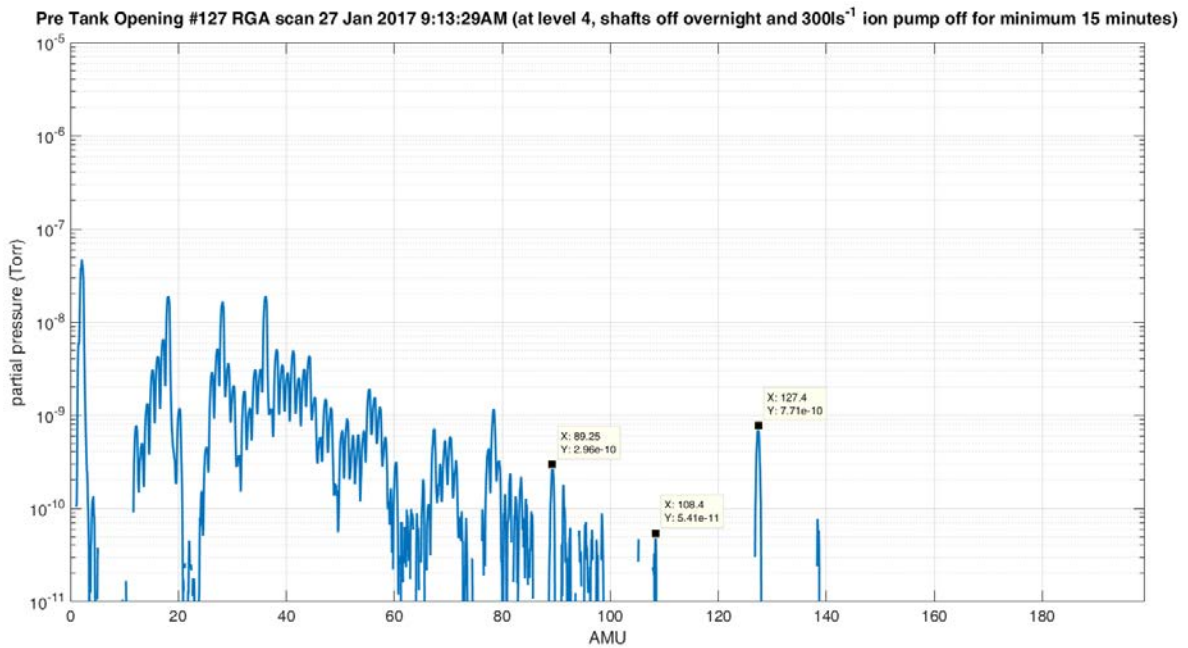
Furthermore, a pre-tank opening series of RGA scans showed small traces of SF₆ in the acceleration tube vacuum space. A representative scan result is shown in Figure 1.

Figure 1 Pre tank opening RGA scan on 27th January. Results were similar on a repeat scan on the morning of 30th January.

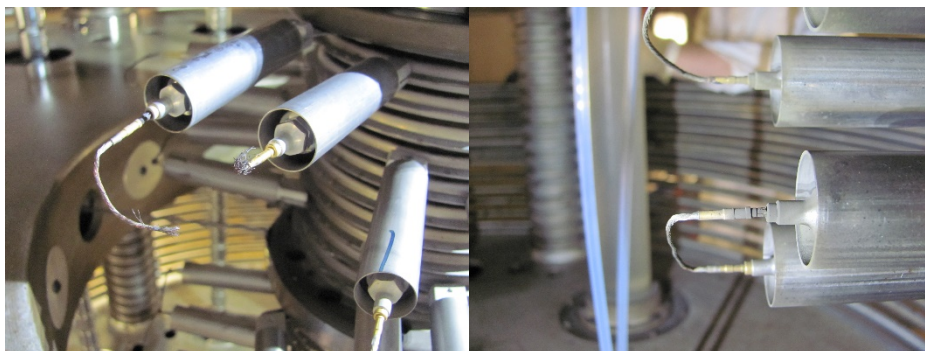
The main issue observed in this tank opening was multiple damaged resistors up and down the machine. Unit 15 was the worst affected with scorched leads, broken leads and broken stringers and mounts. It is not possible to determine what failed first, but it is certain that operating the machine under sub-optimal conditions lead to damage elsewhere.

Figure 2 Multiple resistor issues in unit 15

- New stringer 2 installed with resistor type mount at post end
- Stringer 3 was loose at post end, but retightening was enough
- All internal facing post resistors replaced with new tested assemblies
- Three tangent facing post resistors replaced because of dirty spark gaps

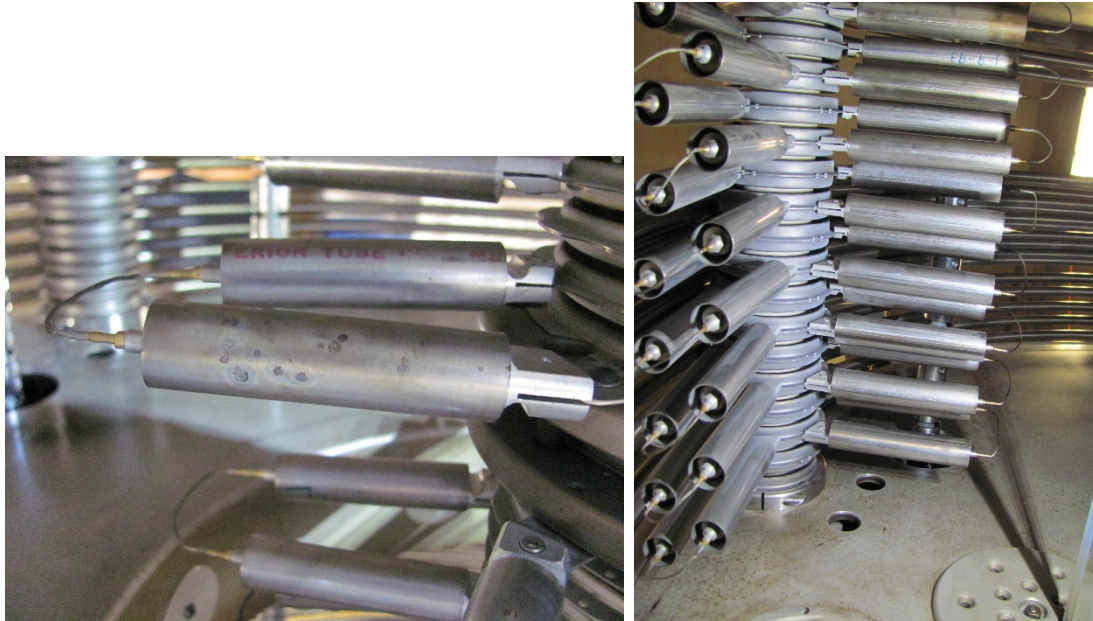
Figure 3 More multiple resistor issues in unit 15

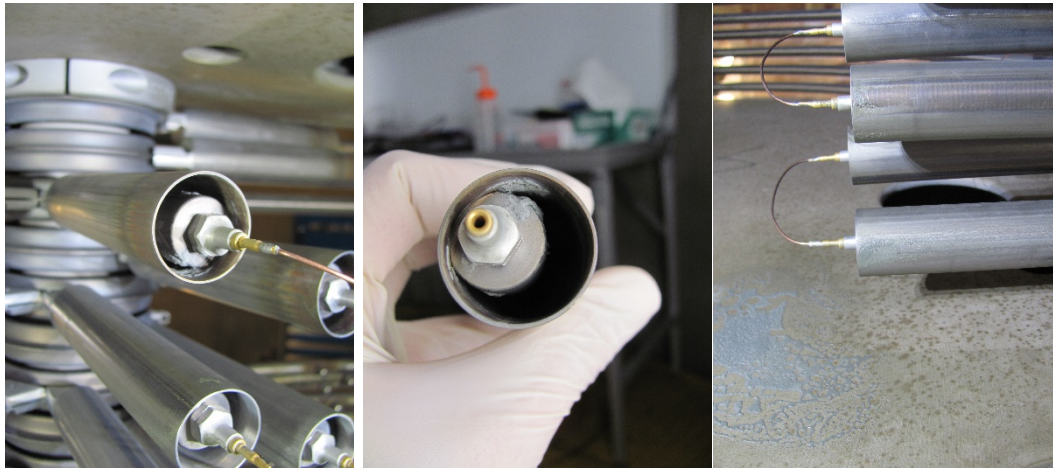
- Problem with unit 4 post gap 3 top resistor. The spark gap was touching the shield electrode and is likely the source of the pool of slag mentioned earlier.

Figure 4 shows the aftereffects of a resistor in unit 4 that broke and allowed the spark gap to touch the outer shield. The titanium spark gap appears to have sputtered away, leaving a pool of “slag” on the casting. This was one reason we were reluctant to install solid leads in more units, since it may be that the additional spring in the solid leads somehow leads to increased stresses on the resistor during dynamic movement.

Figure 4 Broken resistor in unit 4 causing arcing between speak gap and shield (left and middle) with the resulting "slag" shown on the casting below (right)

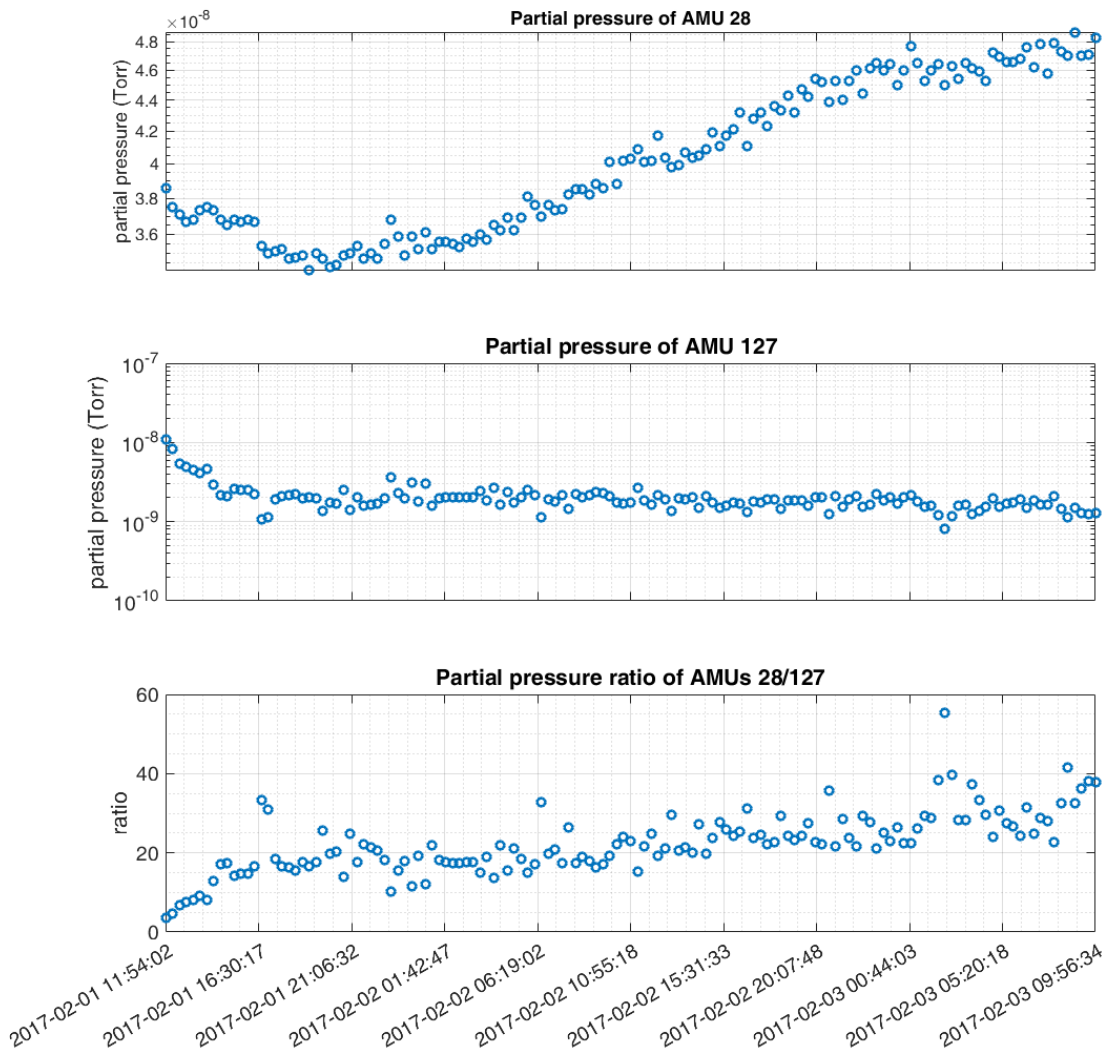
Various RGA measurements throughout the tank opening indicated that there was a low level of SF₆ present even at the end of the tank opening. This led us to consider that perhaps the source of low-level SF₆ is not the acceleration tubes, but the ion pumps. These ion pumps are switched off during RGA measurements and may release some previous pumped SF₆. The 300l/s ion pump at the top of the accelerator (inside the tank) was baked and RGA measurements following this did show a reduction in the amount of SF₆. Nevertheless, we need further investigation so that we better understand what we are measuring and which SF₆ levels we can ignore, if any.

Figure 5 shows the measured SF₆ levels in the acceleration tube vacuum space during pump out of the 14UD pressure vessel.

Figure 5 Partial pressures of N2 (AMU=28) and SF5 (AMU=127) starting from gas out of the 14UD.

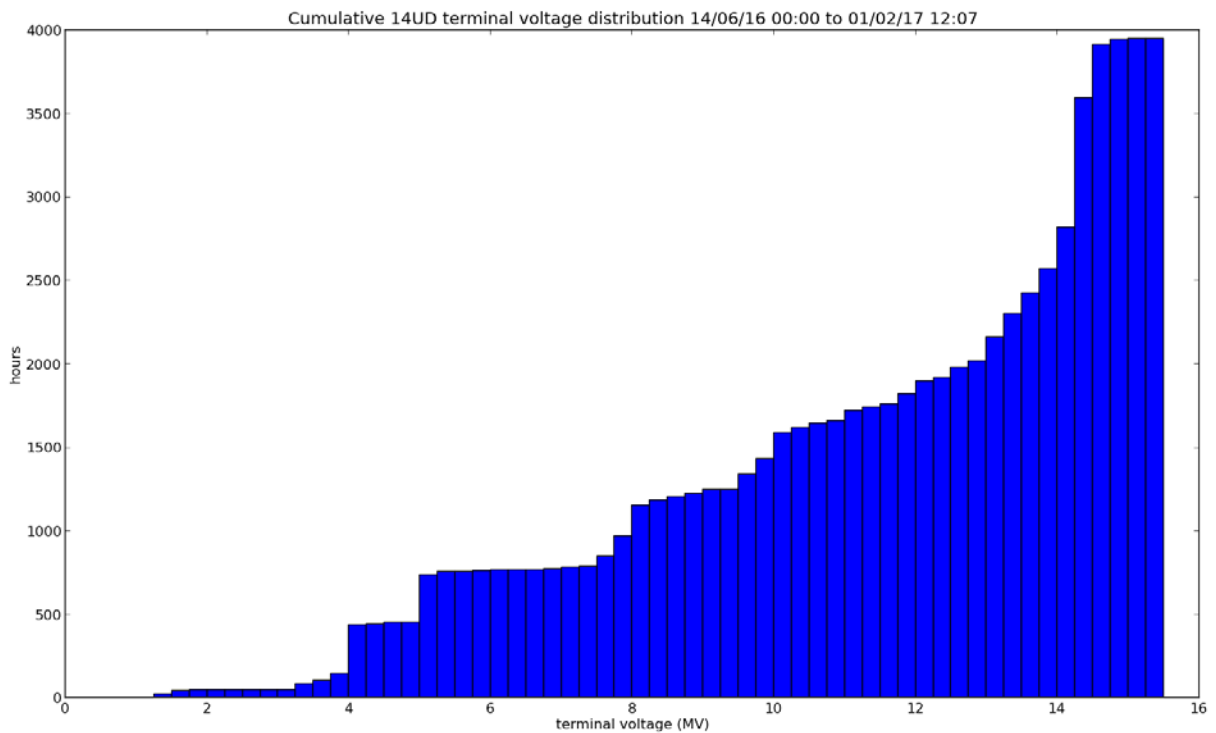
Figure 6 Cumulative terminal voltage distribution for period of operation from the end of tank opening 126 to the start of tank opening 127 (not including the week spent conditioning the machine immediately after tank opening 126)

The total hours with voltage on the terminal was 3948 hrs, which gives a utilization of 71% assuming a twenty-four hour, seven-day maximum. If the Christmas shutdown period is removed from the total available hours, then the utilization is 74%.
