Australian  
National  
University

# 14 UD Tank Opening Report

## #128

16<sup>th</sup> October – 10<sup>th</sup> November 2017

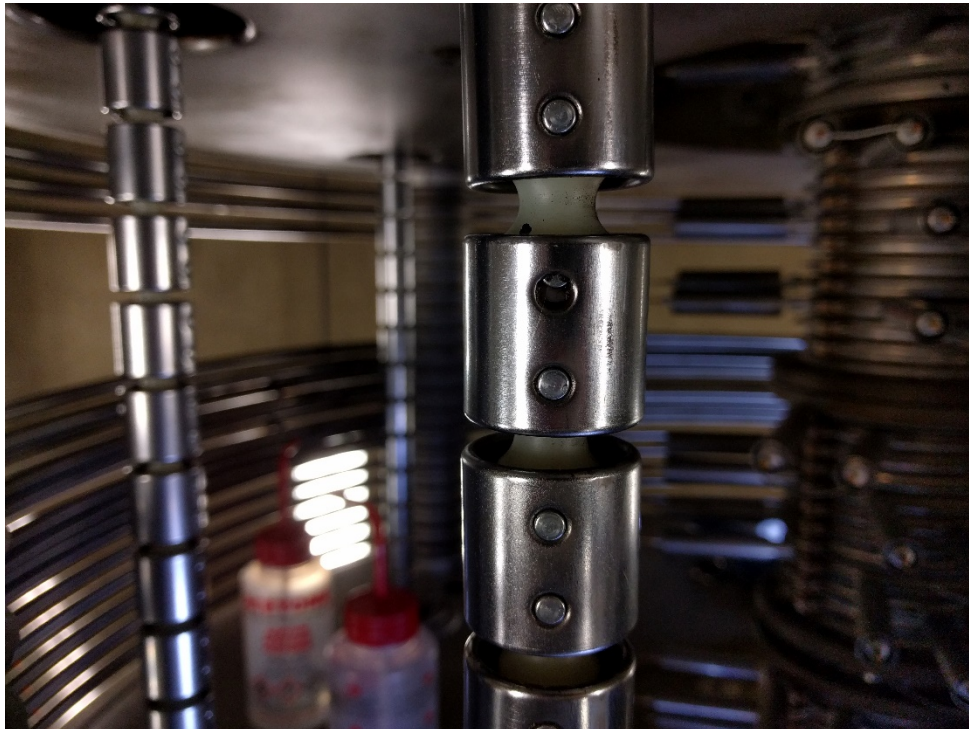
- Cleaned all chains with an acetone wipe down (using new Tiddox Micromax “blue” wipes)
- Found a rivet that had come loose in chain 3, meaning failure was imminent. See Figure 1. Chain 3 is the oldest chain, but still well within the expected lifetime at under 22000 hours. We removed the offending link and re-joined the chain. Also note that the leg clearance needs to be remeasured.
- Proceeded with cleaning and checking resistors etc in remaining units. Some resistor leads were replaced.
- Noticed a crack in gap 1 of unit 16 post B. In fact, there was a piece of ceramic missing. This will have to come out. It wasn't noticed earlier since it was covered by a terminal spinning.

Chain 3 is nominally in the prime of its life, with just under 22000 hours of spin time. However, as mentioned above and shown in Figure 1, we avoided another trip into the tank before Christmas by catching a loose riveted connection. Chain is older than the other two and does show more lip-to-lip spark damage.

*Figure 1 Loose rivet on chain 3*

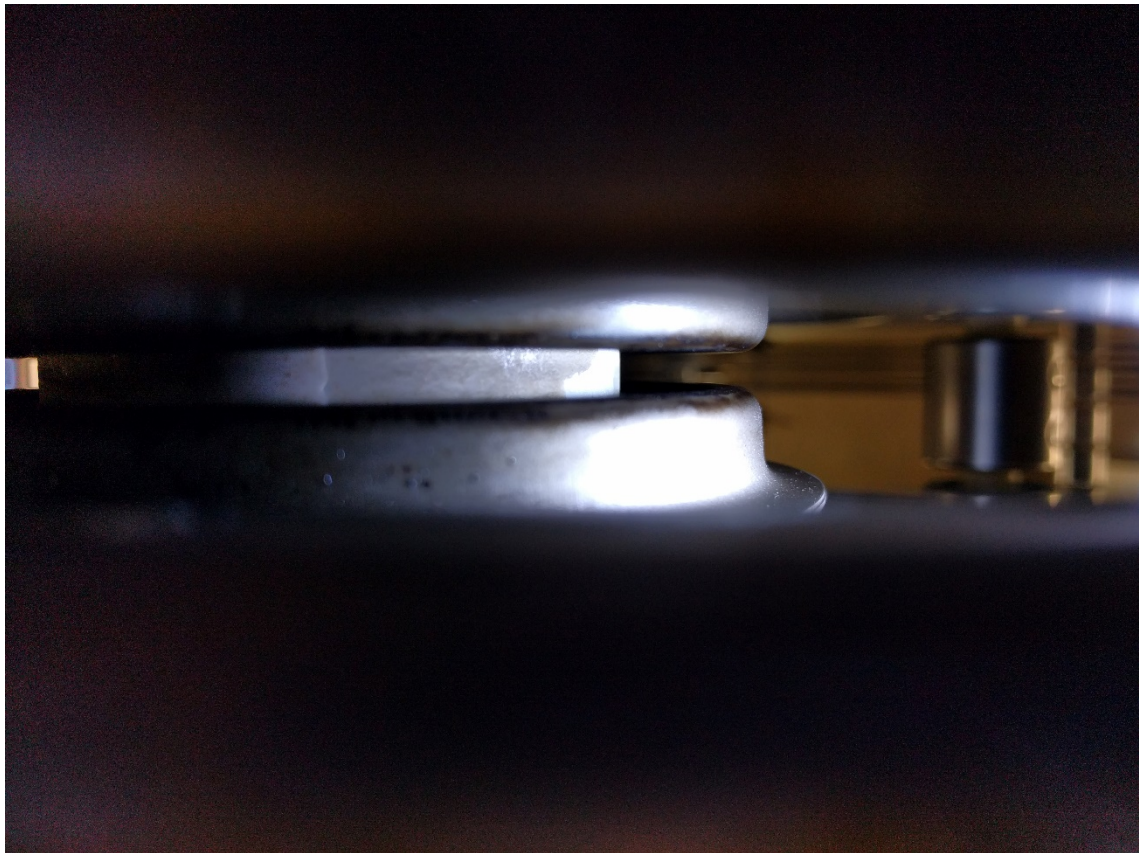
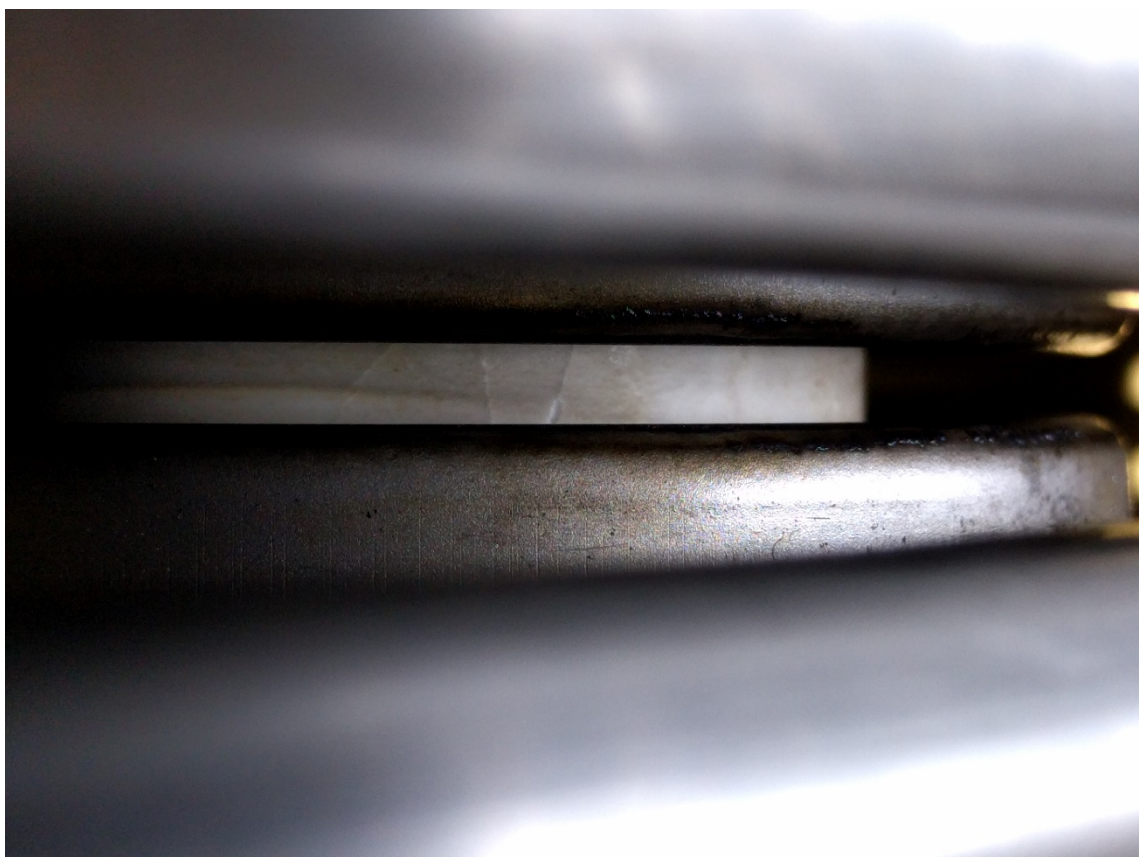
*Figure 2 Unit 16 post B gap 1 cracks in ceramic*

- Removed post #1808 in unit 16 position B and replaced with refurbished and tested post #282.
- Re-ringed all units, replacing ring screws where necessary.

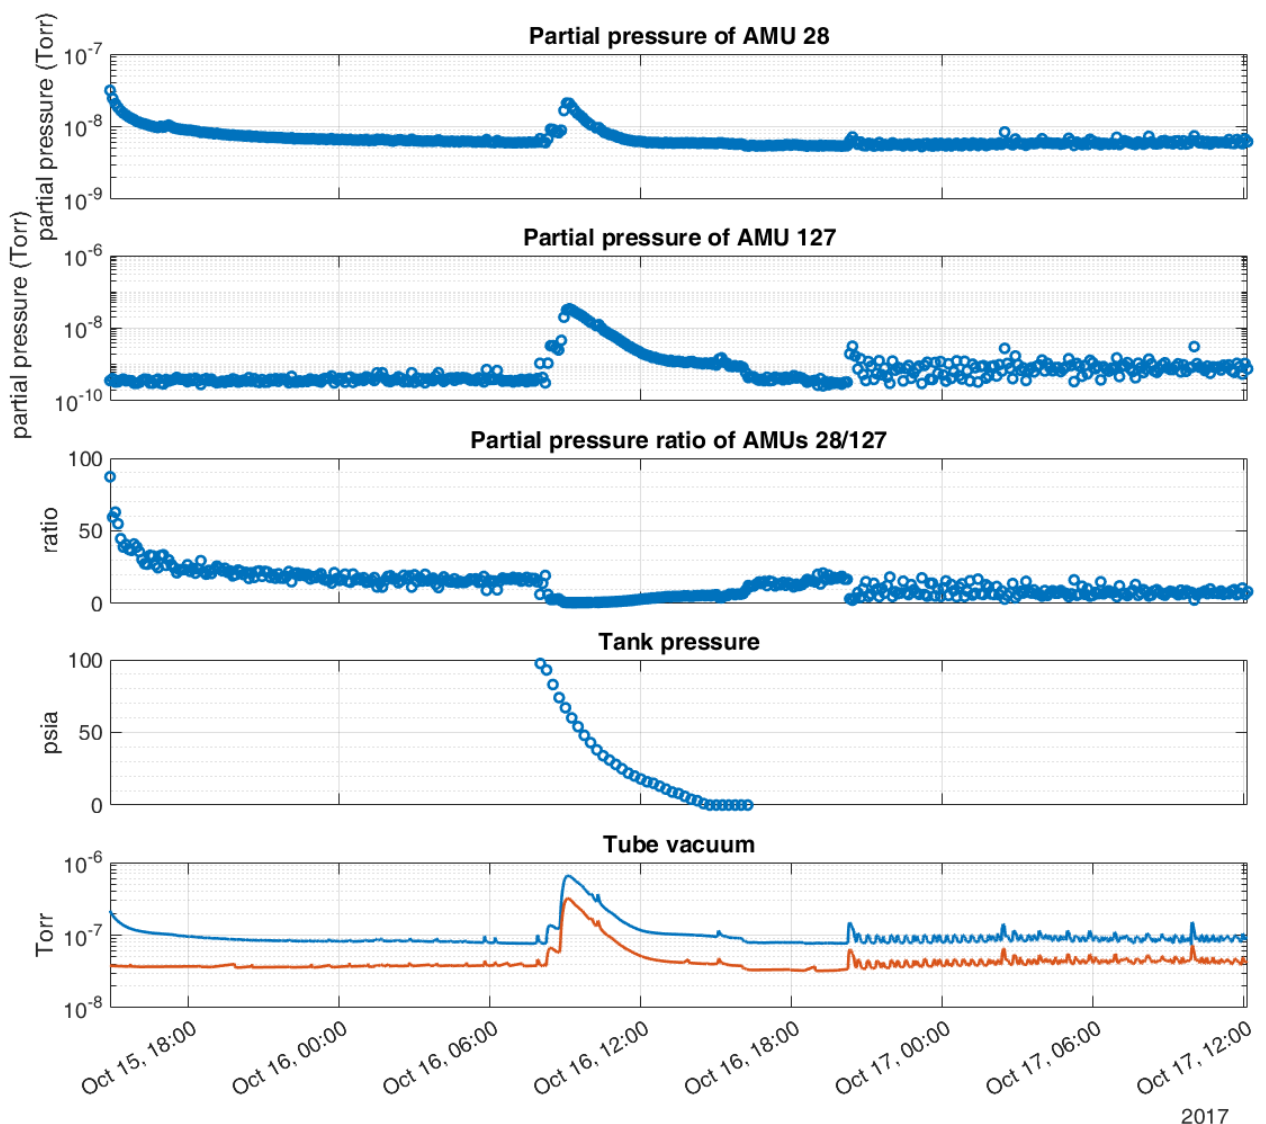
There has been some question about SF<sub>6</sub> ingress into the acceleration tube. There have been temporal examinations of SF<sub>6</sub> levels before, but this time we managed to scan across an entire pump/gas out procedure. We did not like what we saw. The scan showed a sudden increase in tube vacuum, with an increase in the relative level of SF<sub>6</sub>, sometime on the morning of the 16<sup>th</sup> October just after pump out had begun. The SF<sub>6</sub> level did not disappear after few weeks with no SF<sub>6</sub> in the tank. This is consistent with observations during previous tank openings.

Figure 3 RGA scan over pump/gas out at the start of the tank opening
