Australian
National
University

14 UD Tank Opening Report

#130

21st January – 1st April 2019

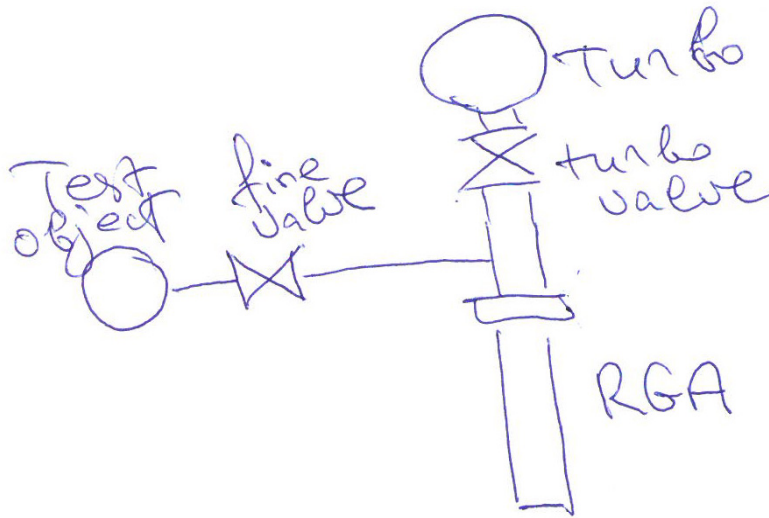
The sketch of setup is shown in Figure 1. It was discovered that RGA was not tuned properly to measure SF₆. SF₆ gas supplied from the recovery system SF₆ bag and cylinder showed no traces of SF₆ detected on the RGA. This explains why no SF₆ was measured at the high energy end of the 14UD during tank opening 129.

The RGA was tuned to He according to the manual and to SF₆ (peak 127) by increasing to maximum width and shifting the peak position. Unfortunately this tune affected the correct position of medium masses (Ar, O, N). Nevertheless the detection of SF₆ was good. This

Figure 1 Sketch of setup used to test for presence of SF_6 in the gas stripper N_2 cylinder using an RGA.

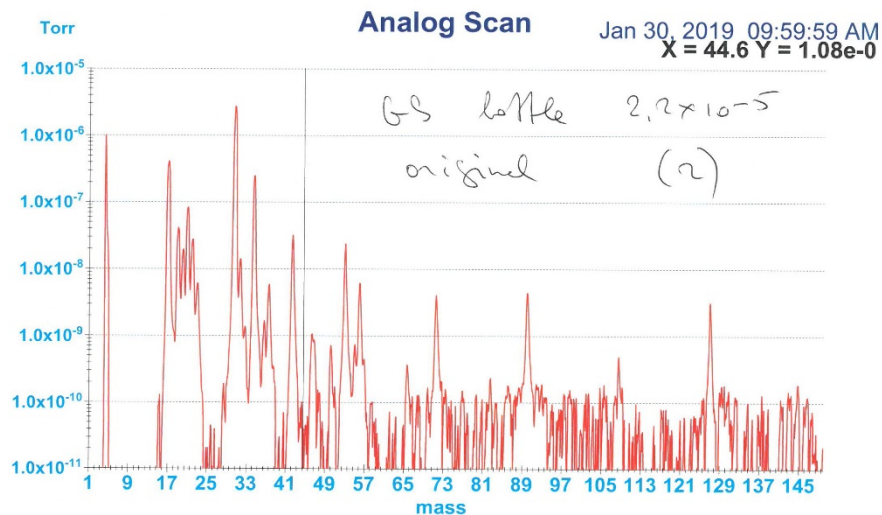
There were suspicions that SF₆ was somehow entering the gas stripper N₂ gas cylinder. Whilst the cylinder was removed from the 14UD, RGA scans were performed to check this idea and to test how many pump purge cycles were required to completely remove the SF₆.

With the retuned RGA, it was confirmed that there was SF_6 in the cylinder, as shown in the trace in Figure 2. The SF_6 trace did not disappear after 1 cycle of pumping to 40 micron and backfill with gaseous N_2 , as shown in Figure 3. After 3 more pump purge cycles, the SF_6 trace disappears from the RGA trace and was not detected with halogen detector, as shown in Figure 4.

Figure 2 First RGA scan shown presence of SF_6 in N_2 gas cylinder.

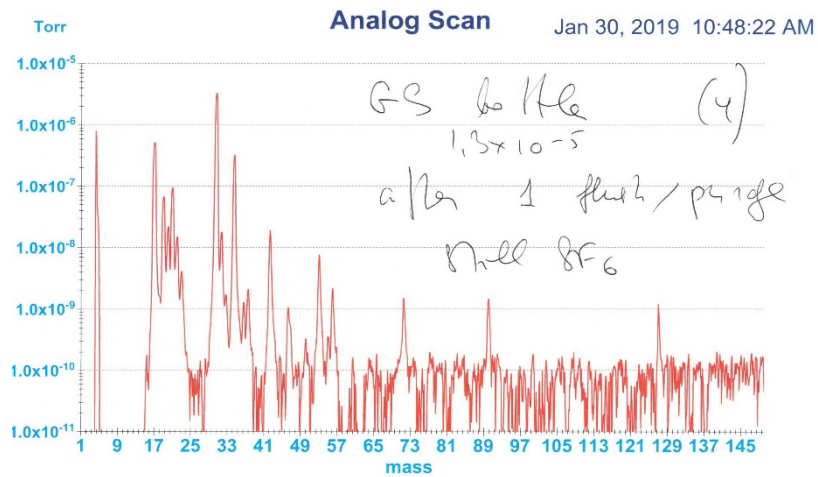
Figure 3 Second RGA scan shown presence of SF₆ in N₂ gas cylinder even after a pump purge cycle down to 40 micron and backfilled with gaseous N₂.

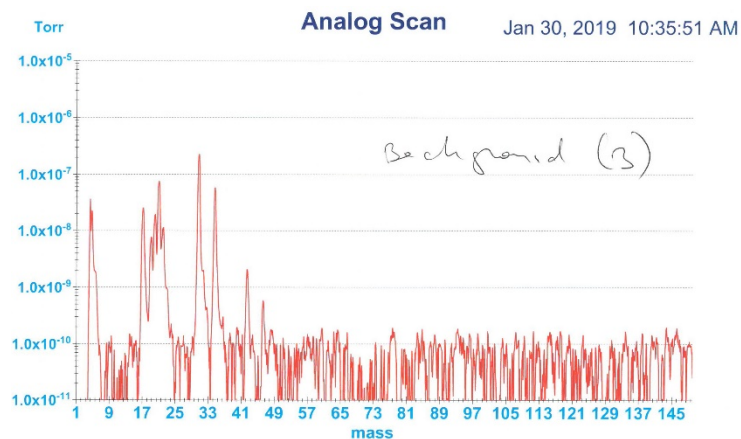
Figure 4 Final RGA scan showing no presence of SF₆ in N₂ gas cylinder after three pump purge cycles.

Hence, three pump purge cycles are sufficient. Both the RGA and halogen detector seem to produce similar conclusions.

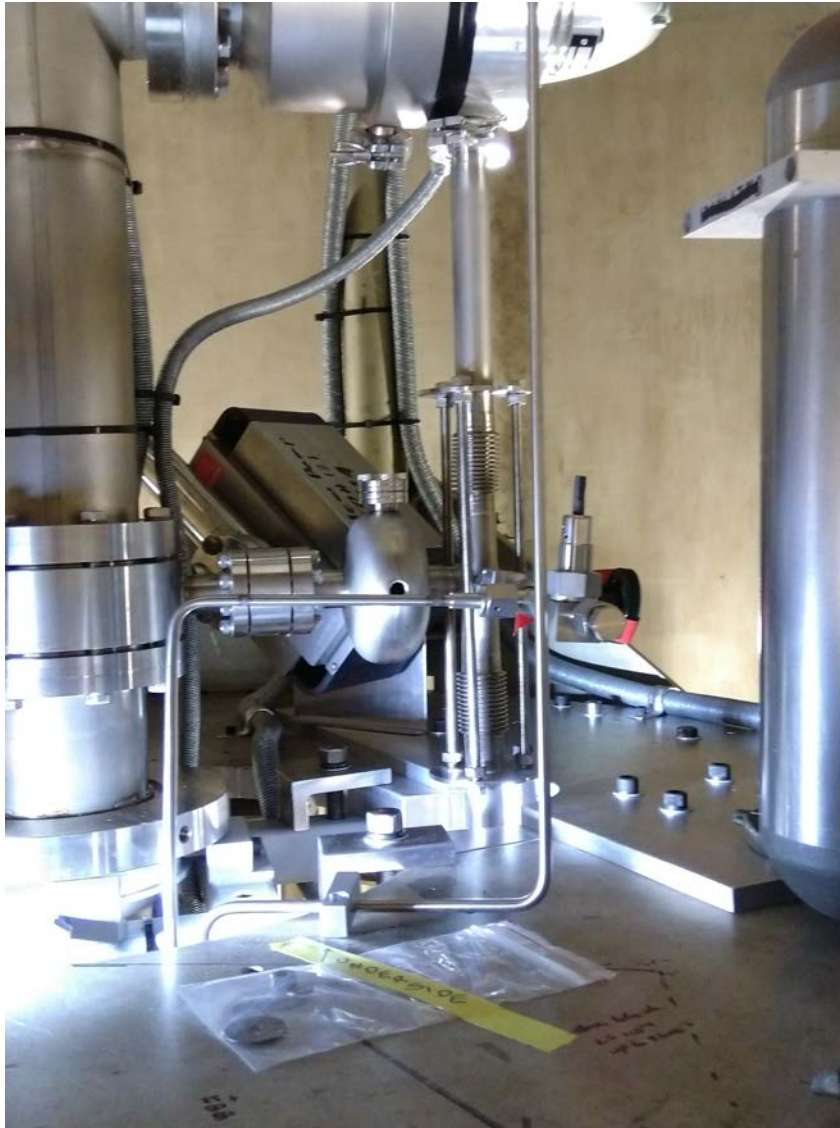
- Attempted to fit the new NEC gas stripper backing manifold and found that the tee section that is meant to connect to the acceleration tube is about 1 inch too short. The upside was that the mistake was not ours and the manifold was simply not made according to the dimensions on the approved drawing.
- Brent is making a 1 inch "extension" piece to bridge the gap.
- Aside from that, all preparations were made to be ready to pump down the acceleration tube.

The other challenge was the supplied manifold was not consistent with the approved drawing, with the tee section that connects to the accelerator tube being 1 inch too short. Hence, a stainless steel extension piece had to be fabricated.

Figure 5 New gas stripper backing manifold with slot cut in terminal plate and extension piece to connect to the acceleration tube.

Installation of the new manifold required a hole to be cut into a plate in the terminal. After a number of days of discussing how this should be done, it was removed from the machine and the hole/slot machined in the workshop. Removal of the plate required the use of trigger clamps to slowly push the plate out.

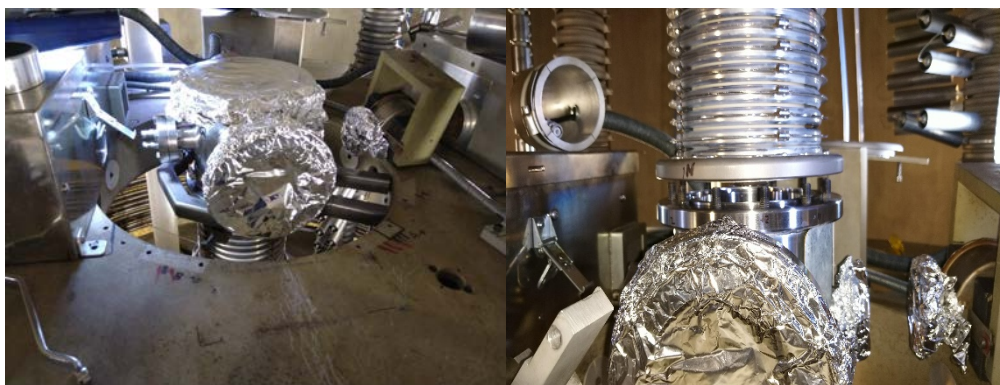
The new high energy stripper was designed to reduce (and hopefully eliminate) loading caused by electron backstreaming, which was reducing the maximum terminal voltage of the accelerator. The first and biggest change was made to the aperture and bias arrangement. The existing stripper had a small (12.7mm) top aperture which was negatively biased, encouraging backstreaming when the beam hit it. The new stripper had a larger top aperture (25.4mm) which allowed the beam to go through to the second smaller aperture (12.7mm) and any secondary electrons were suppressed by the -ve bias on the larger top aperture. Secondly a change was made to the magnet. The existing magnet measured ~60G on axis, down from the nominal designed strength of 100G. After some initial trouble with re-magnetising the existing magnet, a new magnet (of slightly different geometry) with a strength of 150G on axis was fitted. The third change was a foil catcher, a disc at the bottom of the stripper designed to stop any broken foils from entering the tube below and again becoming a source for secondary electrons. Finally, the new stripper has a fresh housing and all new apertures to eliminate contaminated/activated surfaces.

Figure 6 Installation of the new high energy stripper assembly

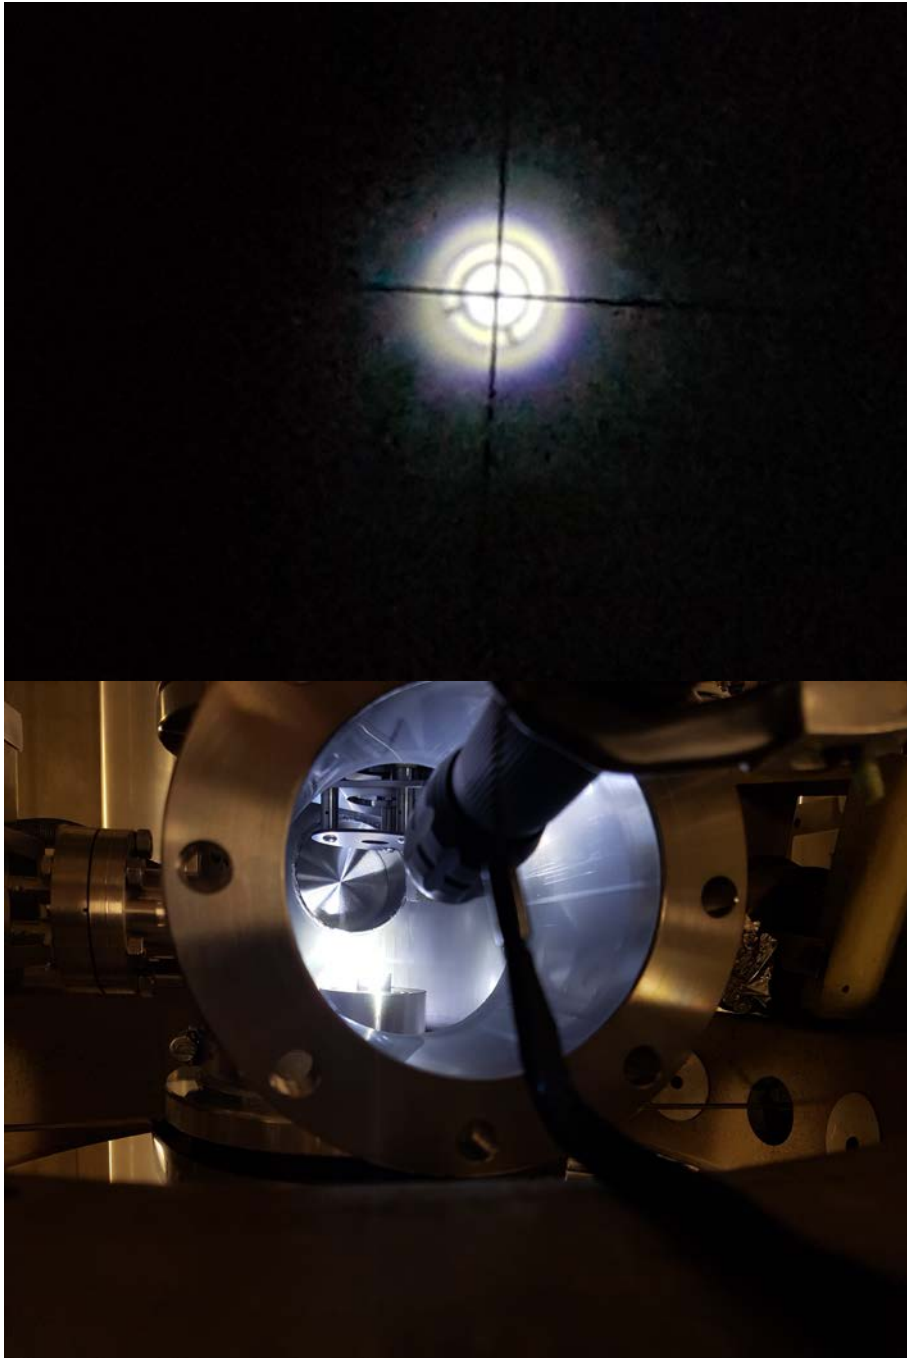
Figure 7 Alignment of the new high energy stripper assembly.

Alignment was achieved by tweaking the spokes that are attached to the top flange of the acceleration tube below the stripper assembly

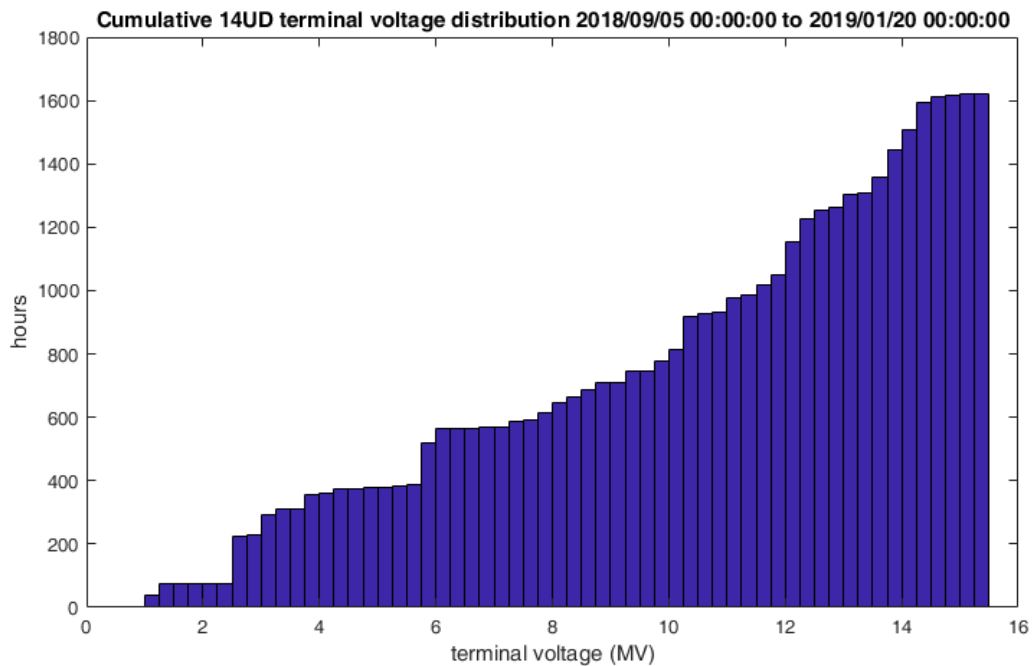
Figure 8 Cumulative terminal voltage distribution for period of operation from the end of tank opening 129 to the start of tank opening 130 (including any time spent conditioning the machine)

The total hours with voltage on the terminal was 1617 hrs, which gives a utilization of 49% assuming a twenty-four hour, seven-day maximum.

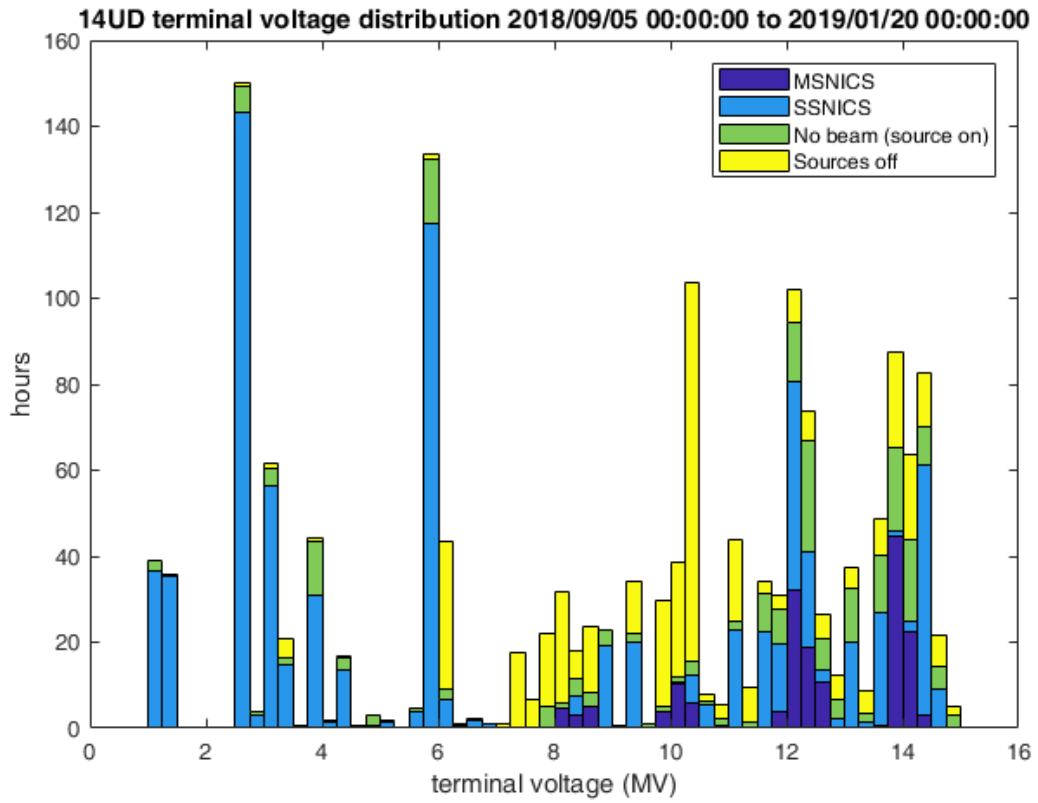
Figure 9 Terminal voltage distribution for period of operation from the end of tank opening 129 to the start of tank opening 130 with breakdown in type of usage.
