Australian  
National  
University

# 14 UD Tank Opening Report

## #131

23<sup>rd</sup> May – 20<sup>th</sup> of June 2019

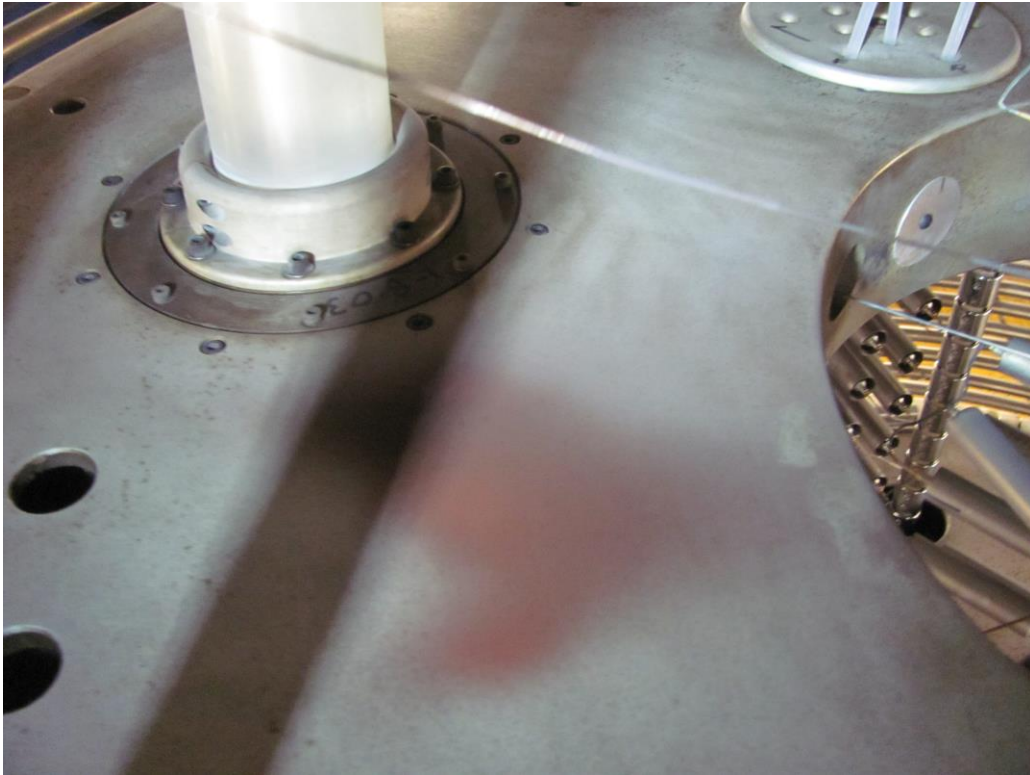
- Continued testing with Megger
- U20 T1 G2 resistor lead broke when removing for testing and was retrieved from U28
- RGA SF6 tests were done (see section 4 *RGA tests for SF6* for details)
- Checked for HE shaft noise reported in the mechanical tests. A cyclic harmonic noise was noticed somewhere around, perhaps inside the terminal. It was not a bearing. No action was deemed necessary.
- U21 T2 was retested and found to be good
  - G8 6.7TΩ gap and 595MΩ resistors
  - G9 9.5TΩ gap and 600MΩ resistors
  - G10 4.6TΩ gap and 602MΩ resistors
- U21 post D should be replaced due to the burnt electrode/spark gap
- Ball ended resistor lead in U19 needs replacing
- U20 stringer was reattached and U21 stringer was replaced
- Noticed a red spray deposit on the casting under the stringer

Figure 1 Residue under loose stringer

- Red deposit was cleaned up with Alcohol and Kimwipes
- Found a shorting rod contact housing was loose in U20 and evidence of sparking underneath. Housing, spring, mesh, and screws were replaced with new items

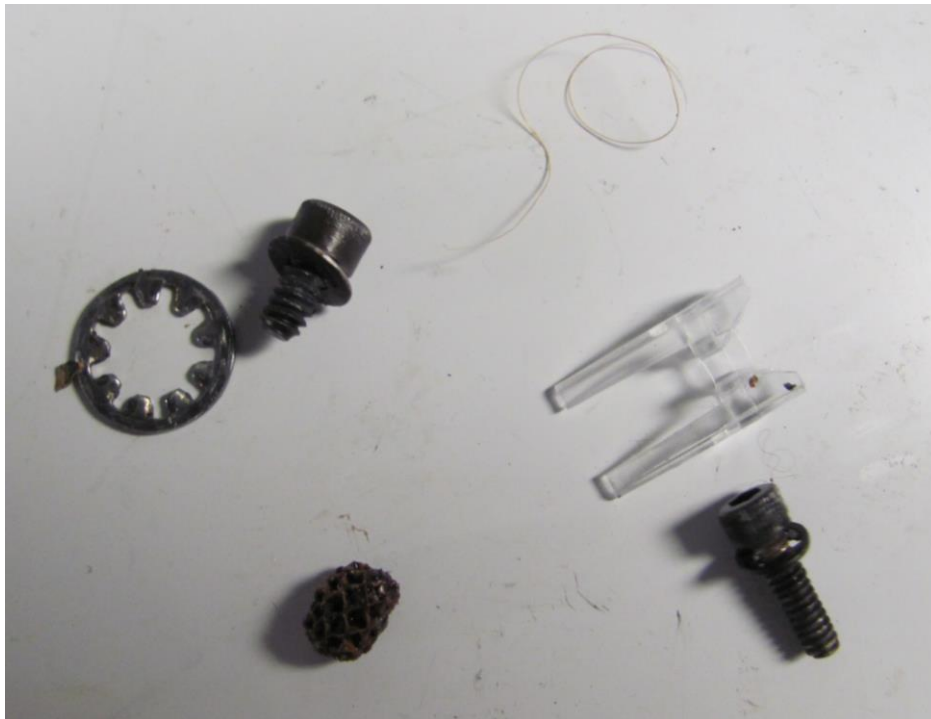
- Searched the bottom of the tank and found:
  - Missing screw and washer from U20 stringer
  - A small pine cone
  - A screw and internal star washer as used in some stringer connections and U19 shorting loops

- Large (5/16"?) internal star washer
  - Broken piece of Ethernet connector
  - 1x Orange hair, possibly pubic

Figure 2 Things found in the bottom of the tank

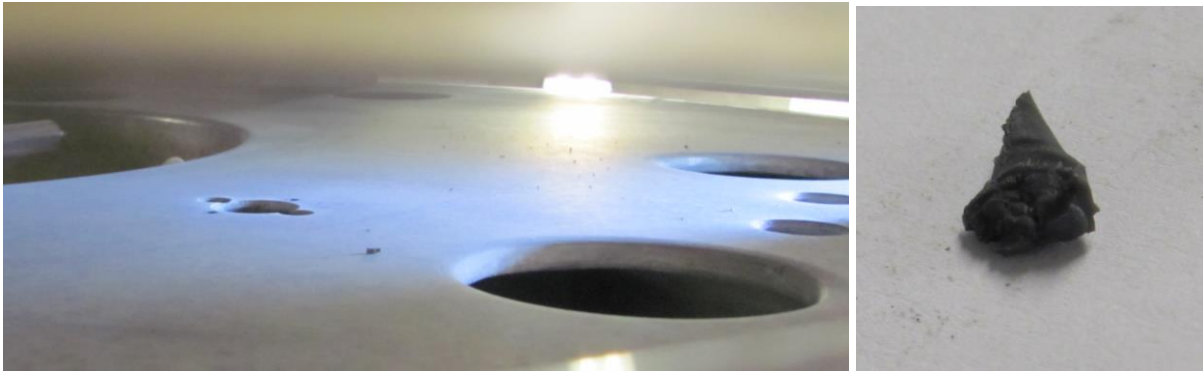
- Found debris on casting in U1, what looked like small hard pieces of plastic.

Figure 3 Debris on casting U1

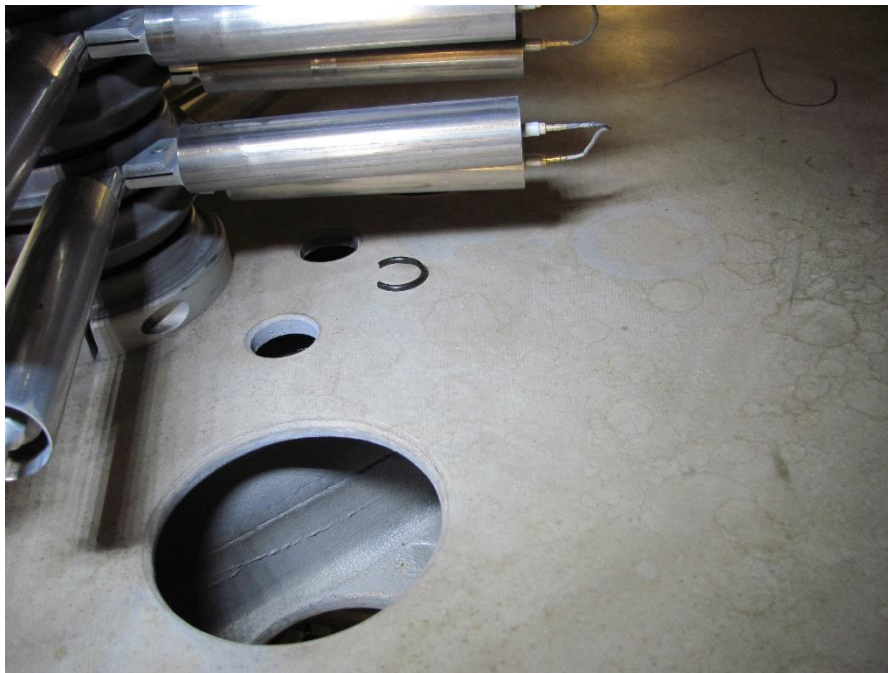
- Found an o-ring on the casting of U2. Its origin is unknown, its cross section is not consistent with the o-rings from the shorting rod clutch.

Figure 4 O-ring piece on casting U2

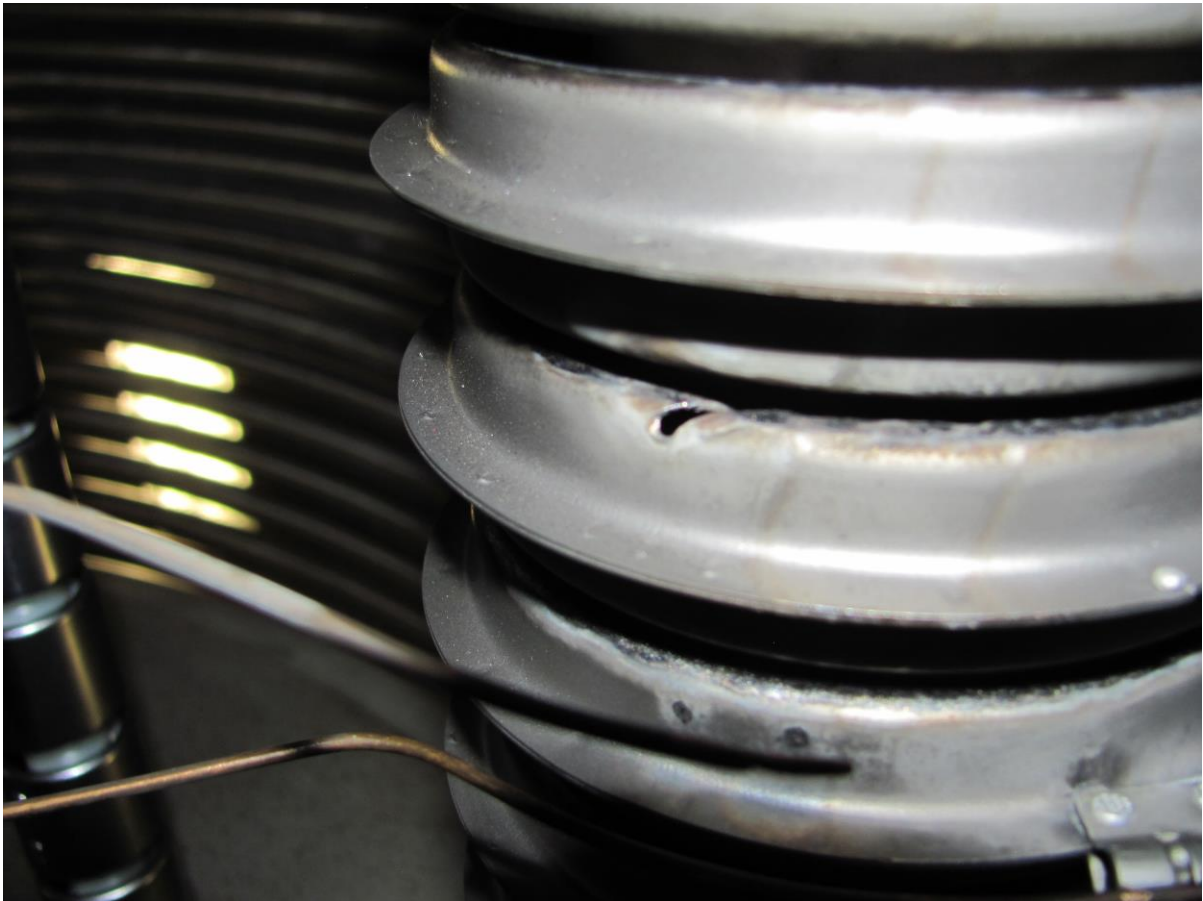
Figure 5 U21 post C damaged by loose stringer

- Swapped out U21 Post C which was damaged by the loose stringer. Serial #307 was removed and #2712 was installed in its place.

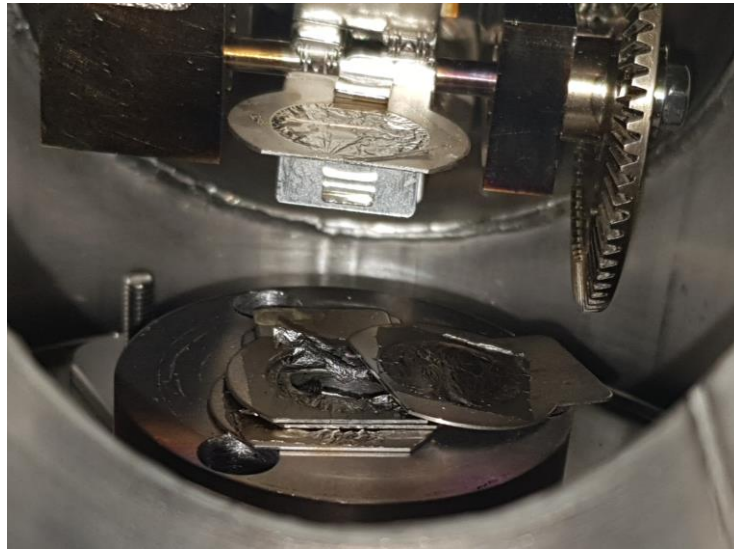
- Opened the terminal to access the Weisser valve. Two spinnings down, the top was left in place.
- Weisser valve was closed and the HE tube was let up to Nitrogen according to normal procedures.
- Removed the HE stripper port blank to view the foil changer. There were three foils found on top of the lower aperture, and 3 more on the foil catcher.

Figure 6 Foils obscuring aperture in HE stripper

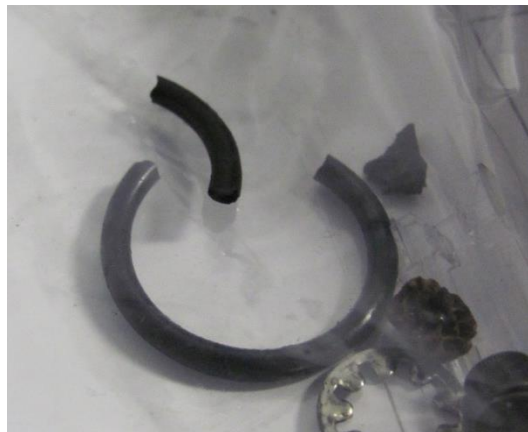
- Checked the stripper modifications by bolting up the foil mechanism on the bench and running through some foil changes. It all looked good.
- The HE tube section was let up to Nitrogen and the cap removed
- In order to maintain alignment, the spokes on the top of the tube in U19 were released by loosening the hose clamp band. The tube alignment jig was used to align the tube, spacer, and stripper and it was bolted up.
- The studs/nuts were torqued in stages of 5, 7, 9, and 10Nm tightening two at a time on opposite sides.
- The top flange of the stripper was capped again and the section was pumped for the long weekend.
- The source of the o-ring on the U2 casting was investigated. The missing piece of the o-ring was found inside the shorting rod 'standpipe'. The pipe was removed and we found a groove in the pressed Nylon piece in the flange that was missing an o-ring.

Figure 8 Found o-ring parts

- Refitted the LE standpipe. The missing o-ring was left out as it was determined that it did not perform any specific function.
- Cleaned and performed checks on U1.
- Found a loose shorting rod contact housing on U1. The housing was very difficult to remove as it was located inside the casting. Looking at the location of other shorting rod contacts, there does not seem to any consistency as to their position inside or outside the casting. Our theory is that the housings were all originally inside the casting but as they were replaced with newer radiussed housings they were placed on the outside as it is much more convenient to work on.
- Four shorting rods were installed in the LE end to check the function and position of the shorting rods. It all looked good with the rod joints located in the middle of the castings when the system was in the parked position.

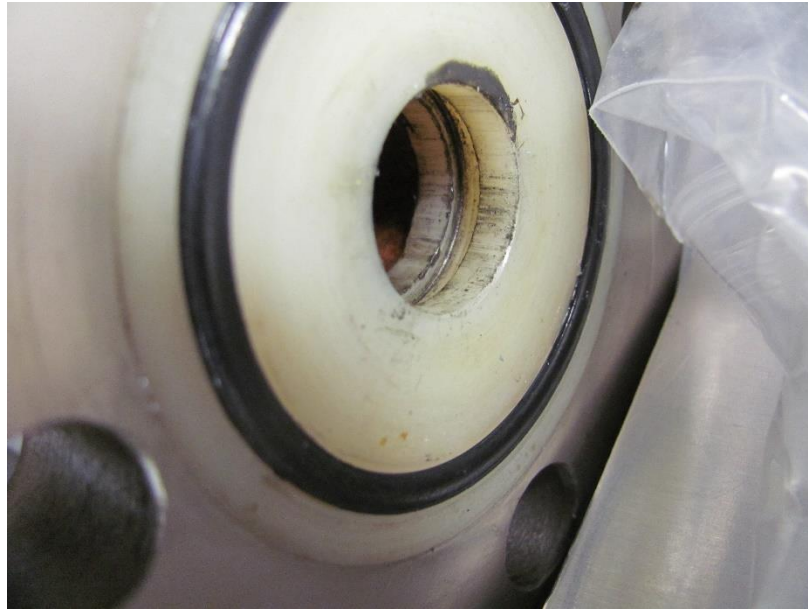
Figure 9 Location of missing o-ring

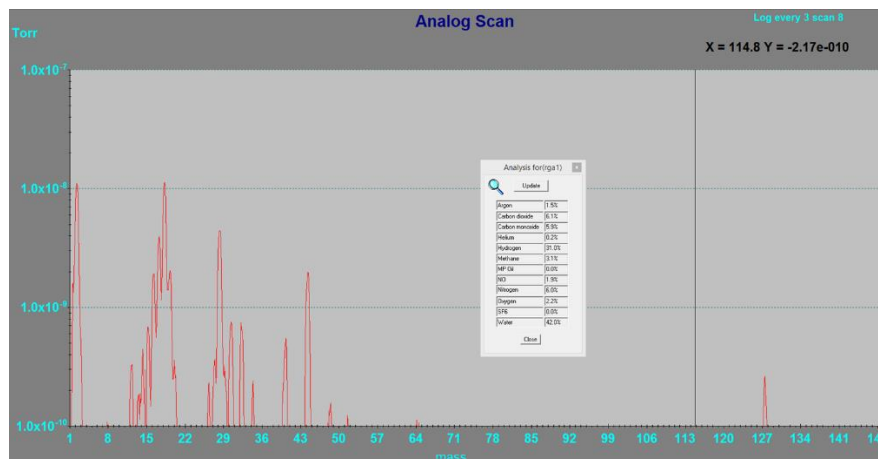
Figure 10 RGA scan 4<sup>th</sup> of July 2019

The spectrum was obtained in Figure 10 is after 5 minutes with all ion pumps off. The spectrum is dominated by a water as expected. The amplitude of peak mass 127 (SF<sub>6</sub>) is  $2 \times 10^{-10}$ . The water peak with mass 28 is  $10^{-8}$ .

Obviously, the SF<sub>6</sub> leak is still present in the 14UD. More likely, it is in the gas stripper plumbing because it was not affected by operation of the lower ion pumps as described above. We will continue the evaluation of possible leaks including turbo pumps and other fittings in the gas stripper plumbing. The good news is that the level of this leak is not significant enough to compromise the operation of the gas stripper or cause significant deconditioning of 14UD.

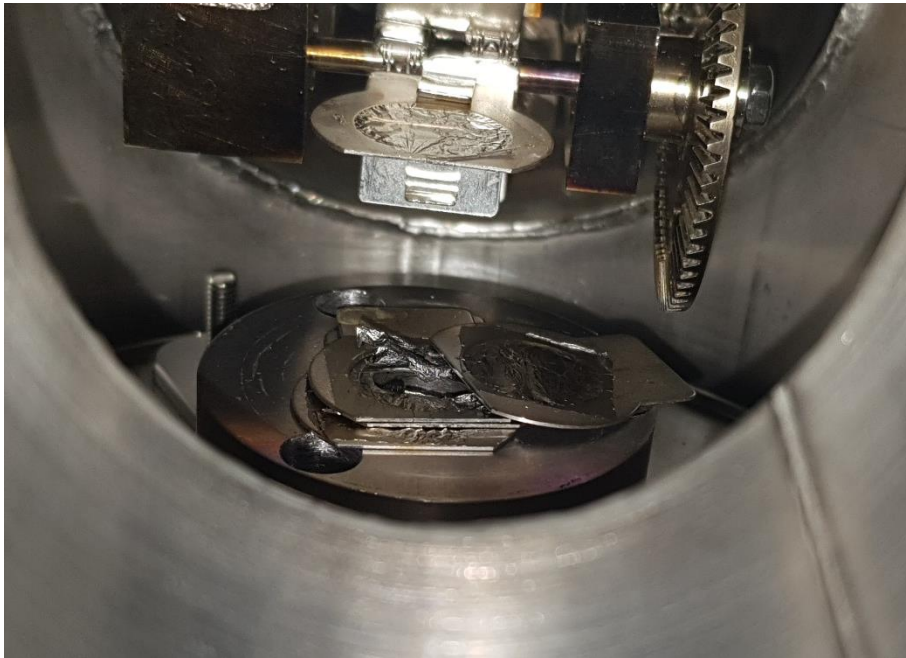
When it was diagnosed that the beam was stopping in the HE mid section, it was theorised that perhaps a foil had dislodged and was blocking it. On inspection, it was found that several foils had fallen onto and around the Tantalum aperture below. Operating the foil drive mechanism showed the frames would strike the lower aperture and dislodge. Investigation showed that the lower aperture was ~9.5mm closer to the foil mechanism than on the old stripper.

Figure 11 View showing the dislodged foil frames on top of the lower aperture

There were two sources of this error. Firstly, the standoffs holding the support for the lower aperture were ~7mm higher than in the old unit, and secondly the foil attachment nipple was ~2.5mm lower than the old unit. The height of the standoffs was correct to the original NEC drawings however it appears that due to an interference with the casting, the stripper was angled when originally installed in the 14UD. This angle required the lowering of the standoffs, but this was not recorded. New standoffs were made 9mm shorter to address both the aperture and nipple height discrepancies. A dry run with the foil mechanism on the bench proved the new arrangement worked.

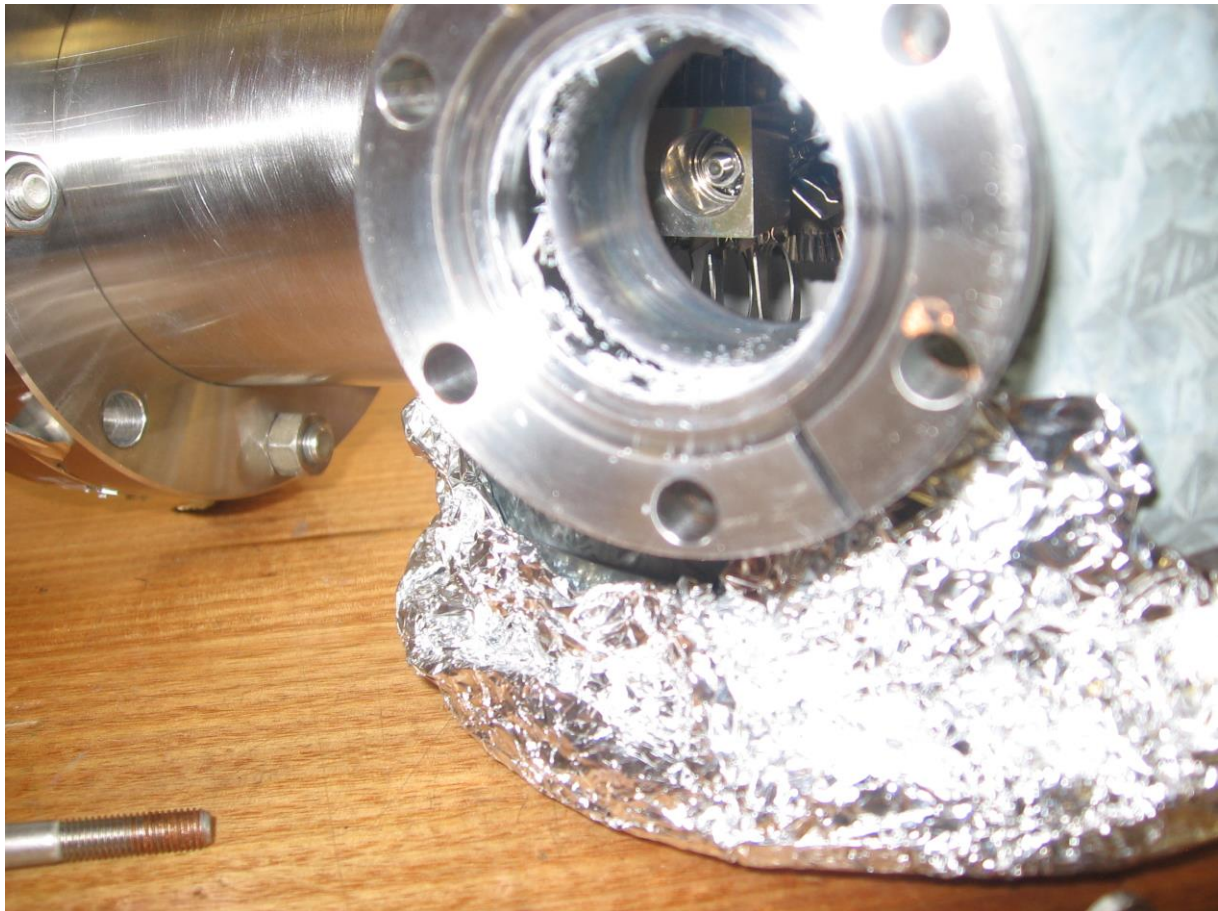
It was decided to replace the HE mid section ion pump as the vacuum in the rest of the machined got slightly worse when it was turned on. The pump was removed with the HE stripper, and a strange, white, furriness was noticed on both the pump and port side of the flanges. The reason for this is unknown, but the stripper housing was cleaned in preparation for a new pump. It's worth noting that this was the new stripper housing that had only been installed in the last tank opening, so the deposit only had ~1100 hours to develop.

Figure 14 HE stripper pump port after old pump removal

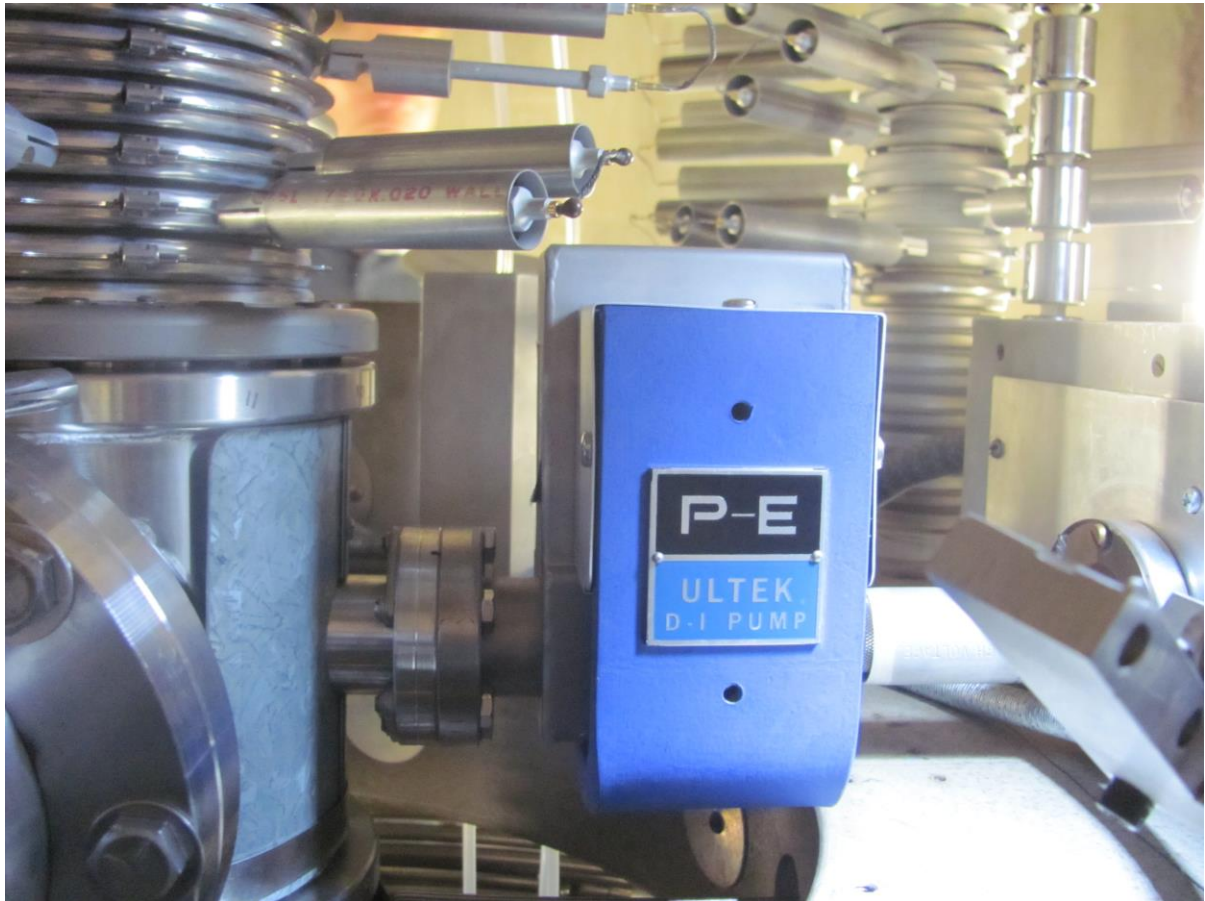
Figure 15 New HE stripper ion pump

A new pump of similar size and form was ordered from Duniway in the USA, however mixups with purchasing meant it would not arrive in time to fit during this tank opening. A pump was located on the old LINAC return line which is no longer used. The history of this pump was not fully known, it was likely to have come across with the Daresbury LINAC parts, but it looked in good condition internally, despite its age (48 years according to the date written on it). The pump was installed on the stripper body, requiring the bottom resistor pair on the tube above be moved around to avoid interference.

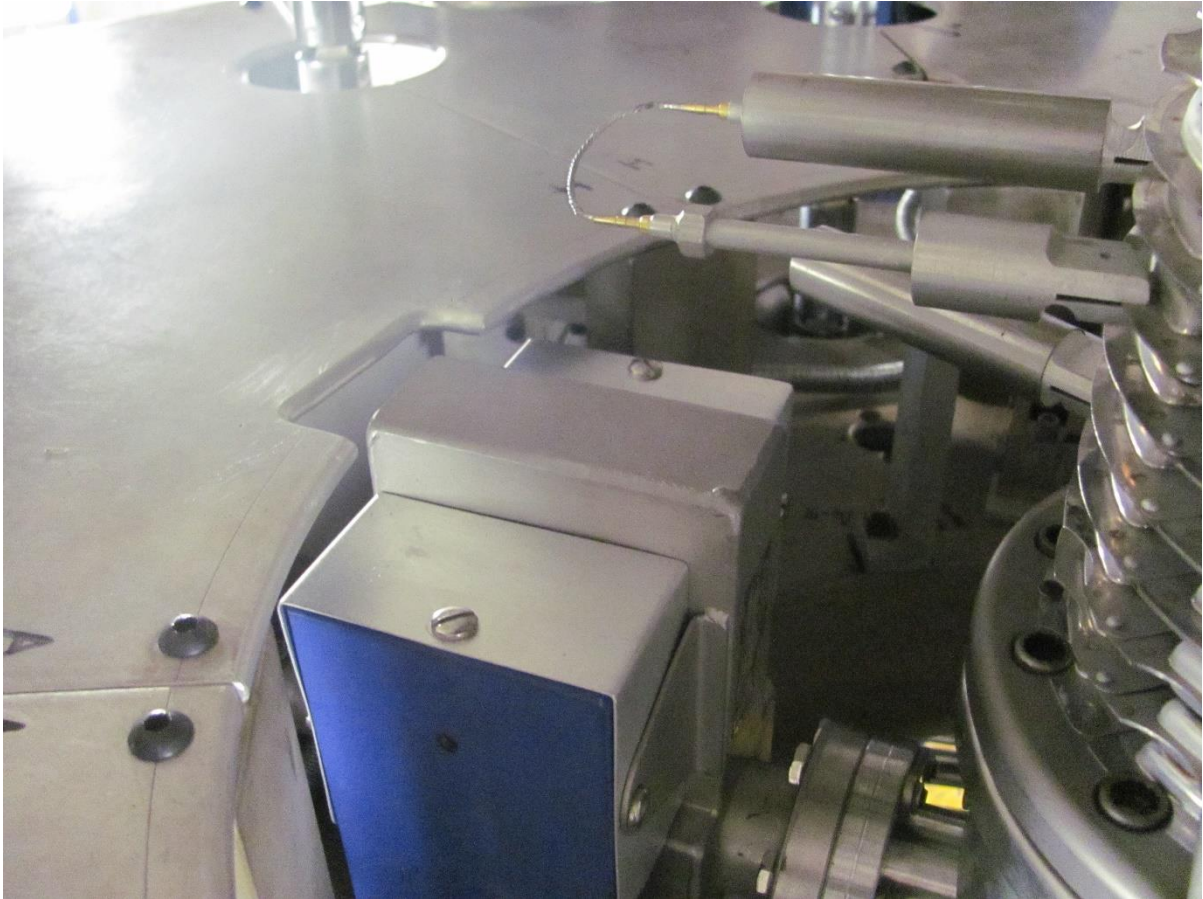
With the pump operational, the U19 deck was reassembled and a slight interference was noted between the top of the pump and the deck. A small cutout was machined into the deck piece to give clearance around the pump as shown in Figure 18. Figure 18 U19 deck cutout for new HE stripper ion pump.

Figure 18 U19 deck cutout for new HE stripper ion pump

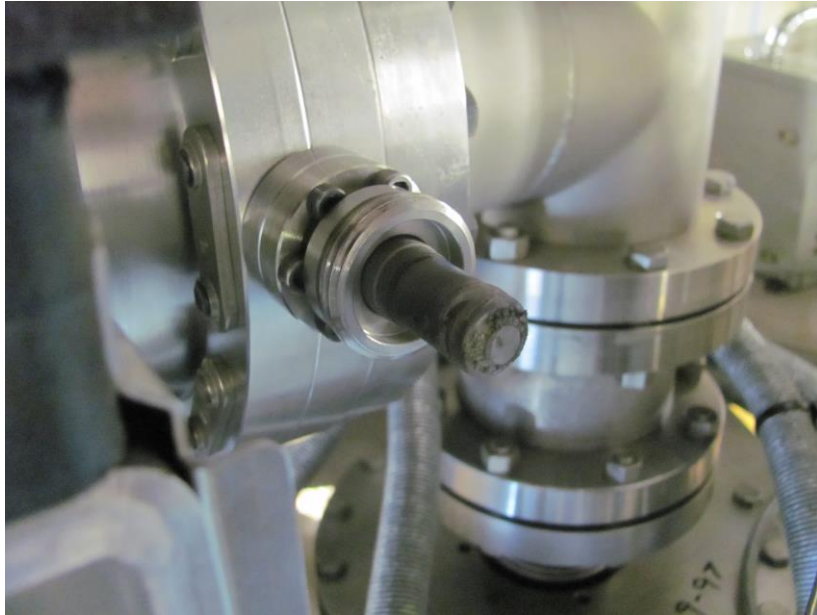
After opening the Weisser valve, the shafts were powered up to run the terminal ion pumps (60L/s LE, 20L/s, and 60L/s HE). With the pumps running, HE vacuum deteriorated to  $10^{-5}$  range, indicating a problem. Suspecting the HE pump could be the issue (since it was in the section that had been let up), it was unplugged. Unplugging revealed a very dirty, black, sooty connector and feedthrough indicating a lot of breakdown/sparking had been occurring. The powder from the connector was collected for later analysis and the components were cleaned up.

Figure 19 HE terminal ion pump feedthrough

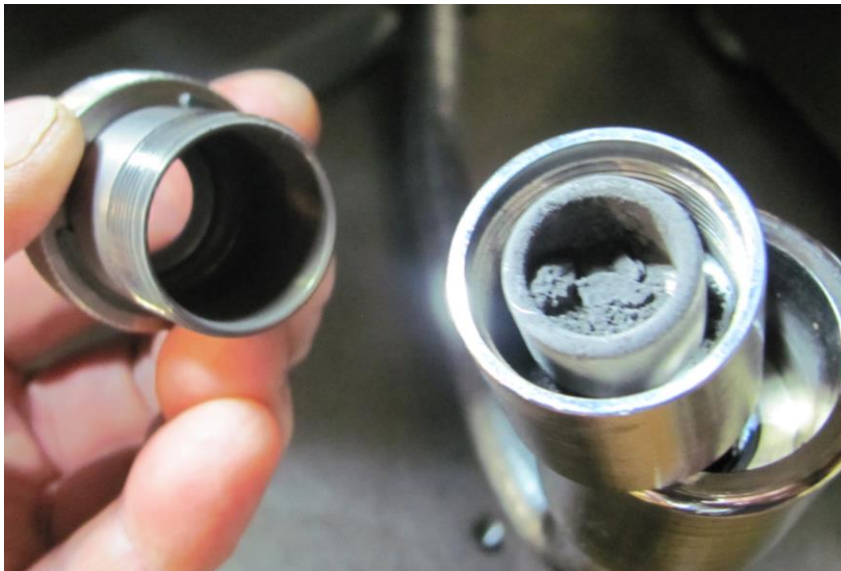
Figure 20 LE terminal ion pump connector
