Australian
National
University

14 UD Tank Opening Report

#134

27th April 2023 – 29th of May 2023

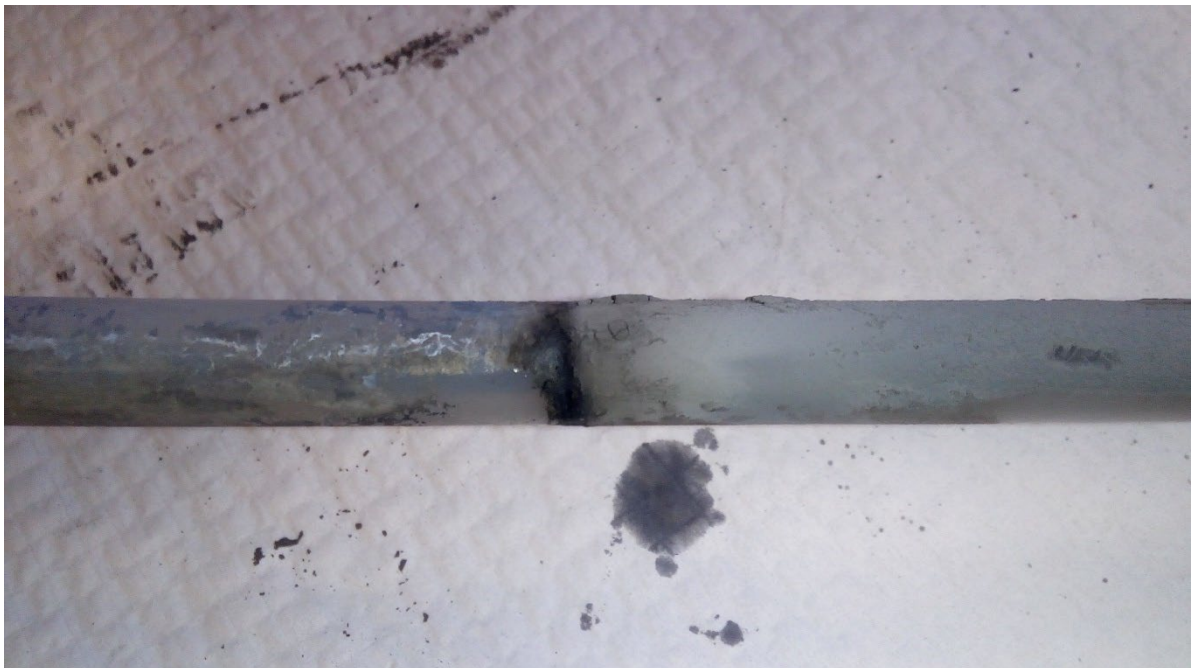
The 150kV low-energy beam focus was sparking above about 120kV. During the tank opening, the entire feed through assembly was removed and inspected. Silicon grease had been used

This grease was heavily blackened as can be seen in Figure 1 through Figure 3. Most of this cleaned off relatively easily but some evidence of damage and activity remained. Figure 4 shows spark marks on the “can” cover, suggesting the sparking was occurring through the grease and grounded on the can at the level where the nylon feed through ends.

Figure 1 150kV beam focus HV cable (air side) showing blackened grease

- Removing all grease
- Shortening the HV cable to remove any damaged length
- Cleaning the inner bore of the can cover
- Reaming the inner bore of the nylon feed through to remove surface damage (there was no evidence of damage in the bulk).
- Reinstalling *without any grease*

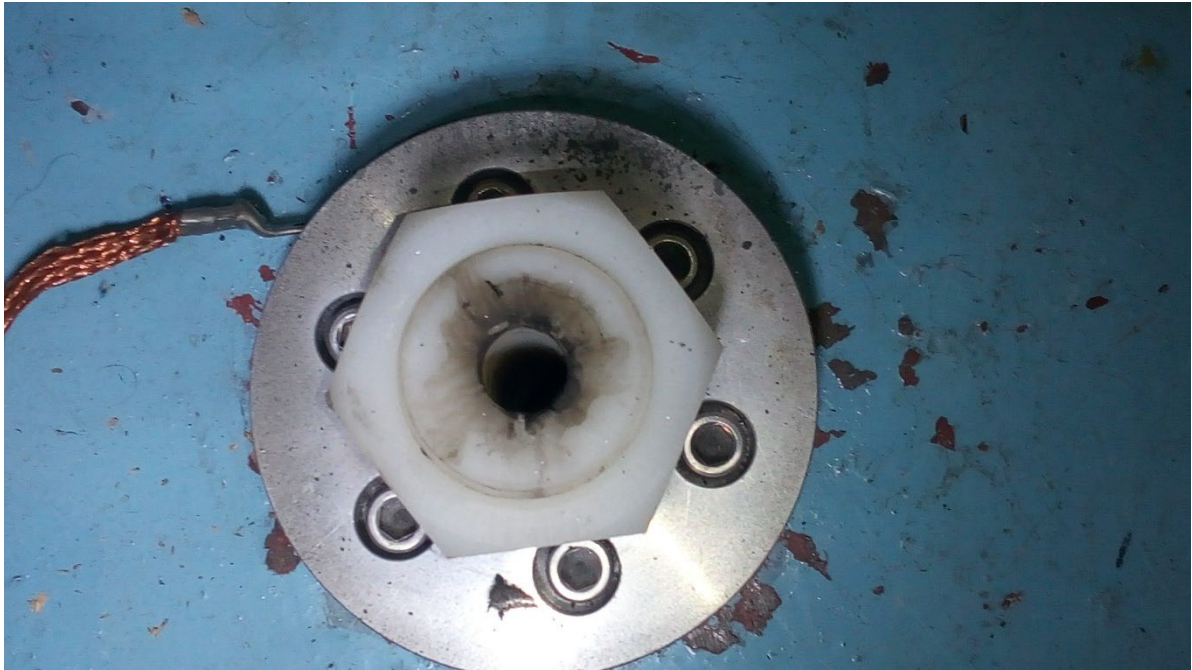
Figure 2 150kV beam focus nylon feed through (air side) showing blackened grease

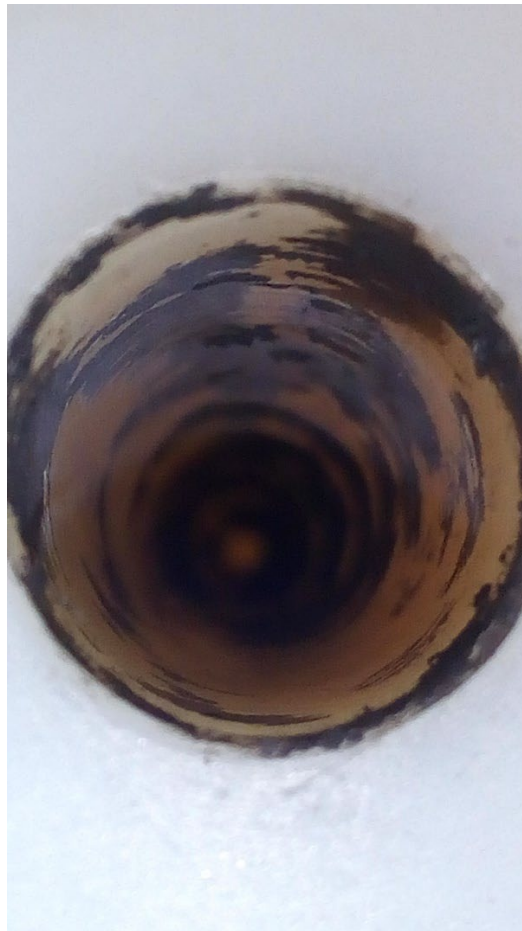
Figure 3 150kV beam focus nylon feed through HV cable (air side) showing blackened grease down bore

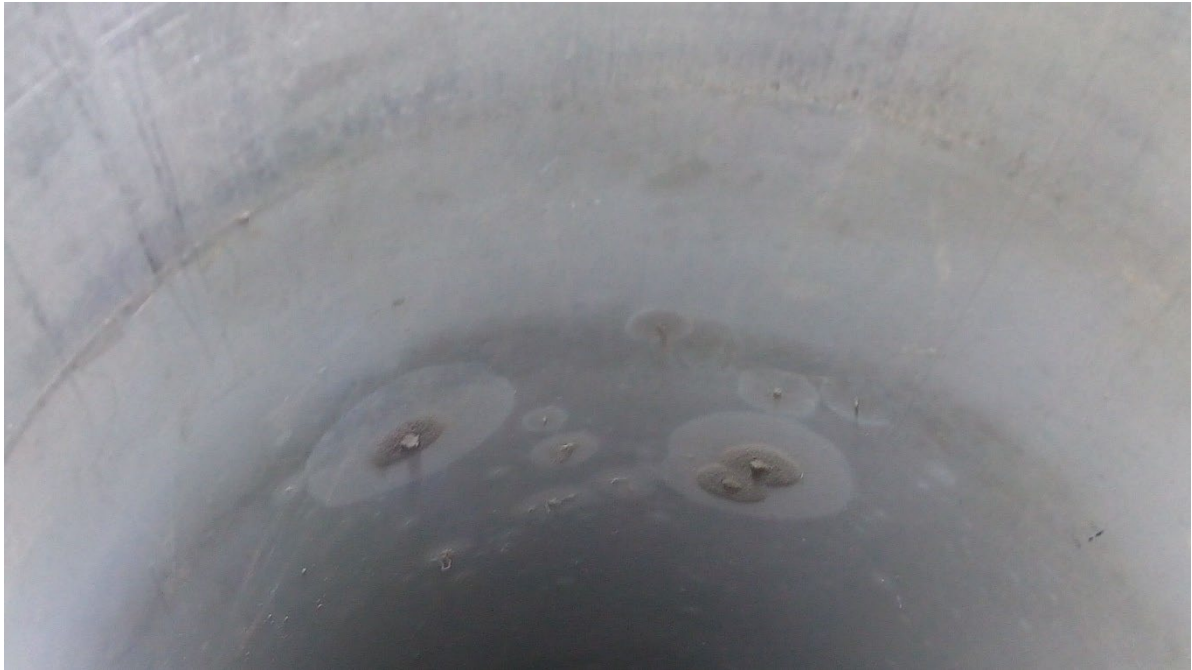
Figure 4 150kV beam focus cover “can” (air side) showing spark marks
