Australian
National
University

14 UD Tank Opening Report

#135

19th June 2023 – 30th of June 2023

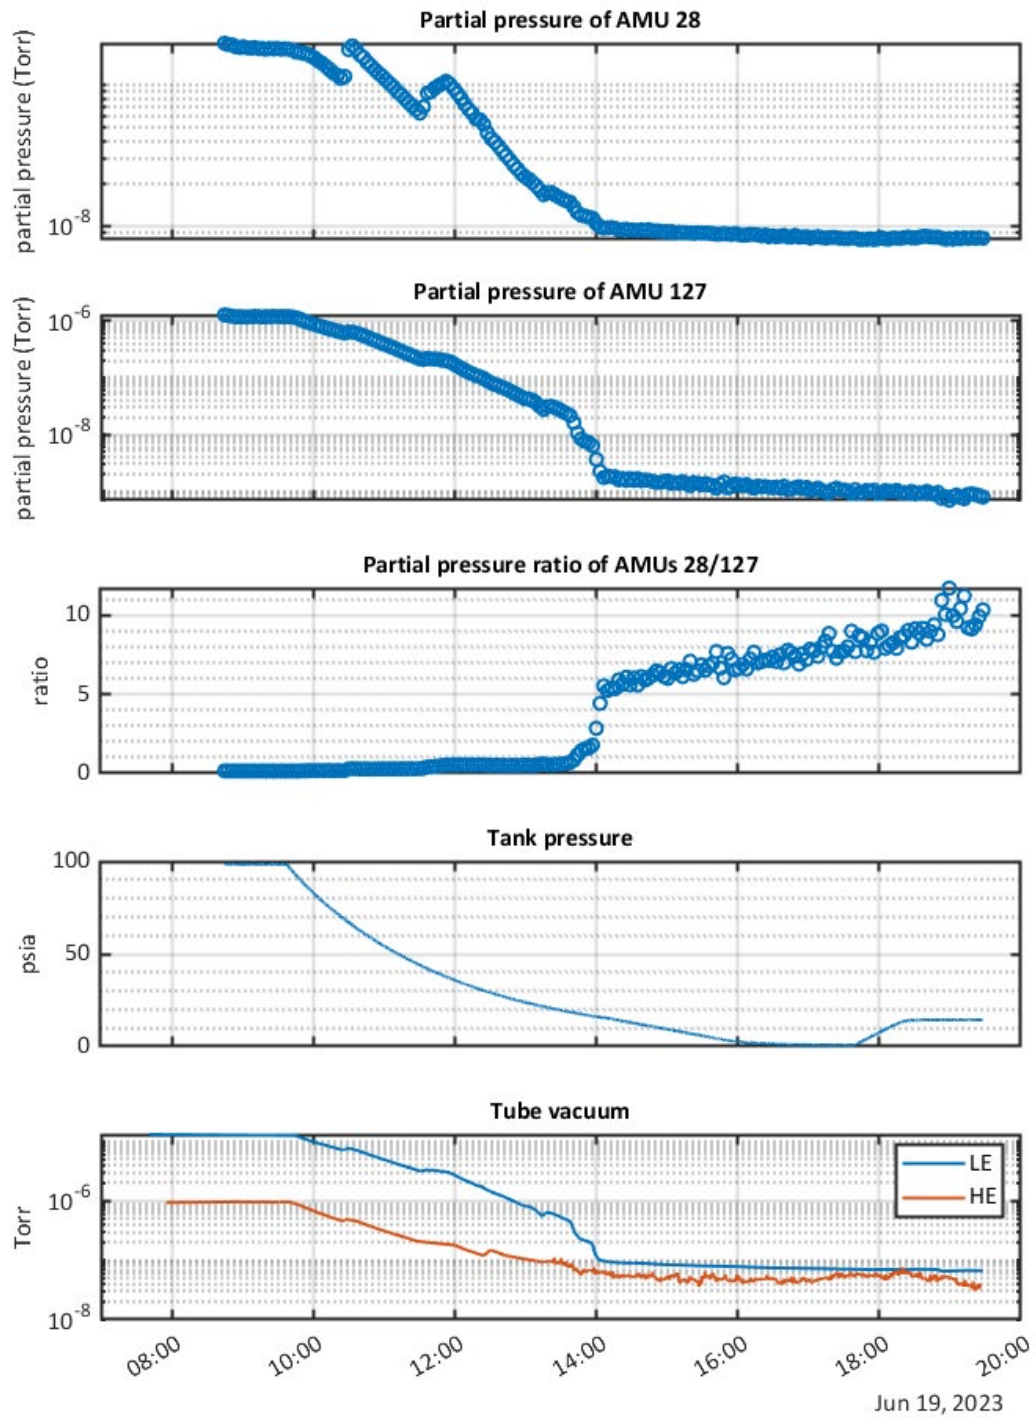
An RGA scan in the usual configuration (RGA at low energy end, shafts off over night and 300lps ion pump off for at least an hour) showed an SF₅ peak at 127 AMU at 1×10^{-6} Torr. This is significant and greater than the levels during the SF₆ issues documented in TOR 117 through TOR 124 (which were of the order of 10^{-8} Torr). The RGA scan is shown in Figure 1.

Figure 1 RGA scan over time during the pump out of the 14UD tank. There is nearly a full order of magnitude step reduction in the SF₅ peak (127) just before the tank reaches atmospheric pressure.

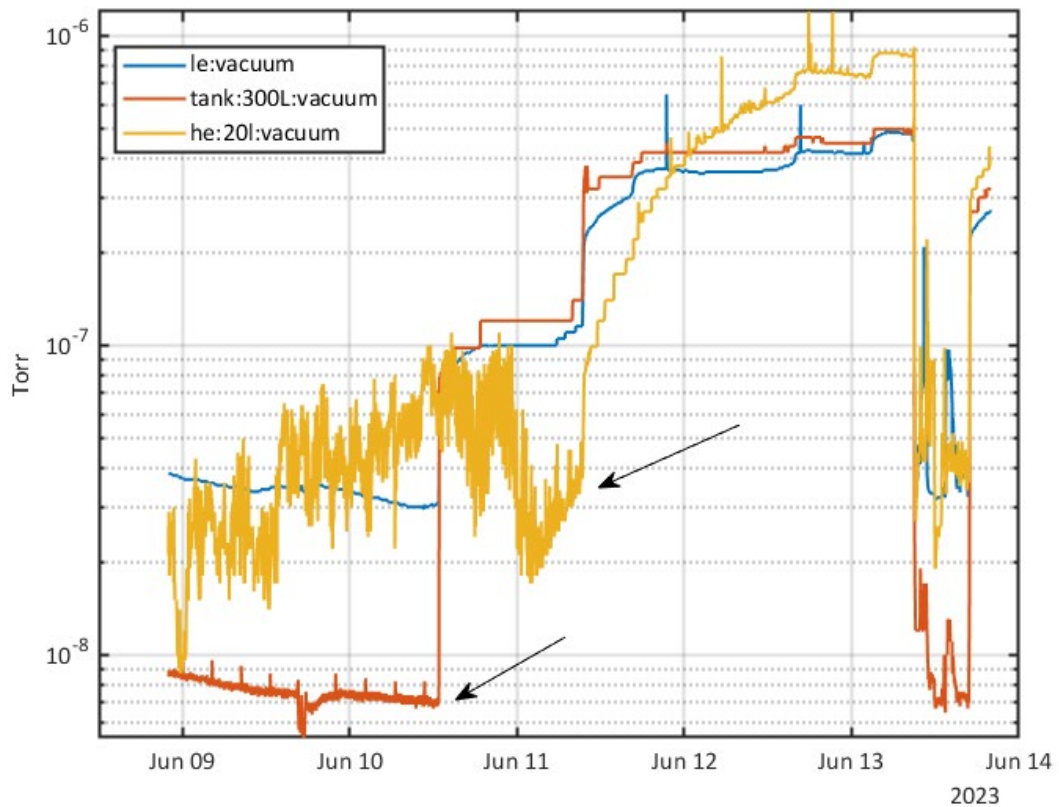
Further investigation showed that there was rapid, order-of-magnitude, degradation in tube vacuums over a four-minute period on the evening of the 10th of July for the low-energy end and on the morning of the 11th July for the high-energy end. This is shown in Figure 2. The machine was not in use at the time, nor were the shafts on.

Figure 2 Jump in accelerator tube vacuum observed in two stages over the 10th and 11th of June 2023. The shafts were not on at times indicated by the arrows and no other event can be determined. The shafts were on during the later improvement in vacuum.

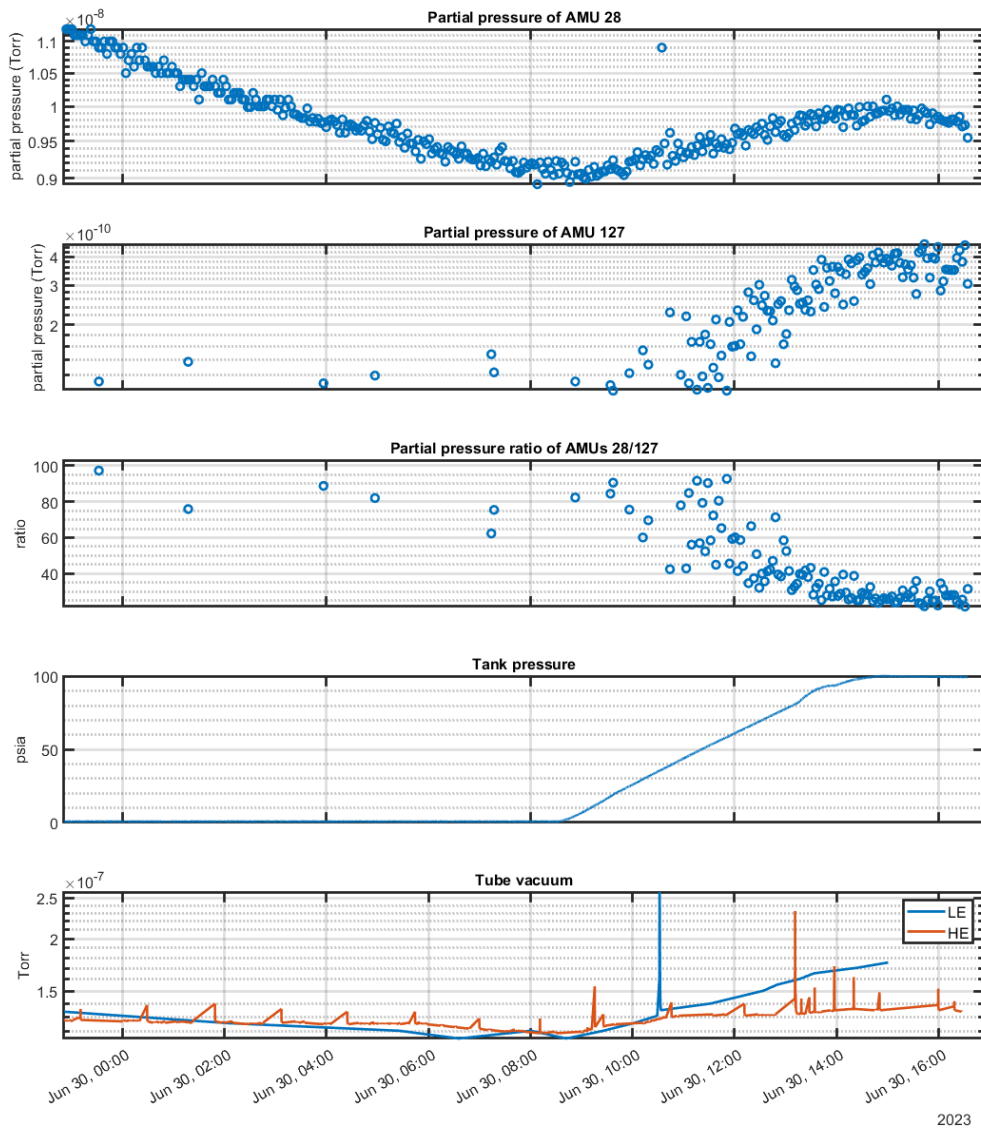
Figure 3 N₂, SF₆ and tube vacuums during tank gas up. A small amount of SF₆ is evident from about 50 psia. It is not at levels of concern, but it is there. IN any case, this is a marked improvement compared to levels shown before the tank opening in Figure 1

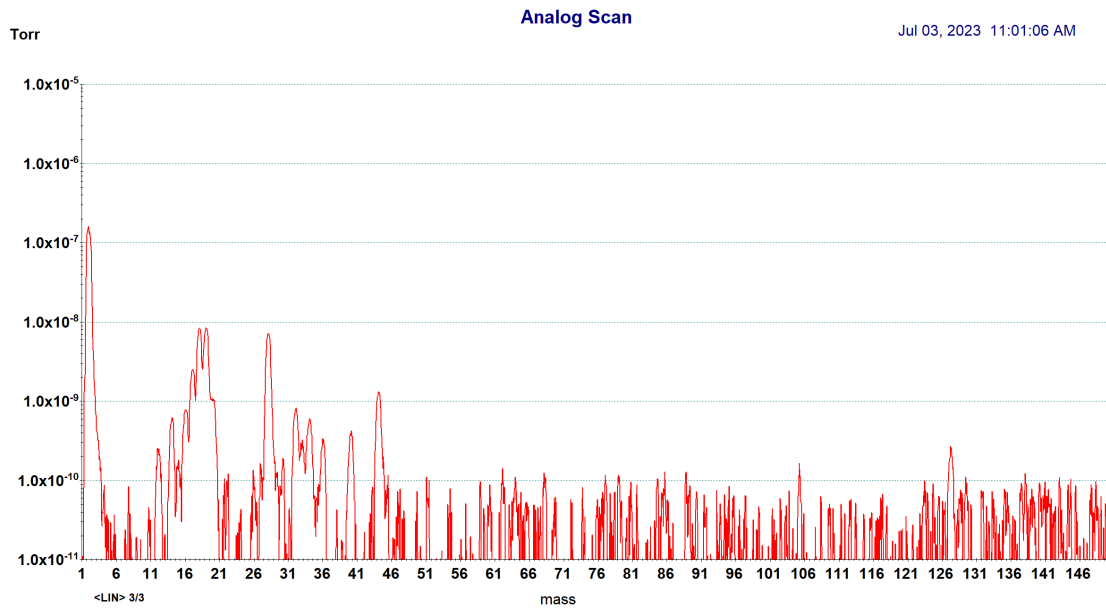
Figure 4 RGA Trace on Monday 3rd July following the tank gas up the previous week. The SF₅ peak is at mid 10^{-10} Torr, which is considered a low background level. Thus, levels have remained static compared to Figure 3.
