# 14 UD Tank Opening Report

#136

5<sup>th</sup> March 2024 – 15<sup>th</sup> of April 2024

Heavy Ion Accelerator Facility

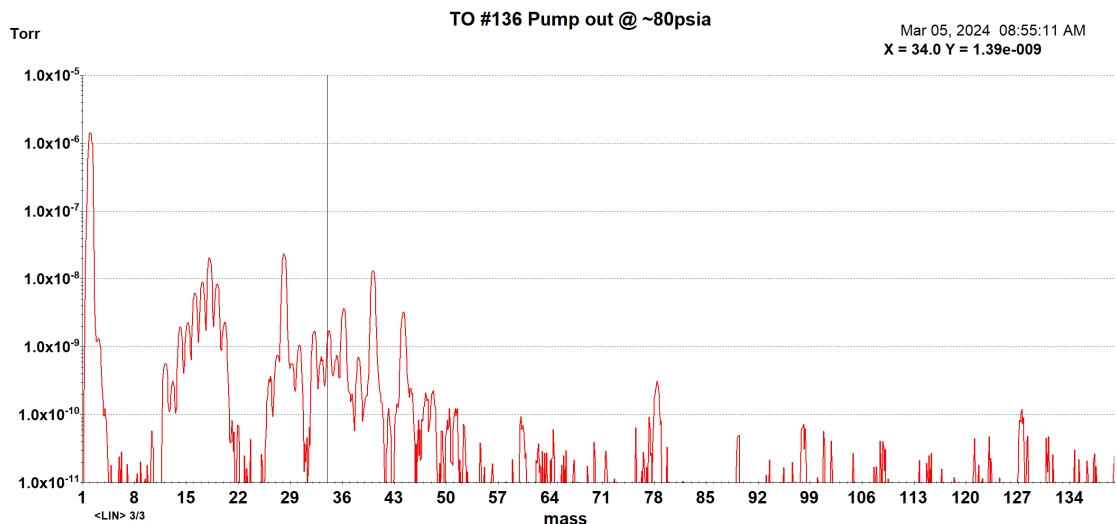
Figure 1 RGA scan during pump out of tank to check for SF<sub>6</sub> levels before reinstalling the gas stripper system. Ideally, this scan should have been before pump out started, but the configuration wasn't appropriate but in any case, it is a good representation of what we should see after stripper installation.

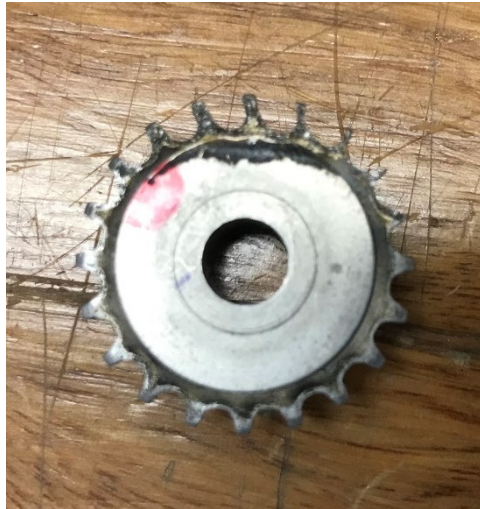
- Baking began again and the vacuum had reached  $3.2 \times 10^{-4}$  Torr overnight just on the turbo cart. Temperatures were monitored and the cartridge heater thermocouple reached  $700^\circ\text{C}$  (!?! ) with the laser thermometer showing  $\sim 200^\circ\text{C}$ . One hour after starting, the vacuum peaked at  $4.9 \times 10^{-2}$  Torr and is slowly coming down.
- A keen eye over the second stripper (HE mid-section) issue discovered spark damage on an idler cog, resulting in damaged teeth and chain. This is highly likely to be the reason for the issue with the stripper. The mechanism also sits very close to the rings, so

measurements are being made for modifications to repositions the system further away from the rings.

Figure 2 Damaged cog in mid-section stripper mechanism

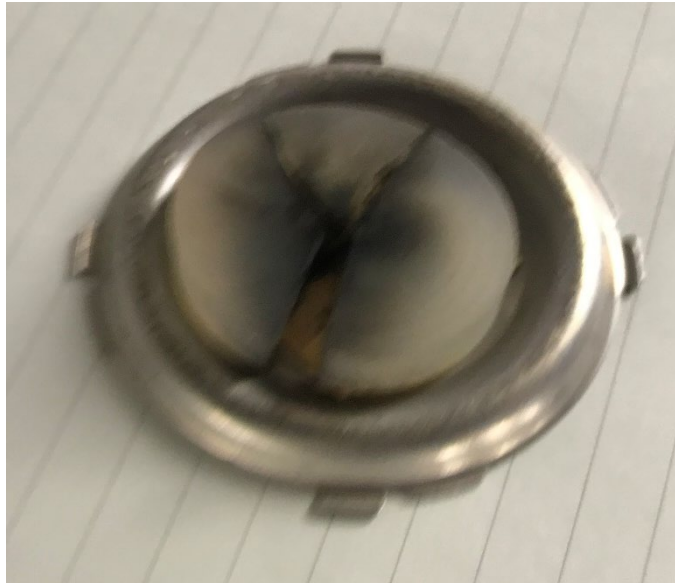
Figure 3 Damaged stand off/insulator on top of terminal control box

- VCR seal at gas stripper manifold was leaking, tightened.
- There is a very small leak through the Weisser valve.
- Opened N<sub>2</sub> bottle.
- Installed new terminal box standoff.
- The timing seems off, but took measurements of the turbo bearing cover. Must have vented.
- Fitted new bearing and carrier to the U12 alternator assembly and reinstalled.
- Clocked U12 shaft

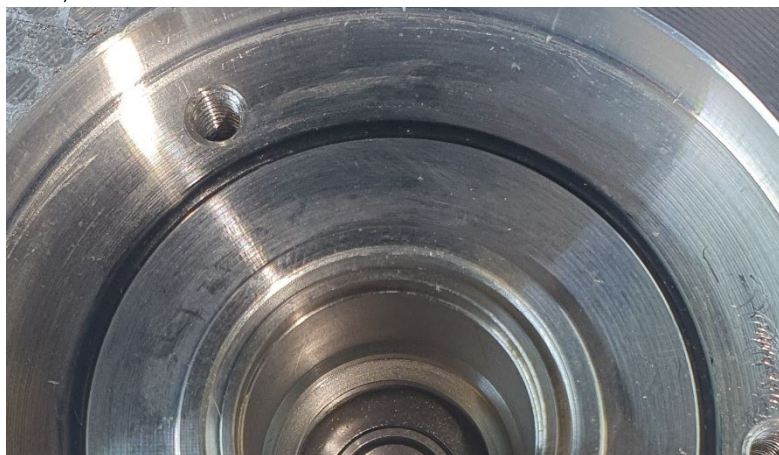
- To check the bearing cover seal, the LE tube was vented to  $N_2$  and the bearing cover was removed. Dirt and debris was found all around the o-ring area, so it was all cleaned (including the o-ring) and reinstalled with new screws (as the heads on the old screws were chewed out).

Figure 4 Dirt and debris on top bearing cover seal

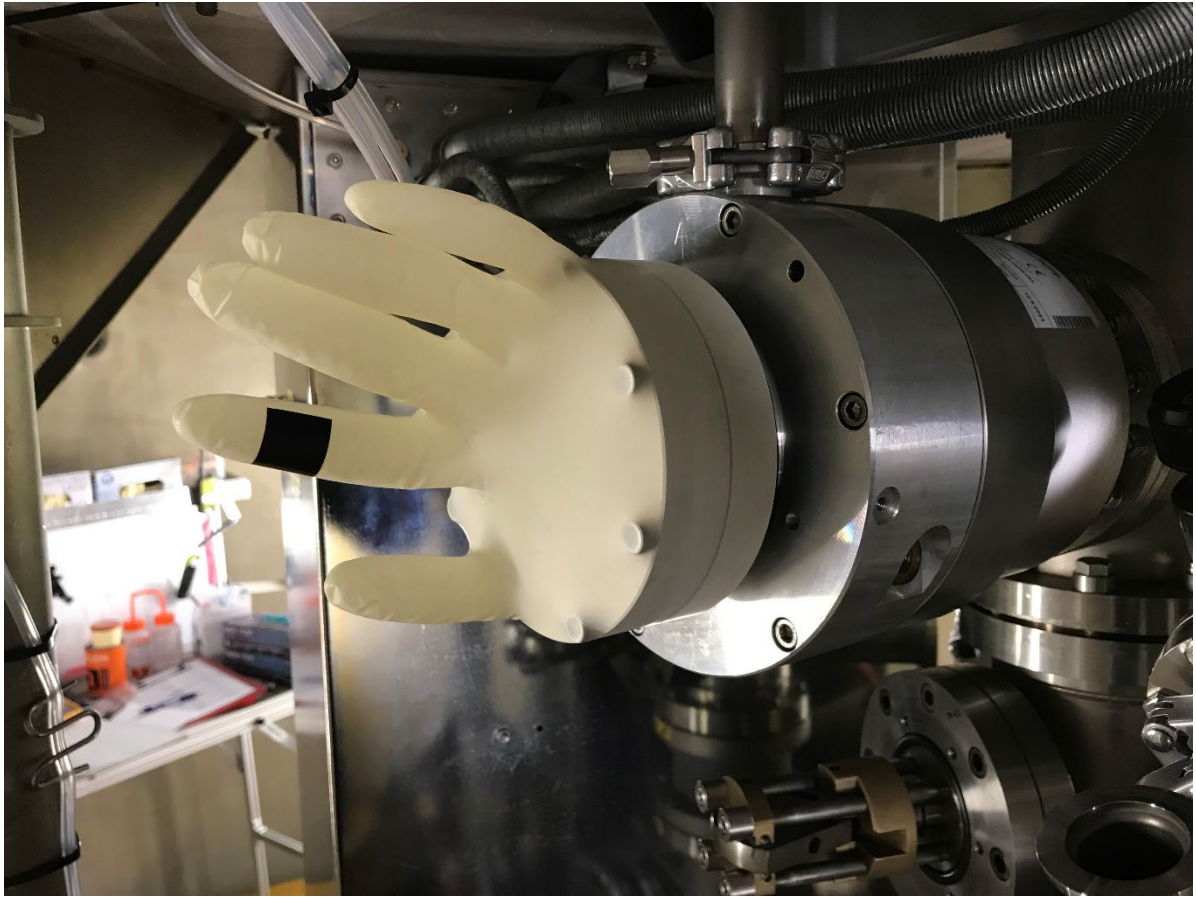
Over a number of He leak tests, it became clear that the rear bearing cover cap of the gas stripper turbos would not be able to hold off a leak, even with changing to a larger section o-ring. This was not surprising in the end as in the operation they are designed for, leaks in this part have no impact.

Figure 5 Leak testing of bearing covers using a Helium pressurised glove

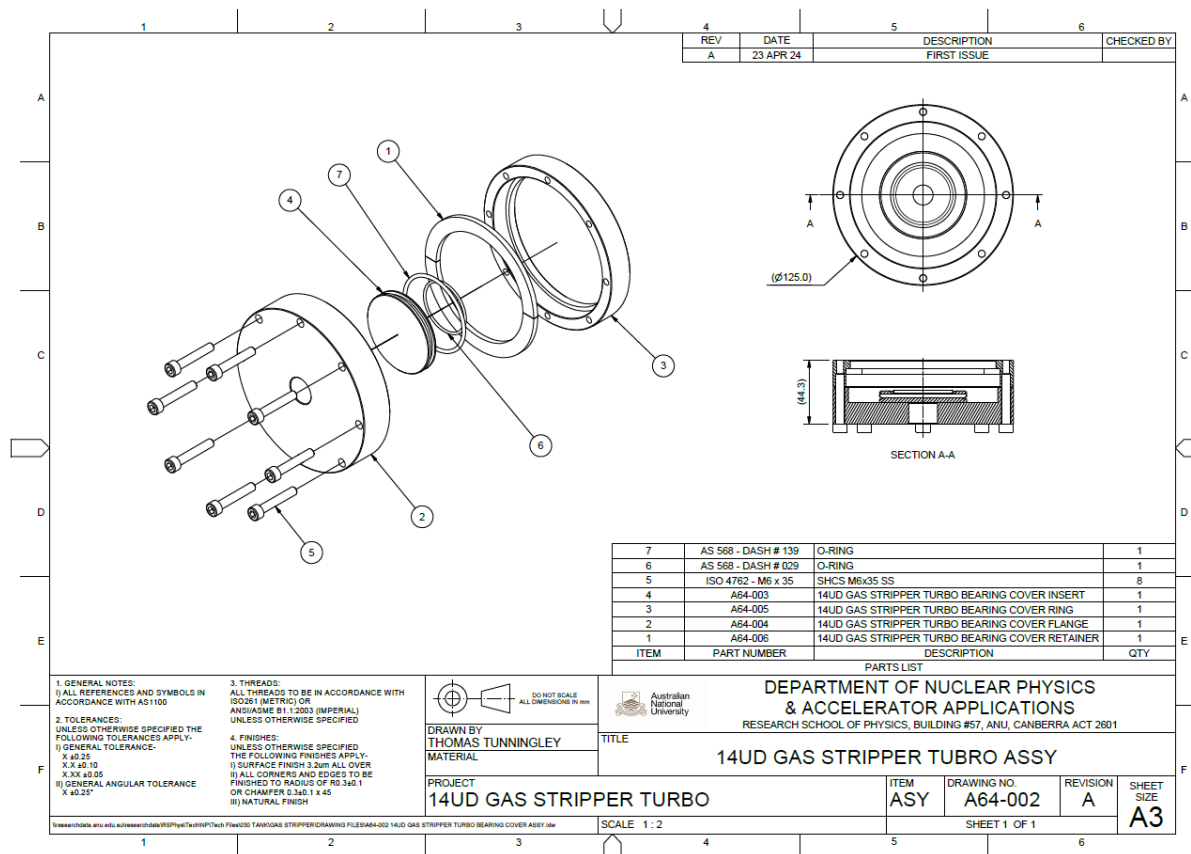
Figure 6 Assembly of modified bearing cover and clamping rings (A64-002)

A new cap with improved o-ring grooves, additional backup o-rings and a clamping mechanism was designed. This is project A64-XXX 14UD GAS STRIPPER TURBO in T:\030 TANK\GAS STRIPPER and is shown in Figure 6.

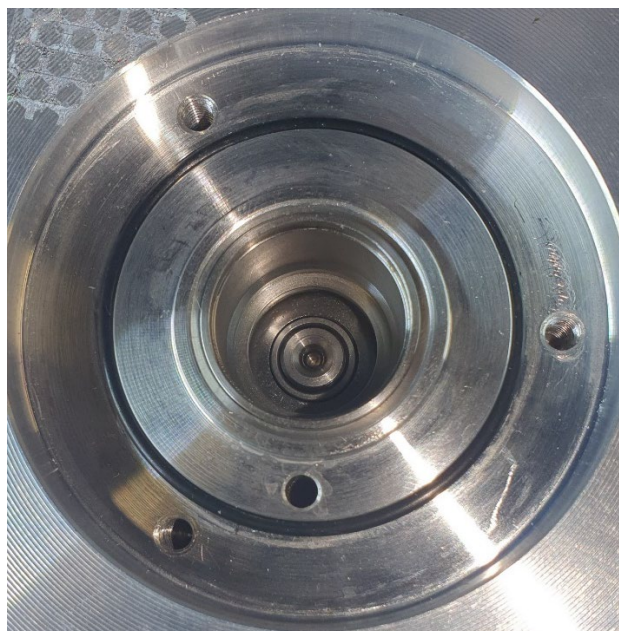
Figure 7 shows the turbos with the bearing cover removed. The small o-ring is the only mechanism that seals this section and there are only three screws into aluminium, which limits the clamping force. The new assembly adds another o-ring to the bearing cover and adds clamp rings to allow a higher clamping force. A half and full assembly is shown in Figure 8 and Figure 9.

Figure 7 View of rear of gas stripper turbos with bearing cap removed. There is a single small cross section o-ring that always leaks.

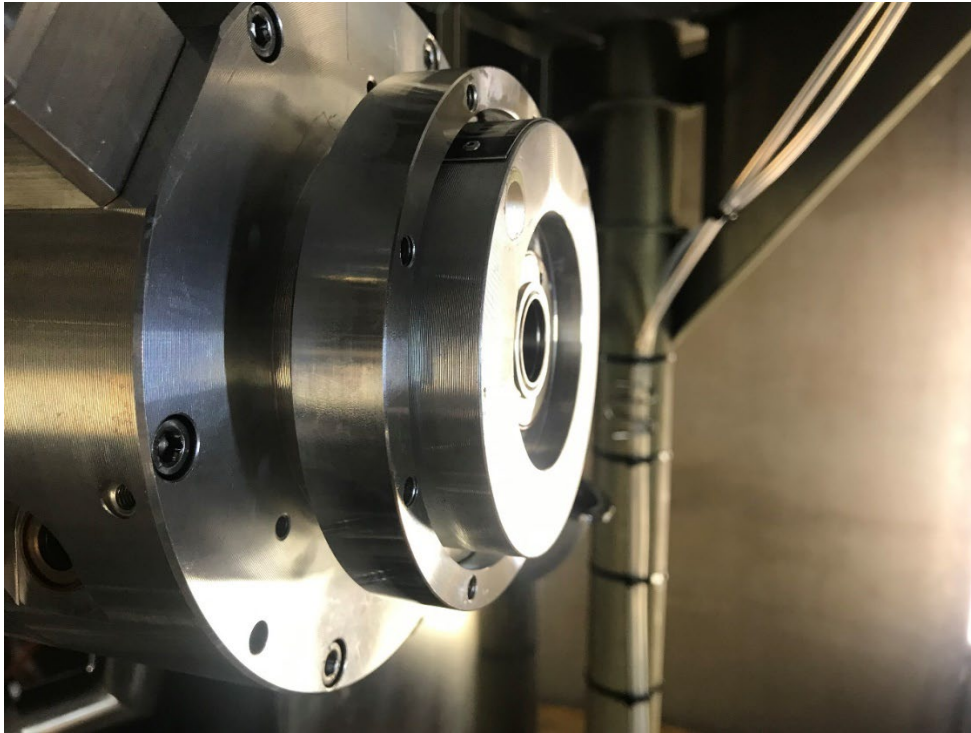
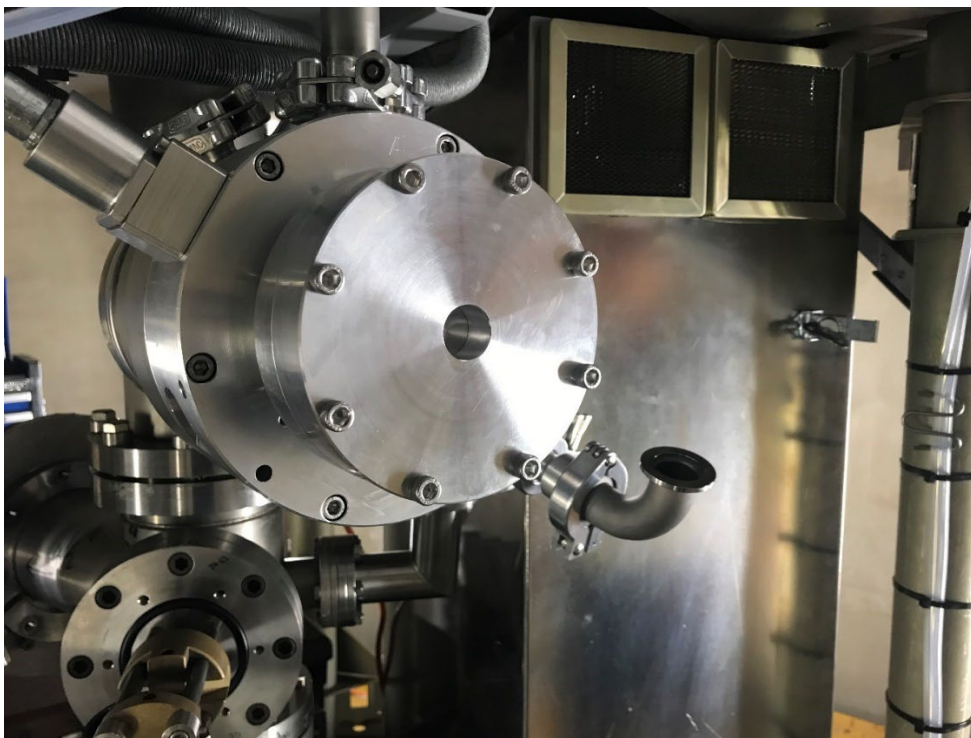
Figure 8 Rear clamp ring of new bearing cap arrangement on gas stripper turbos

Figure 9 Assembled new bearing cap arrangement on gas stripper turbos

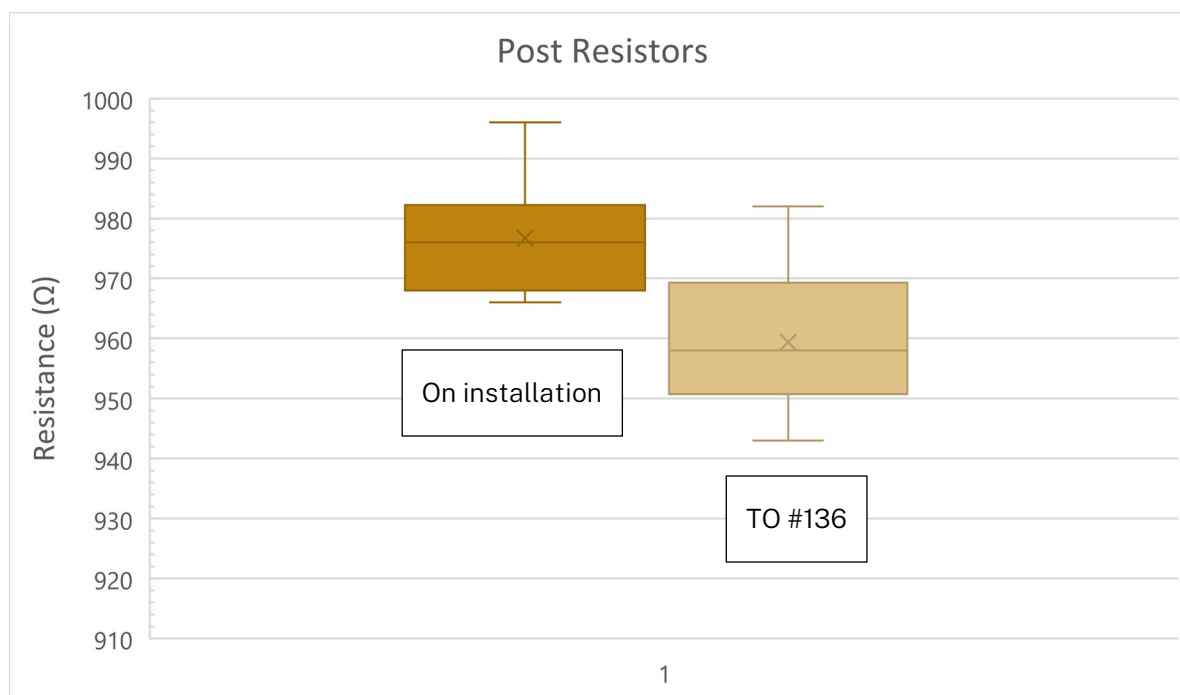
During the entry HV tests, we noted that the resistance of the new EBG resistor equipped unit had dropped. All resistors were removed and tested on the bench. We were able to compare to the values measured before installation in TO #134. Data is stored in

Nominal values are 980M $\Omega$  and 300M $\Omega$  respectively with a nominal tolerance of 2%. The changes are shown in Table 1, Figure 10 and Figure 11.

Figure 10 Quartile representation of U16 post resistors before installation in TO #134 and after use during TO #136

Resistors were reinstalled because we need to determine if the resistances will settle over time.

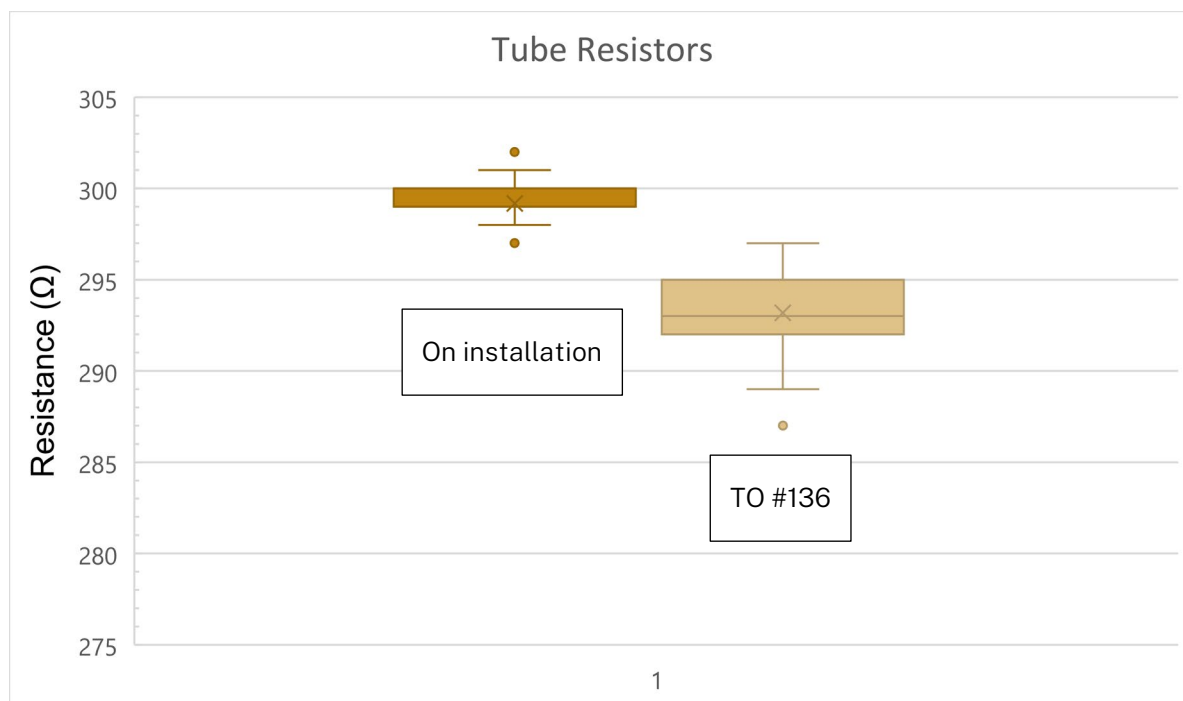
Figure 11 Quartile representation of U16 tube resistors before installation in TO #134 and after use during TO #136. Note the appearance of outliers.

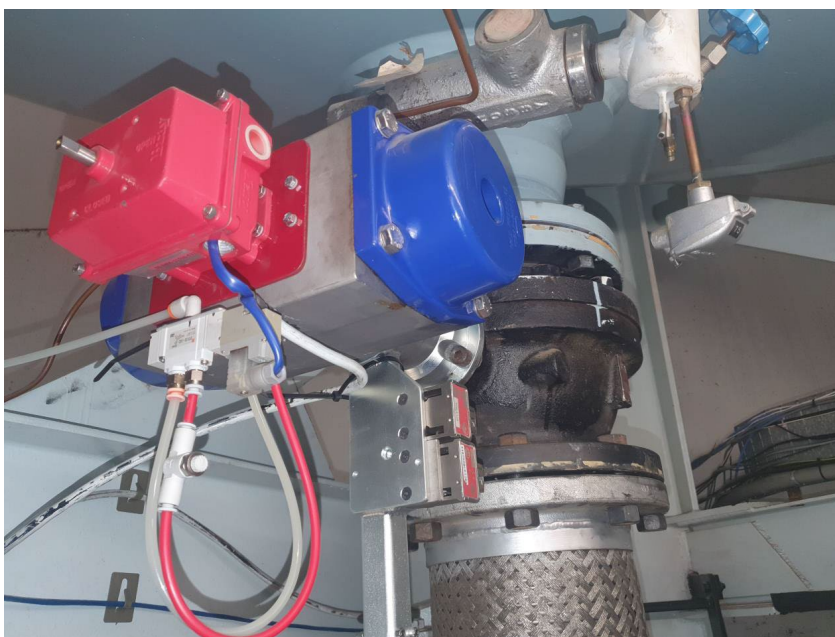
During routine SF<sub>6</sub> leak chasing in May 2023, a leak was discovered around the stem of the main tank valve of the 14UD pressure vessel,

Figure 12 Old valve and bellows before removal

The valve was original equipment from the 1970s so we decided to order a new replacement. The bellows below the valve was of the same vintage and would need to be removed for access so it was also renewed. An 8-inch ball valve, JC brand, was ordered from Global Supply Line and custom length 8" flexible bellows from Radcoflex.

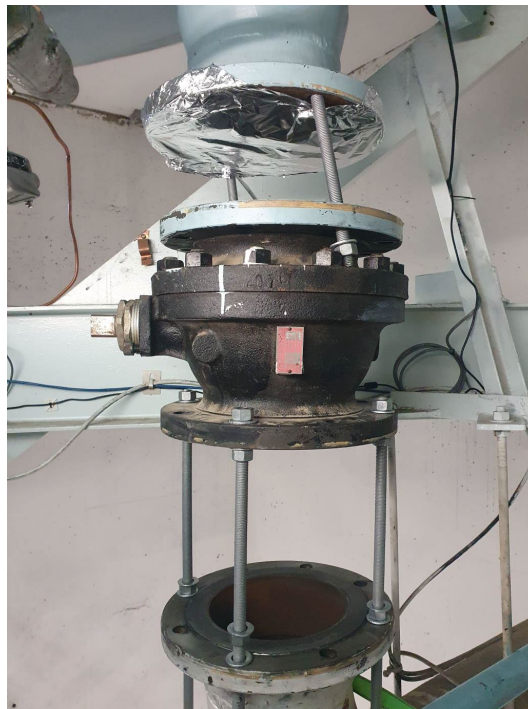
Another consideration was the gaskets used in the original installation. Other gaskets in the gas handling plant room were found to contain asbestos and these looked suspect. WSP were called in to test the gasket material and found the gaskets contained chrysolite asbestos so would need removing by hazardous waste specialists. This process was particularly difficult due to the location of the tank valve at "Level 1 ¾" which is 12m from ground level, and also its weight which was believed to be around 90kg. Special jigs were designed by Cooper and manufactured by Tranter to enable gasket removal with the valve and bellows still in place by lowering them down threaded rods. Aztec building services asbestos team was called in. They were able to remove and clean the gasket material and leave the heavy lifting for us when the area was declared decontaminated.

Figure 14 Old valve after asbestos gasket removal

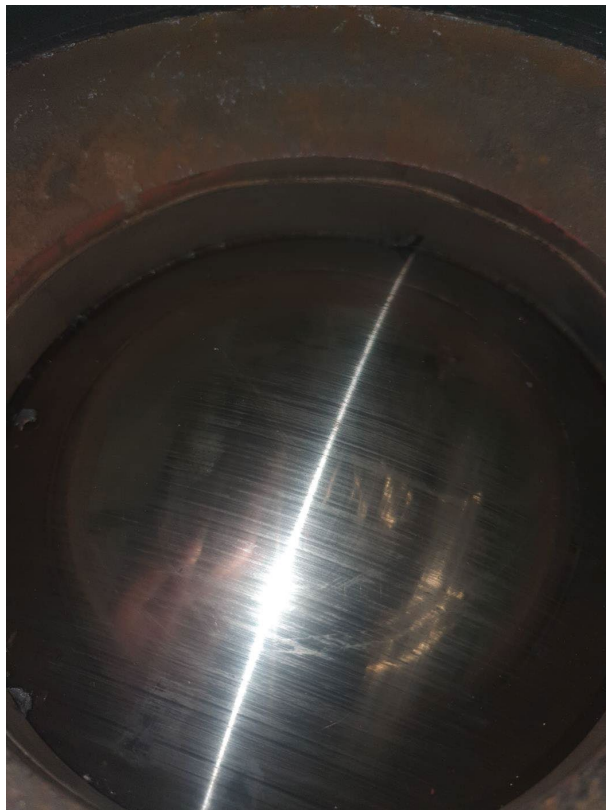
Figure 16 Scratches and scuffs on old ball valve

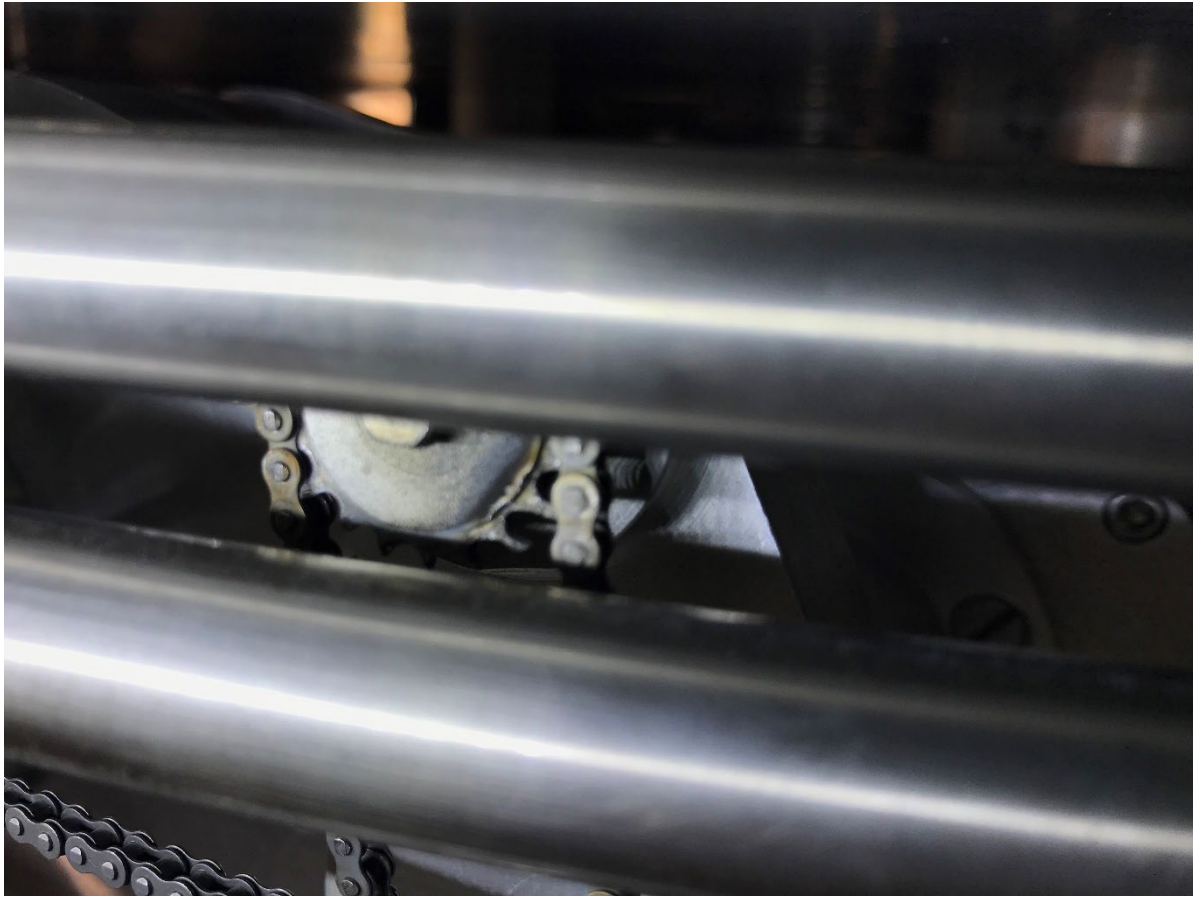
Figure 21 HE stripper sprocket in situ

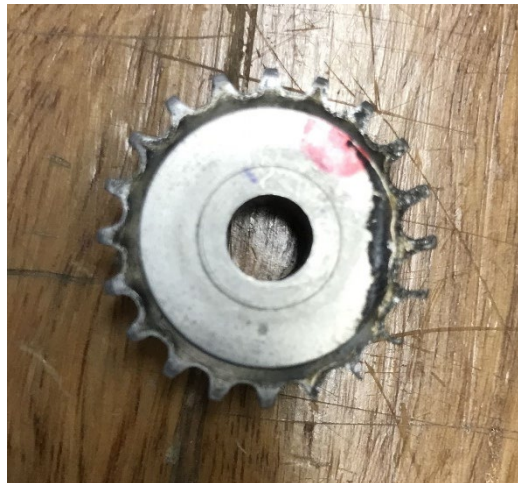
In a random inspection, it was noted that there was spark damage to the sprocket on the foil change mechanism, and this could explain the difficulty in changing foils, especially when attempting to move several in one go. When operating the foil changer, it could be seen rubbing on the ring. Further investigation revealed the extent of damage to the sprocket, so it was decided to replace it.

Figure 22 HE stripper sprocket spark damage

In making a replacement sprocket, we could move the chain back away from the ring, and a new sprocket was designed to do that. It was made from some blank already machined and kept with the micro pitch chain bits. The freshly manufactured sprocket was a little 'sticky' with the chain and would occasionally grab, which seemed to be because the root of the teeth was quite deep. Some finishing and run-in was performed on the sprocket and its performance was improved. It was also decided that the chain be replaced as it was likely that the old chain had also suffered spark damage. Fitting the sprocket was somewhat difficult. After the initial fitting, it was noticed that the chain was still quite loose, but removing another link would make

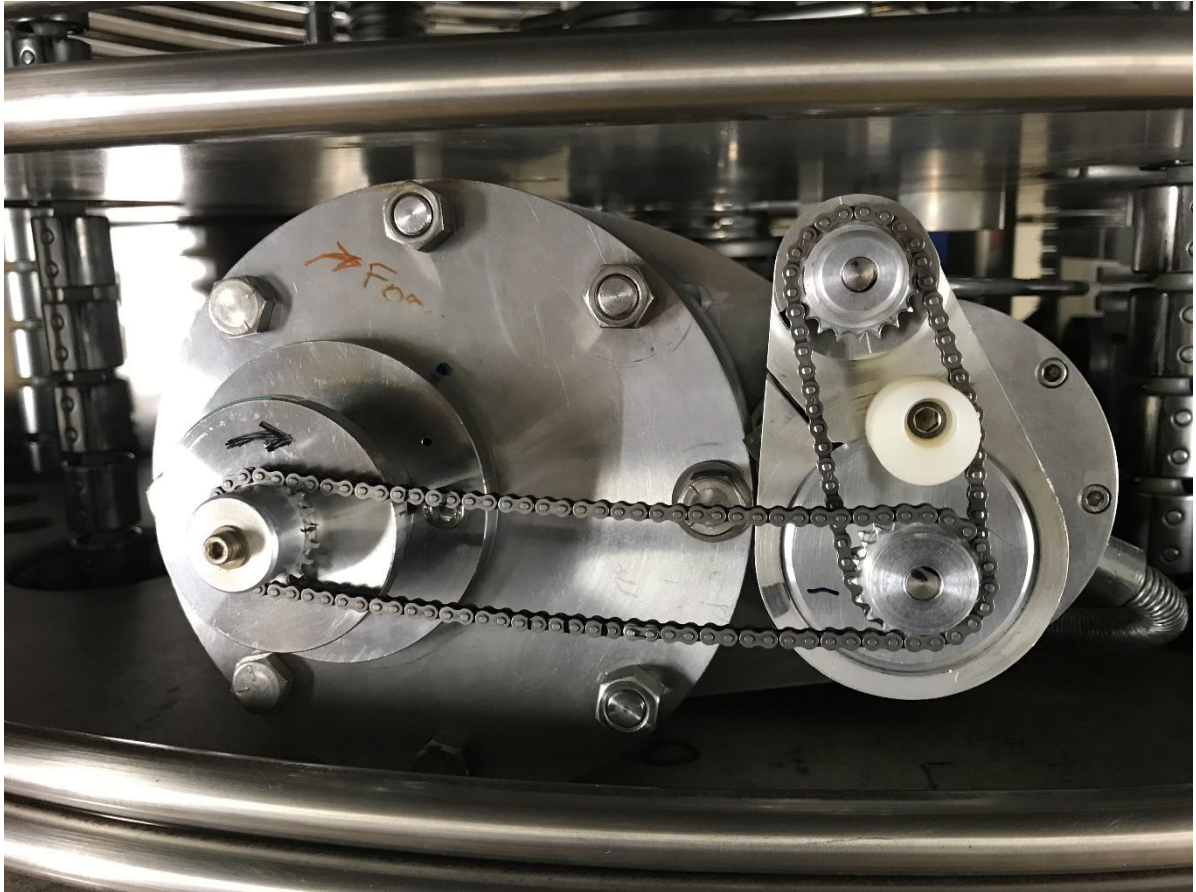
Figure 23 HE stripper assembled with new sprocket and nylon idler

it too tight, so a nylon idler was made with an eccentric mounting hole to adjust the tension. Before refitting the chain, the mechanism and motor were synchronised to ensure that the motor was not stalled midway between counts.

With the new sprocket, chain, and idler installed, the mechanism was extensively tested in both forward and backwards directions and seemed to operate well, and the gap between the ring and sprocket looked acceptable.

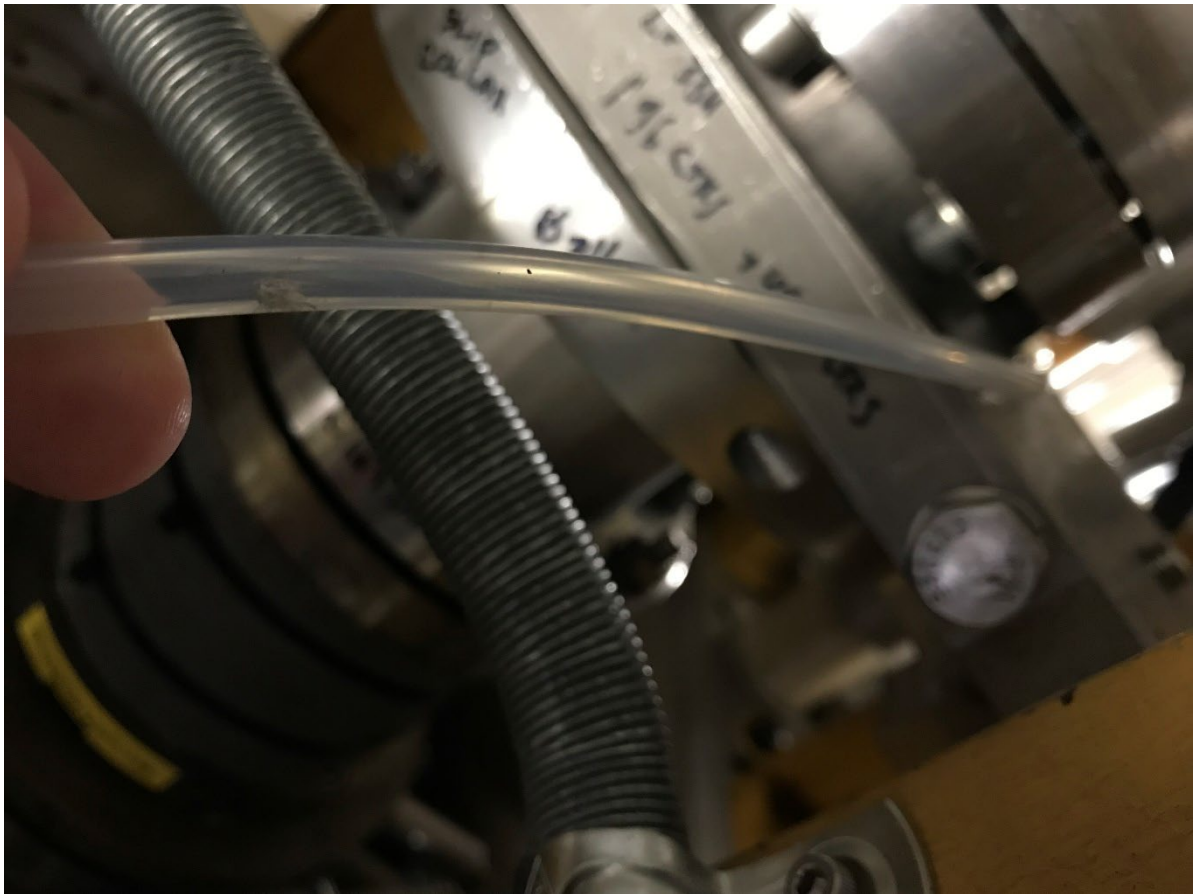
It was a known issue that the terminal cup had not been operating properly for a while. With the shafts on to power the terminal and the external SF6 bottle turned on, the cup was actuated. In the activated position, the mechanism did not trigger the limit switch. The mechanism was not at a hard stop as it could easily be pushed by hand to hit the limit switch. It seemed to actuate and relax. An increase in bottle pressure did not help. A later attempt was made to operate the cup, this time without being powered by the shafts. During this test we found an audible leak previously disguised by the shaft noise. The leak was quickly traced down to the pneumatic supply line, possibly because of spark damage. A section of tube was cut and removed, then replaced with a new piece of tubing (PFA to match) joined with a Swagelok union. The cup was then tested and operated correctly.

Figure 24 Holein PFA tubing to tank cup

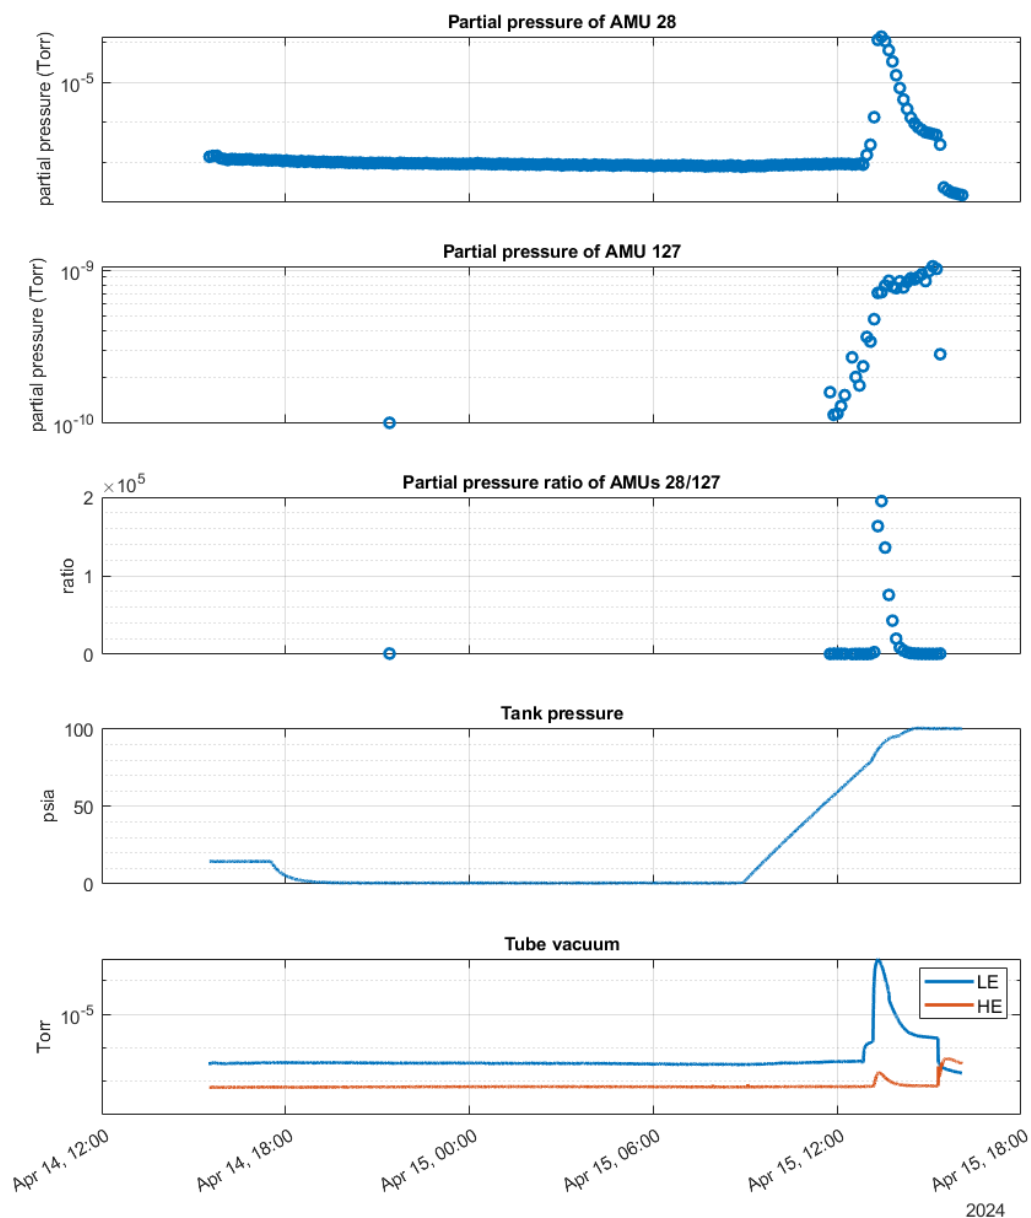
Figure 25 Recording of SF<sub>6</sub> levels during gas up at the end of the tank opening. SF<sub>6</sub> starts being detected at a tank pressure of about 60psia. This is expected but does rise to the  $10^{-9}$  Torr level which is very slightly higher than we would like. The large increase in low energy vacuum is due to a leak in the inflection valve at level 5 during a swing of the inflection magnet and is not related to SF<sub>6</sub> issues in the tank.

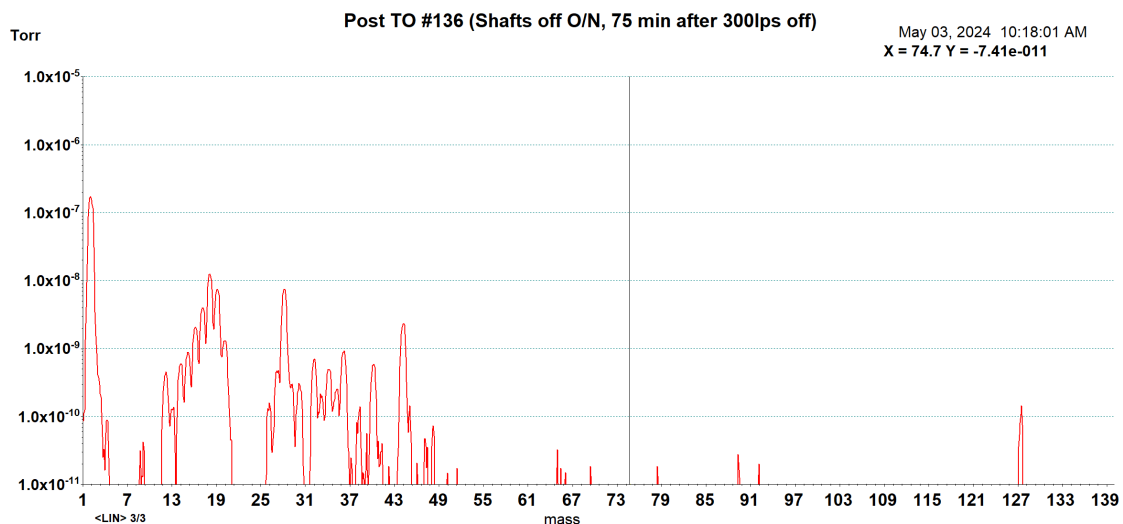
On May 3, another  $\text{SF}_6$  RGA was performed as shown below. The 127 mass peak ( $\text{SF}_5$ ) was at a very low  $10^{-10}$  range which is a particularly good background for the current state of the machine. It matches the  $\text{SF}_6$  levels observed without the gas stripper system installed.

Figure 28  $\text{SF}_6$  trace (single, average of 3) taken on May 3 after a couple of weeks of operation. The  $\text{SF}_5$  peak is at  $1.3 \times 10^{-10}$  Torr, which is back to historically “best” levels.
