## AUSTRALIAN NATIONAL UNIVERSITY

DEPARTMENT OF NUCLEAR PHYSICS

14UD TANK OPENING REPORT No.57

26th February 1987  
(1 day open.)

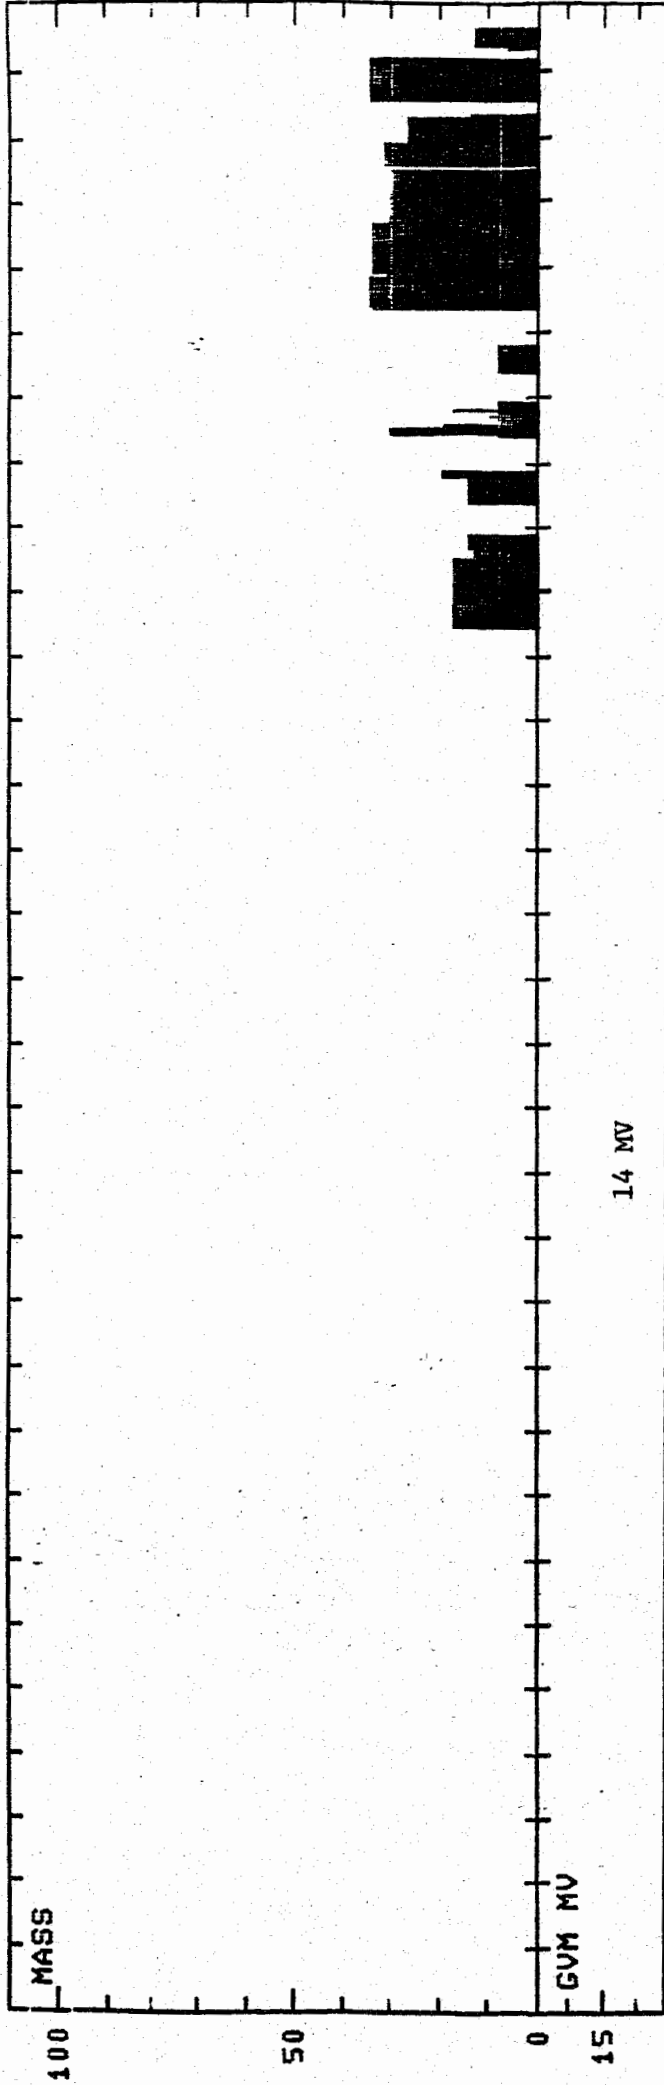
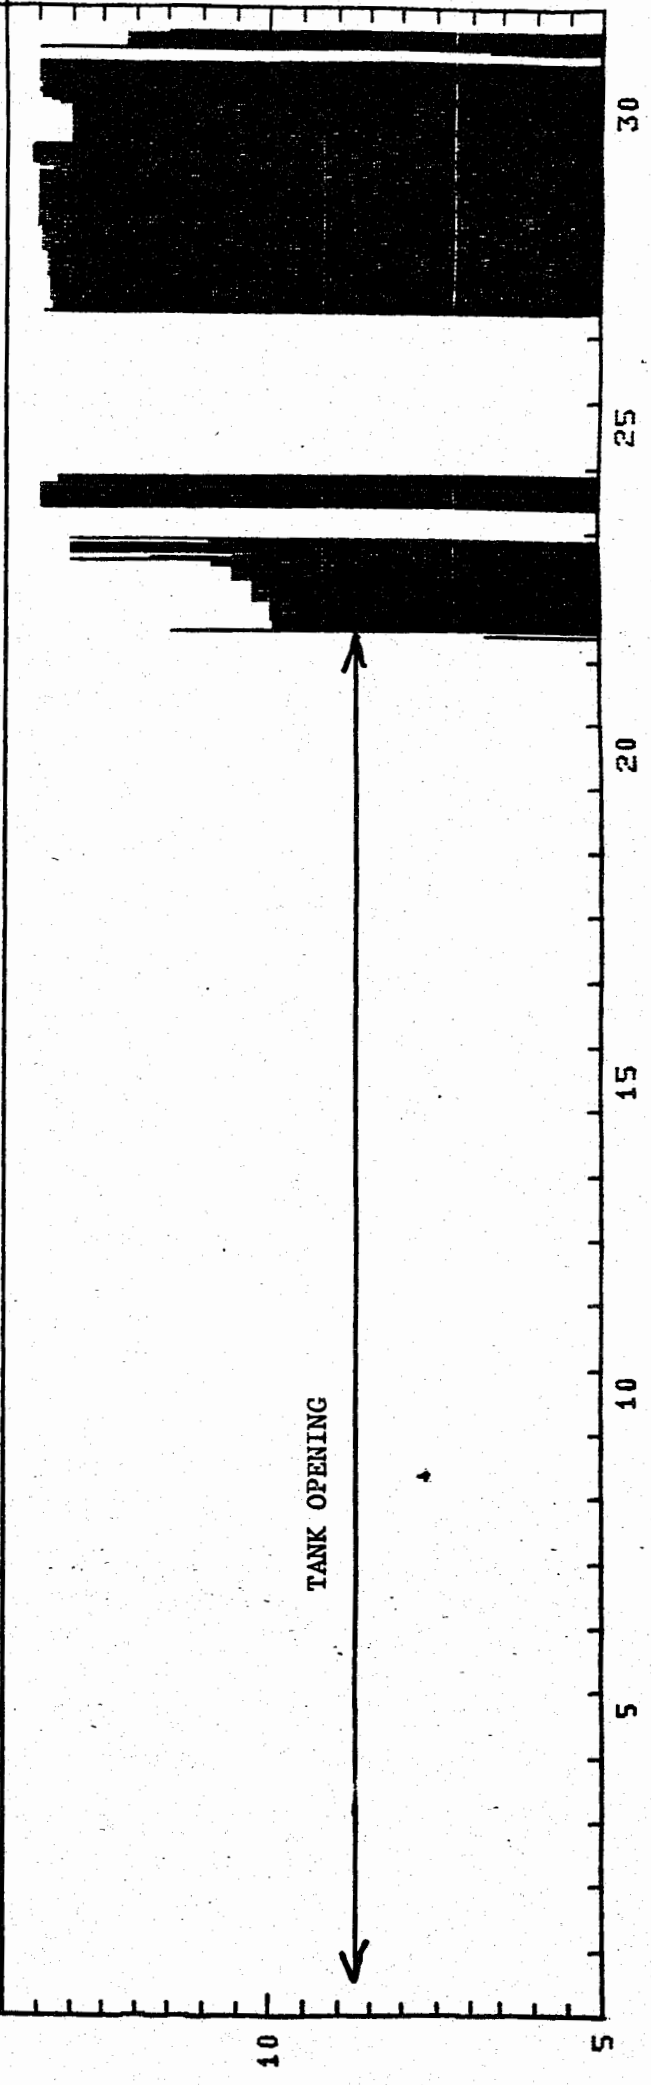
14UD 109 JANUARY 1987

Plots of particle masses accelerated, and operating terminal voltages.

NOTE: On the plot of terminal voltages we have drawn a horizontal line at 14 MV for easy reference to performance near the nominal voltage limit of the 14UD.
