AUSTRALIAN NATIONAL UNIVERSITY

DEPARTMENT OF NUCLEAR PHYSICS

14UD TANK OPENING REPORT No. 59

29th June to 22nd July 1987

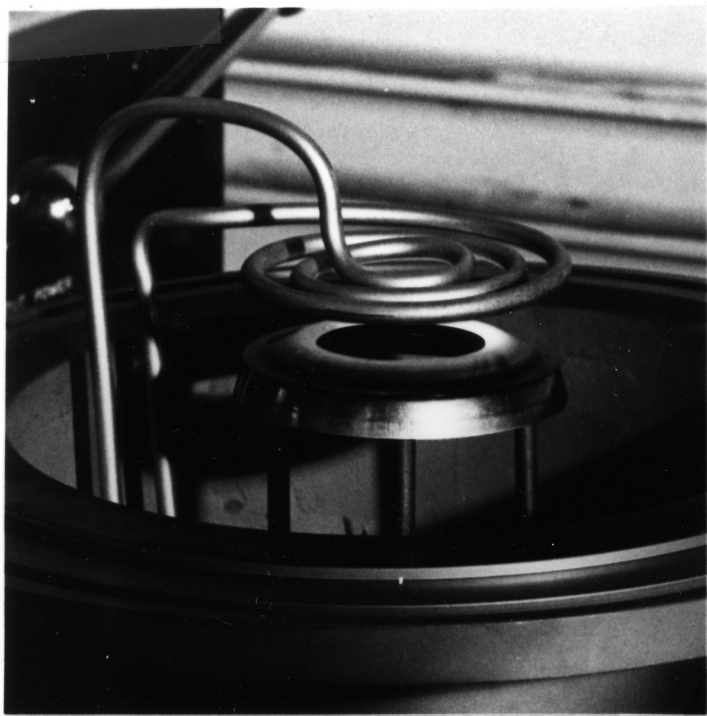
1

The electrodes were oxidized by heating in air to about 700°C for a couple of seconds using an RF induction heater, (see photo No.1).

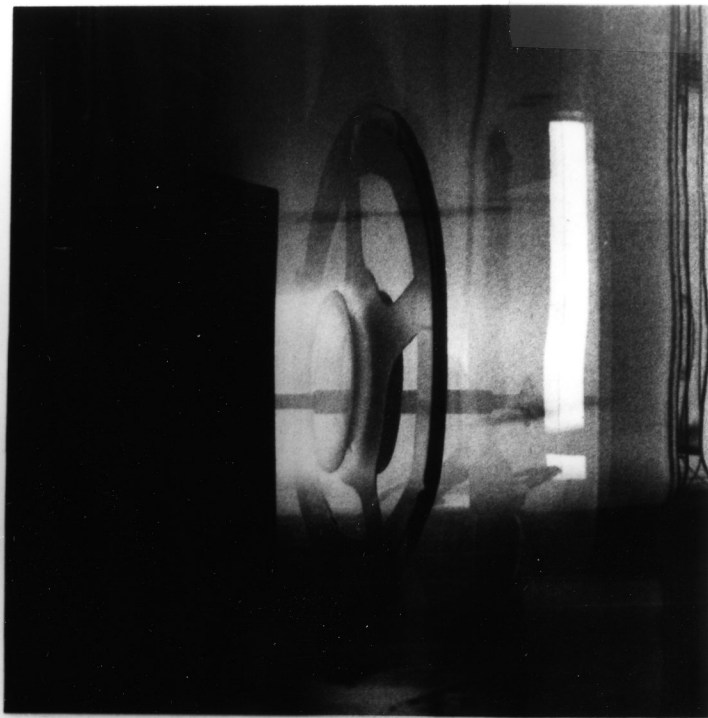
2

We chose to remove the oxidation residues by sputtering them away in an argon-magnetron sputtering device. This was adapted from our Nb sputtering effect on superconductors, (photo No. 2). Robert Rathmell told us that the first tubes at Munich had been argon sputtered and continued to bleed argon into the tube for years. We eliminated

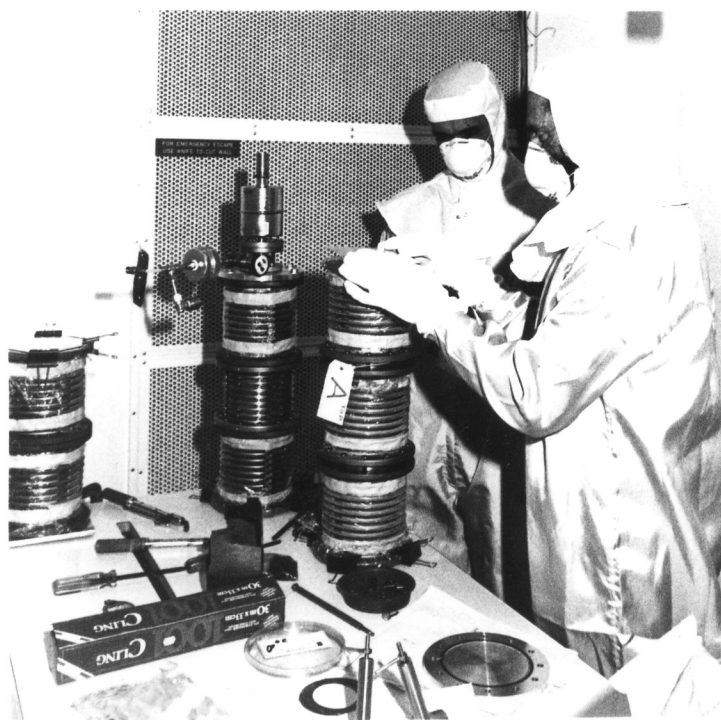
Electrode treatment was being developed concurrently. As soon as tube sections for units 3 and 4 became available, they were fitted with new untreated electrodes. Three element assemblies were sealed together in the clean room and then removed for helium leak testing, (photos 7 and 8).
